#### Watershed Conservation Resource Center

#### 319 Program Stream Restoration Projects Update

# 07-400/07-2000 West Fork White River Stream Restoration Project **Update**

### 09-1900 White River Bank Stabilization Project

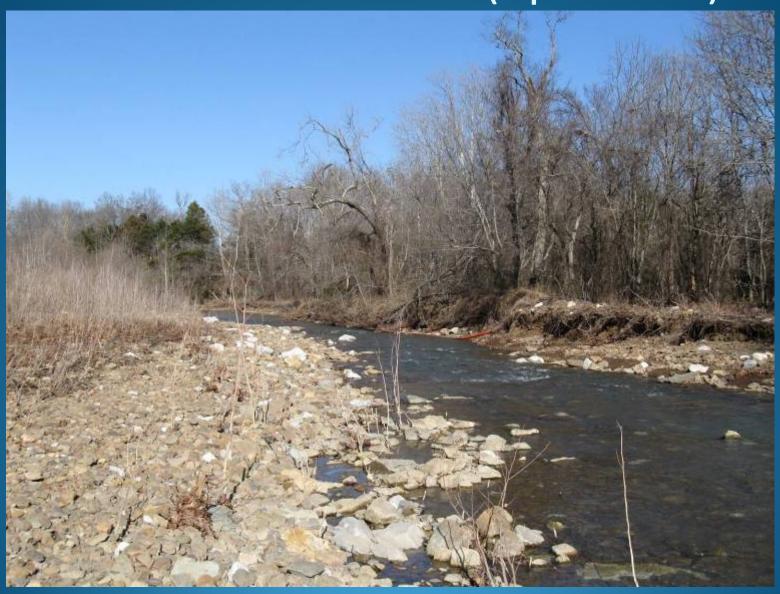
## Site Photos Before Restoration (upstream)

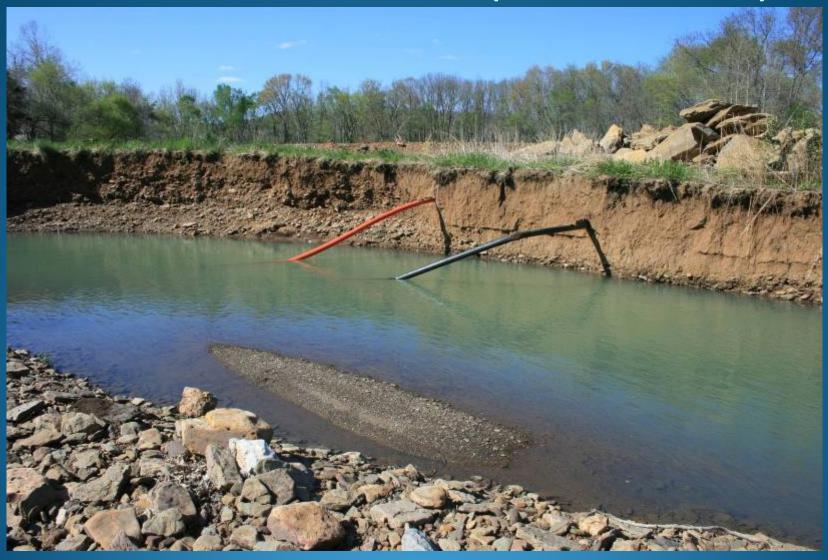
## Site Photos Before Restoration (mid-section)

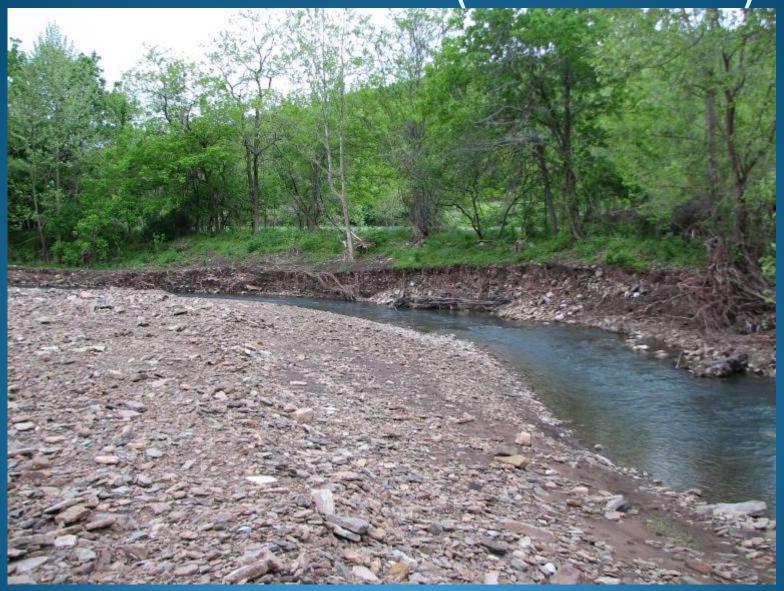
## Site Photos Before Restoration (downstream)

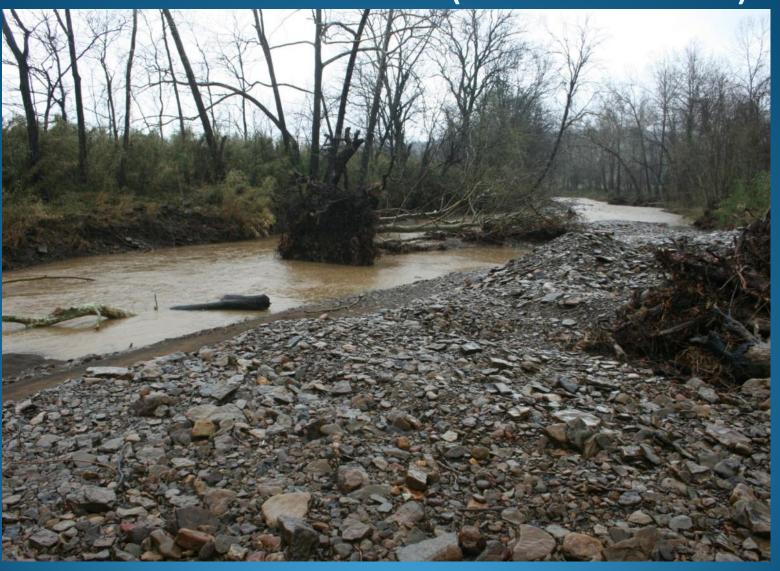
## Site Photos Before Restoration (downstream)

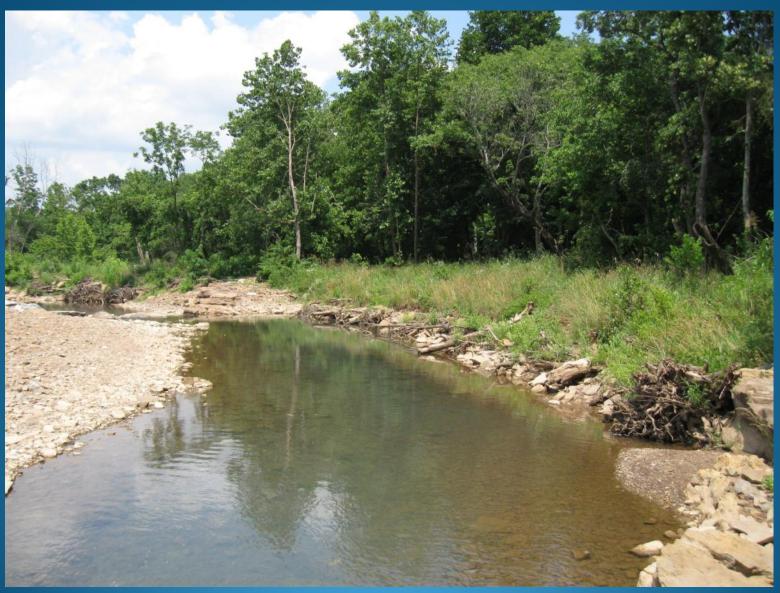
## Site Photos After Restoration (upstream)

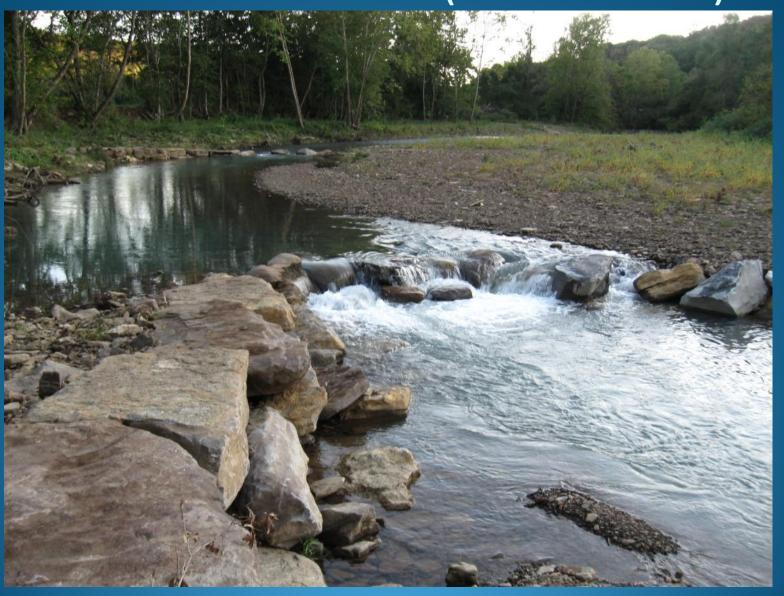
## Site Photos After Restoration (mid-section)

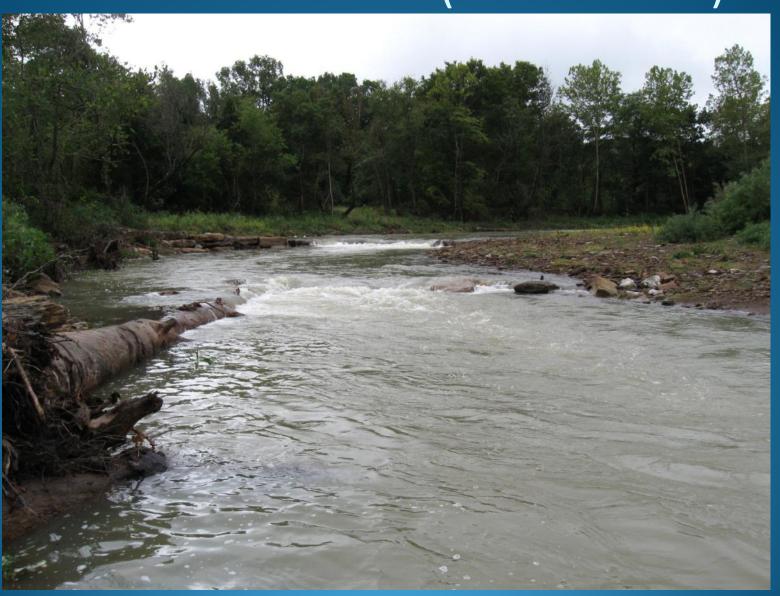
## Site Photos After Restoration (mid-section)

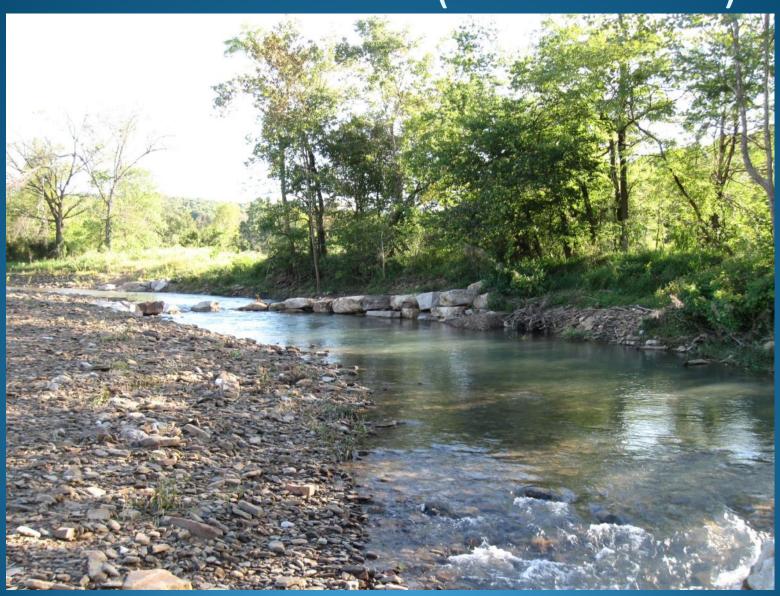
## Site Photos After Restoration (downstream)

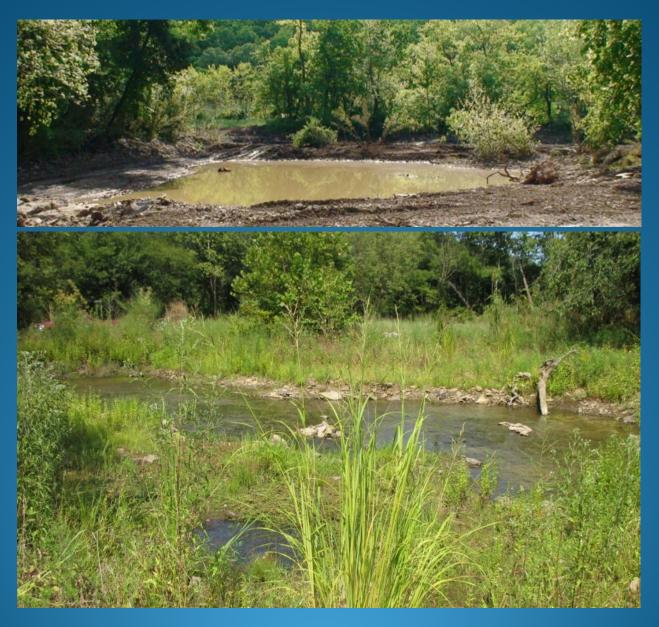
#### Site Photos: Constructed Wetlands

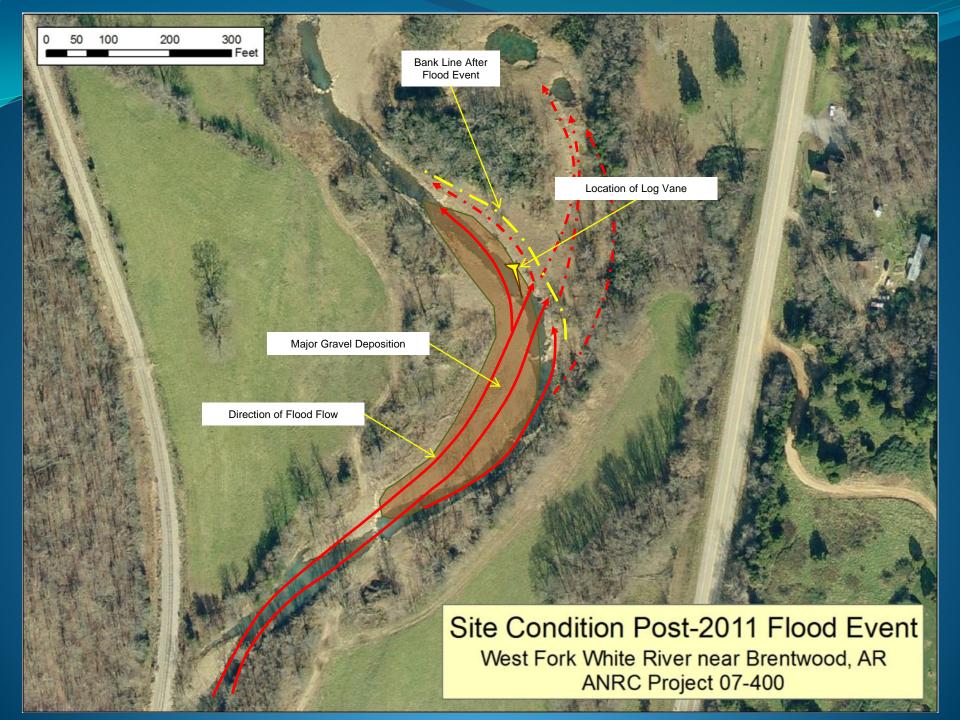
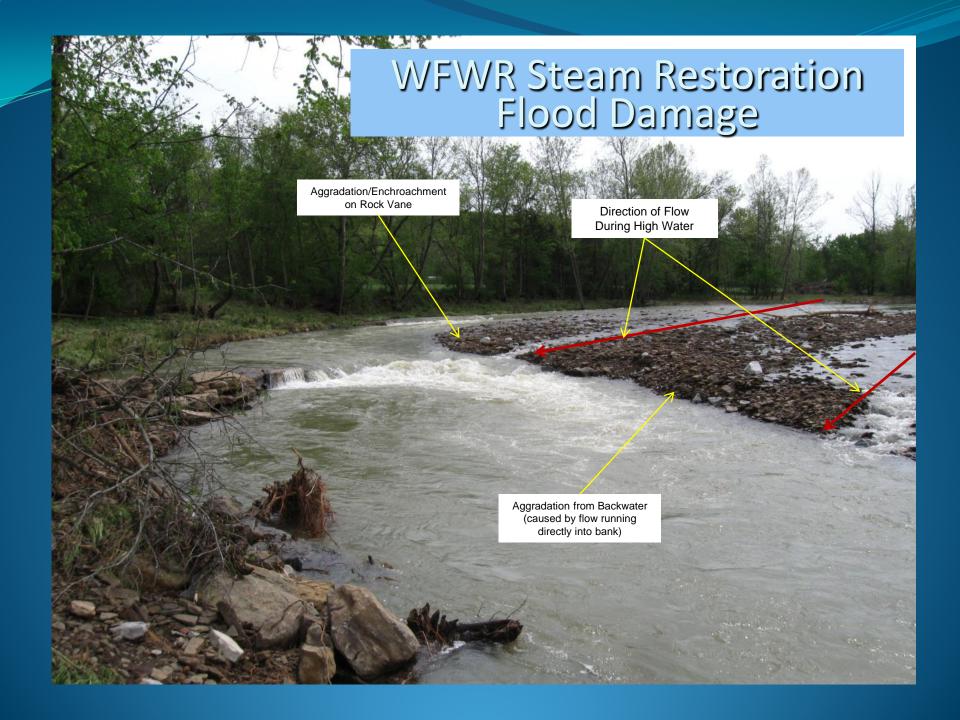
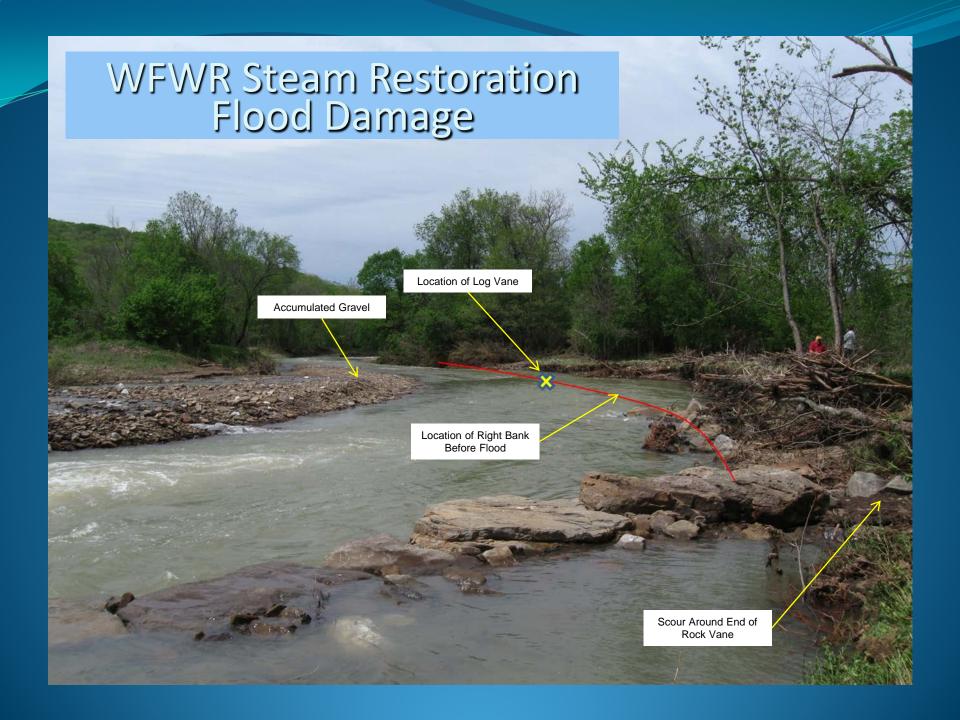
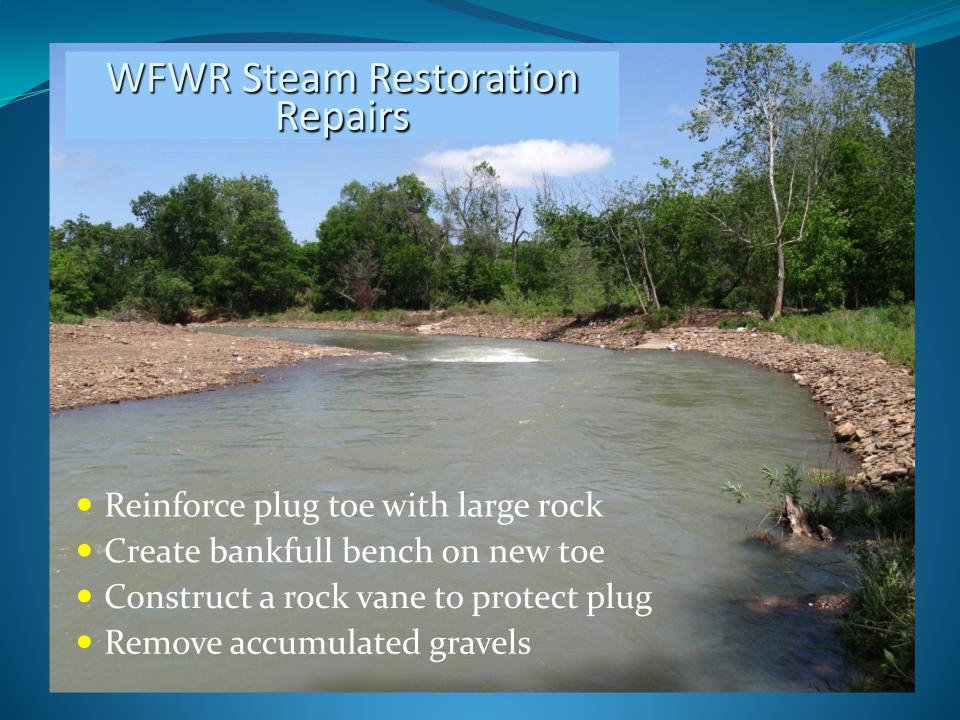
### April Flood – NWA 2011

Although historic flooding caused damage to the project in 2011, significant loads reductions are being realized

- Avoid Placement of Log Vanes in Critical Areas
- Priority 2 Restoration Watch flood channel dimensions within and upstream and downstream of your project
- Priority 2 Restoration: Plan for Channel Maintenance
- "Work with the River" when possible
- Go with rock in most vulnerable areas
- Develop contingency funding mechanisms
  - Bonds
  - Set-asides
- Pre-implementation budgets and on the ground realities do not always coincide
- Get in and repair ASAP to avoid further damage

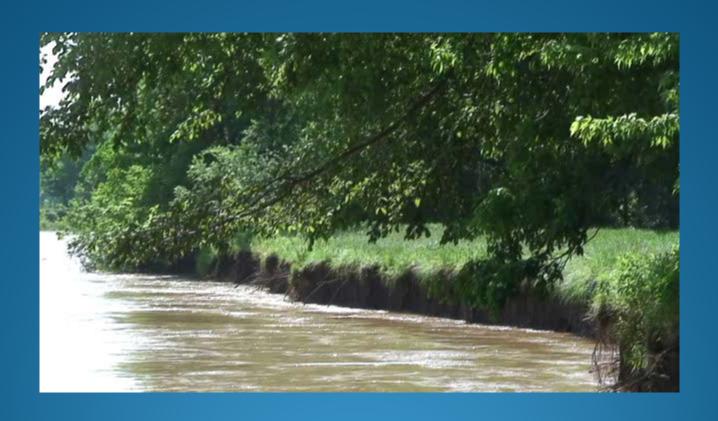
#### **Erosion During Bankfull Event**
