White River Streambank Restoration Project

ANRC Project 09-1900

NPS Annual Meeting September 27, 2012

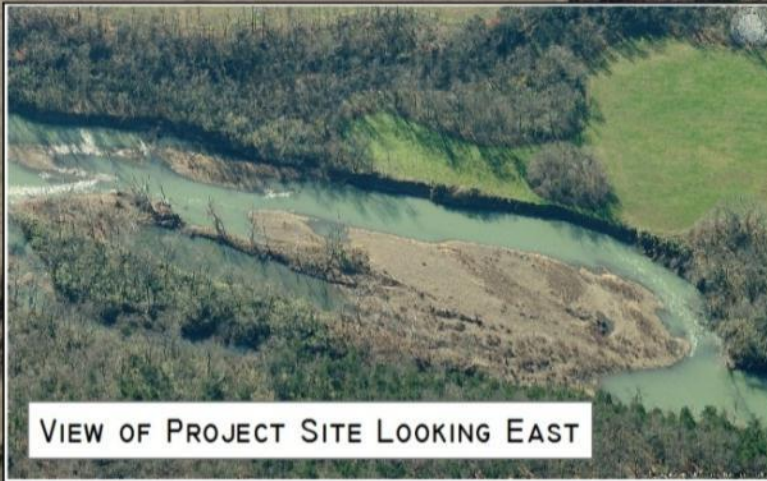
VIEW OF PROJECT SITE LOOKING EAST

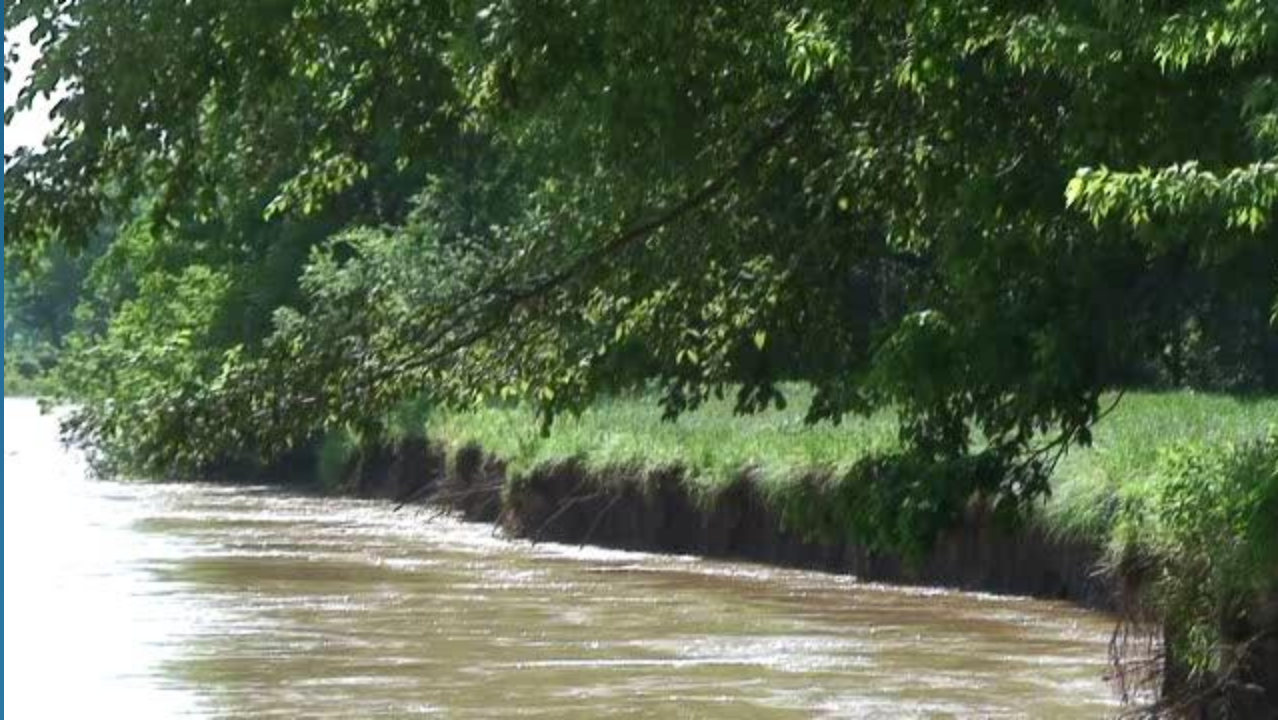
Erosion During Bankfull Event

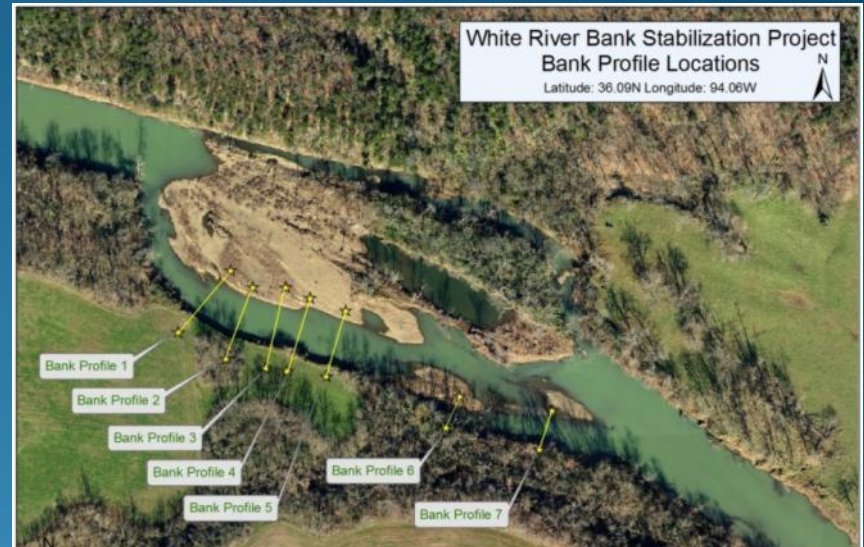
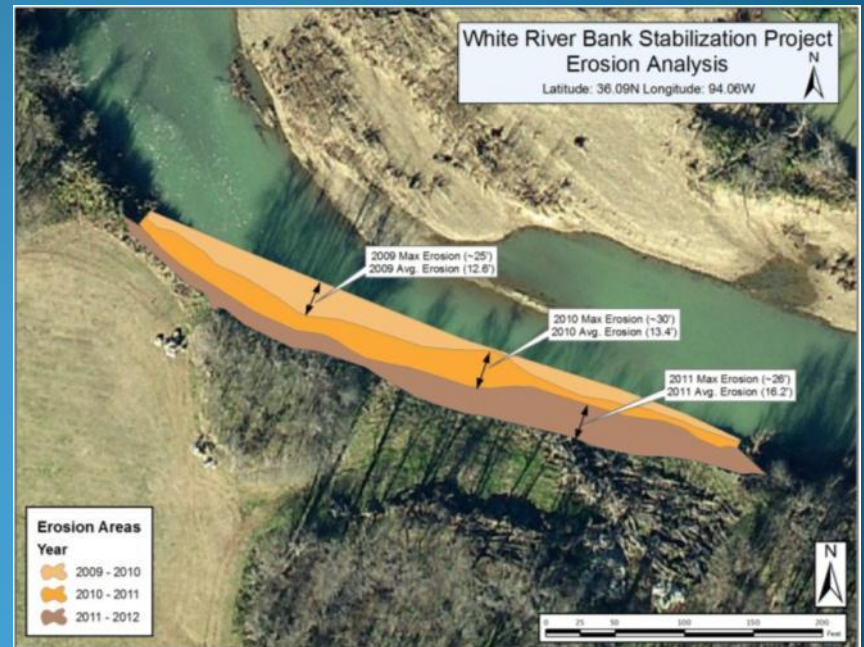
- Bank Erosion Monitoring Results
 - Sites 1-5 ranged from 3.1 to 21.7 feet over a 7 month period
 - Included two major flood events that occurred in April and May 2011
- Air Photo Evaluation of Lateral Bank Erosion 2009 - 2011
 - Average rate over three years was 14 ft/year

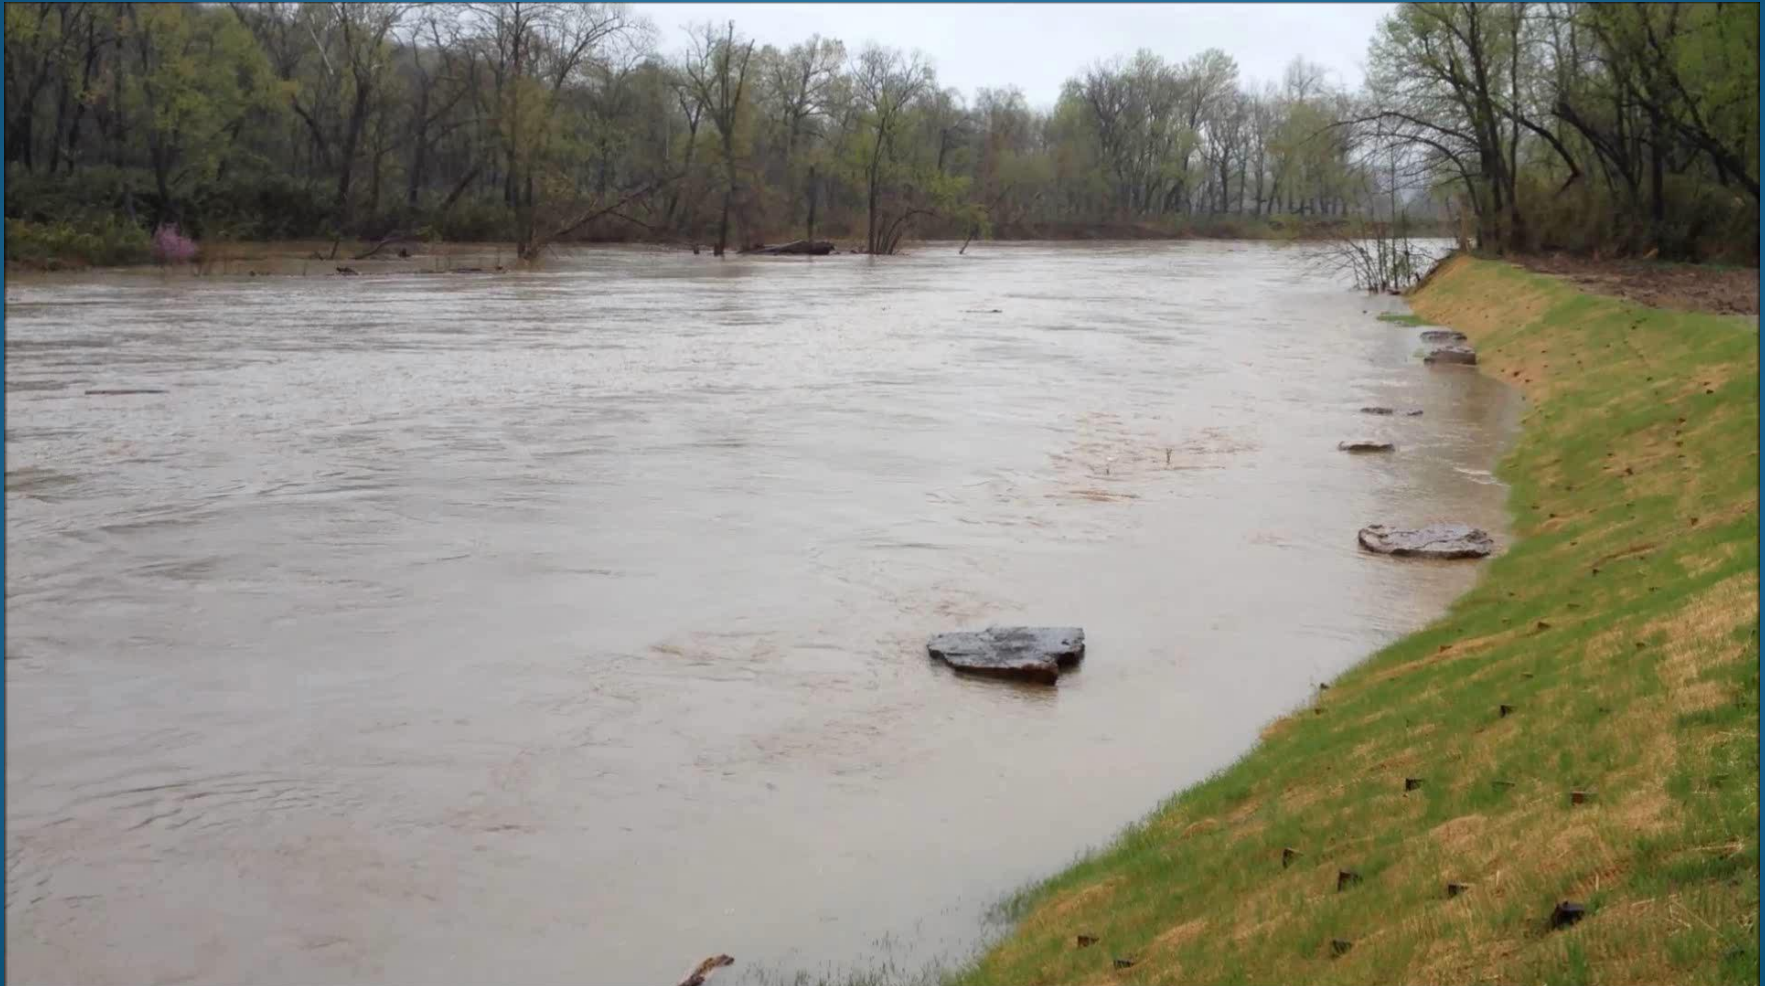
- If you need rain, build a stream restoration
- Two weeks following construction, 13,000 cfs peak flow (bankfull Q is 11,500 cfs)
