West Fork White River Stream Restoration Project Update

Watershed Conservation Resource Center

Project Goal

Demonstrate an rural stream restoration using a natural channel design approach

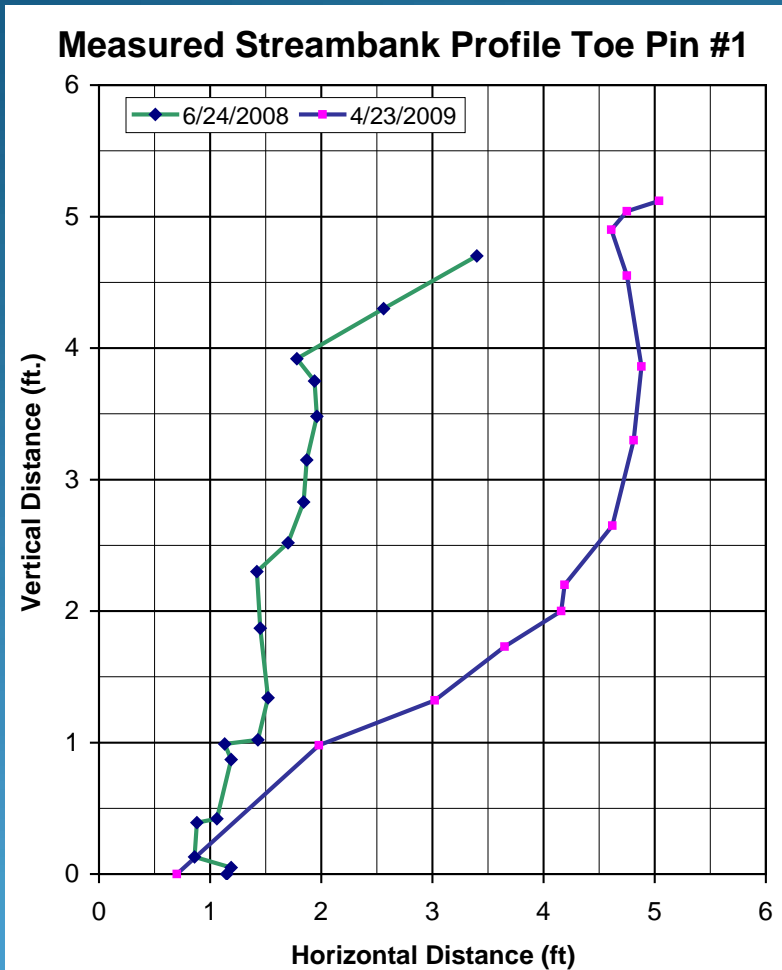
Average $\Delta H = 1.72'$ (Toe Pin #1)

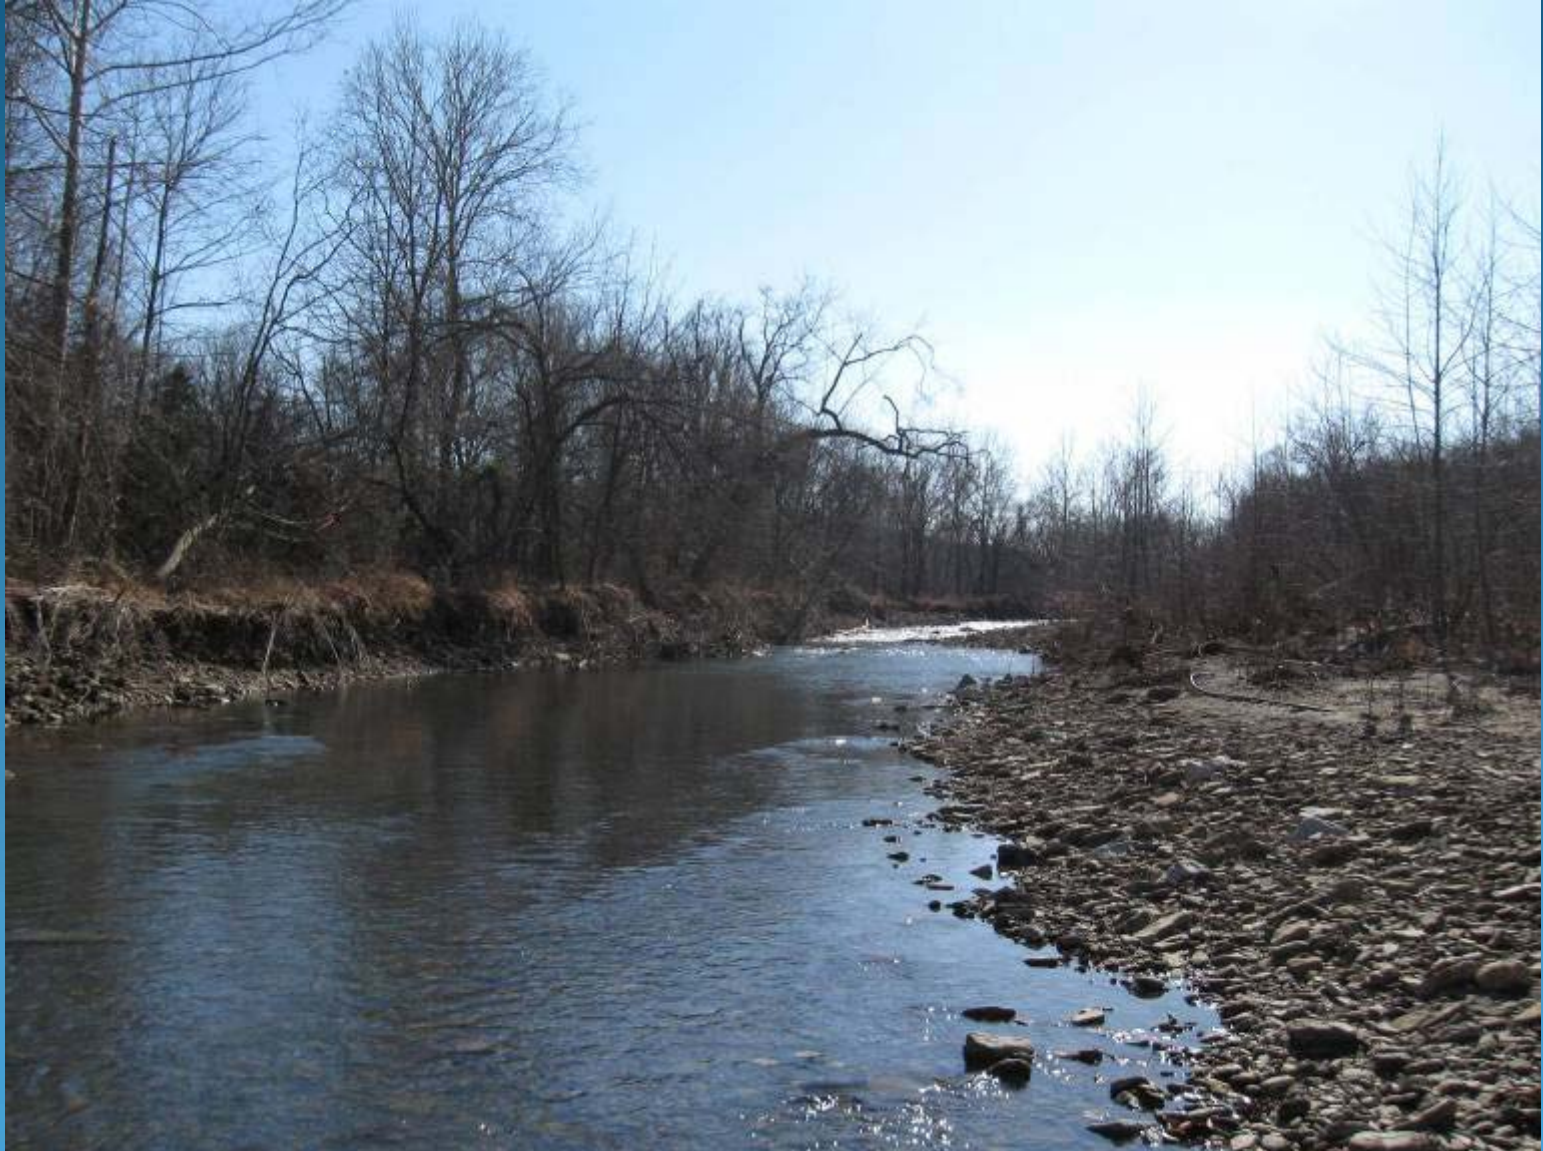
Site Photos Before Restoration (upstream)

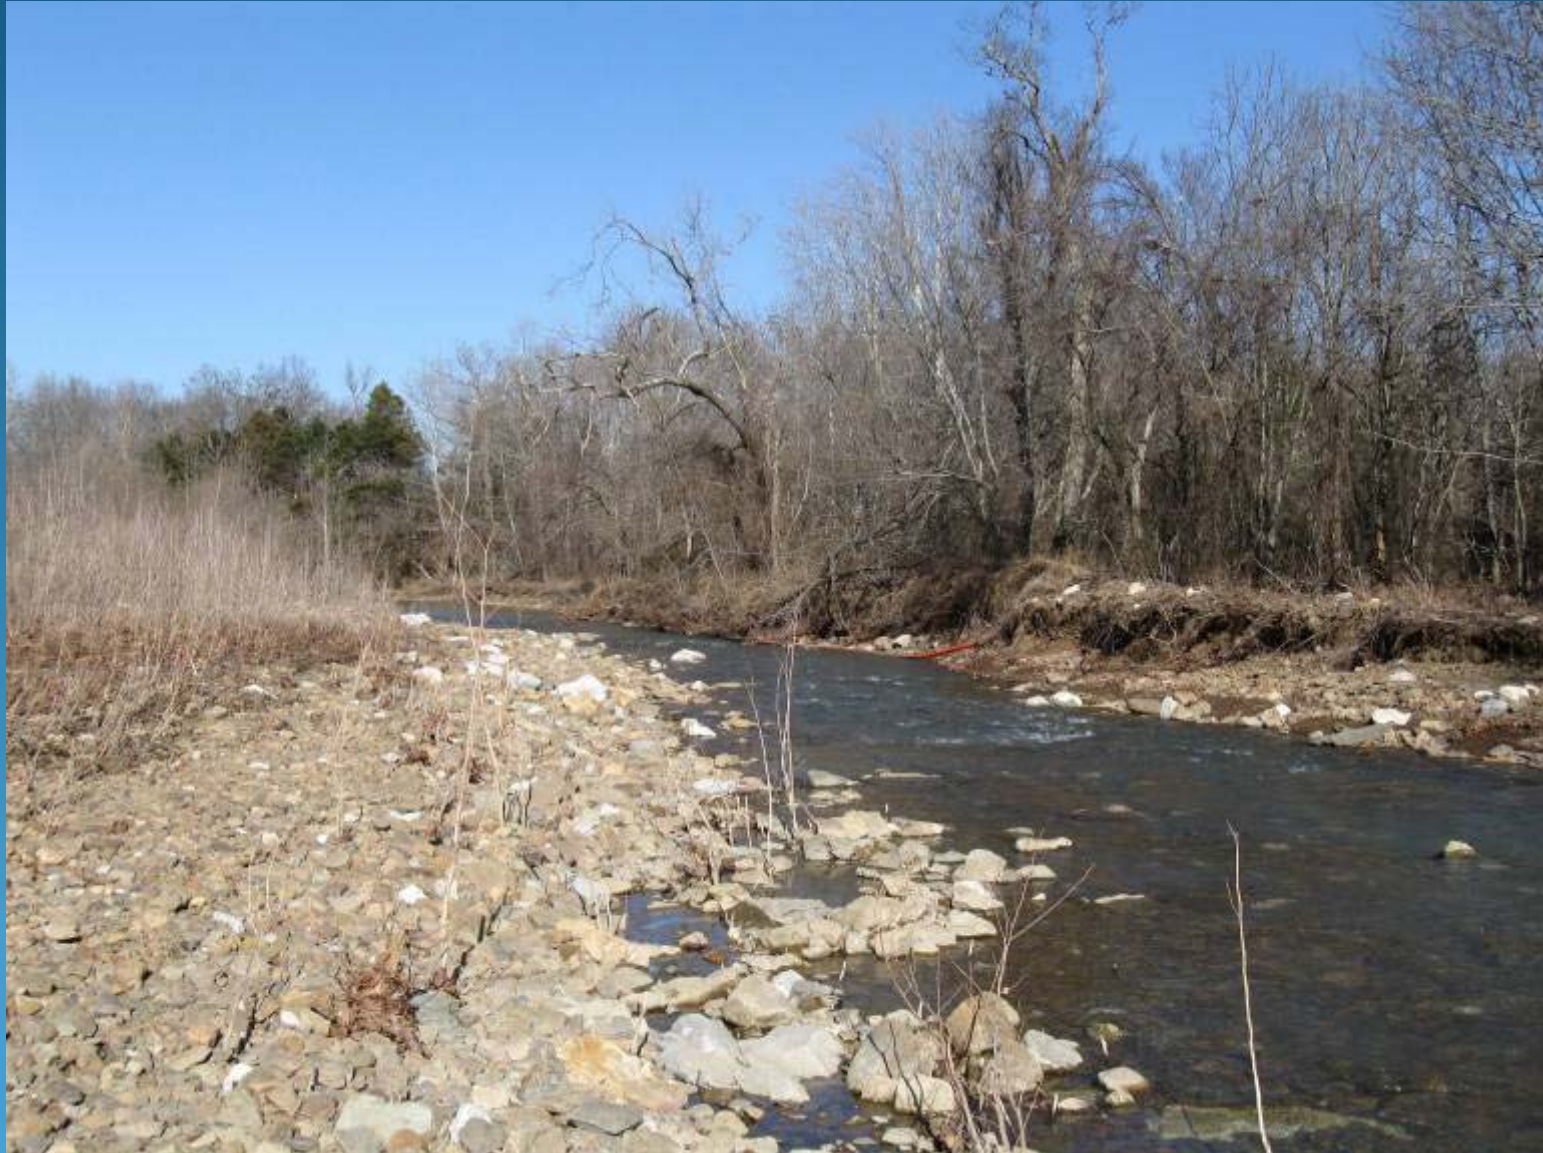
Site Photos Before Restoration (upstream)

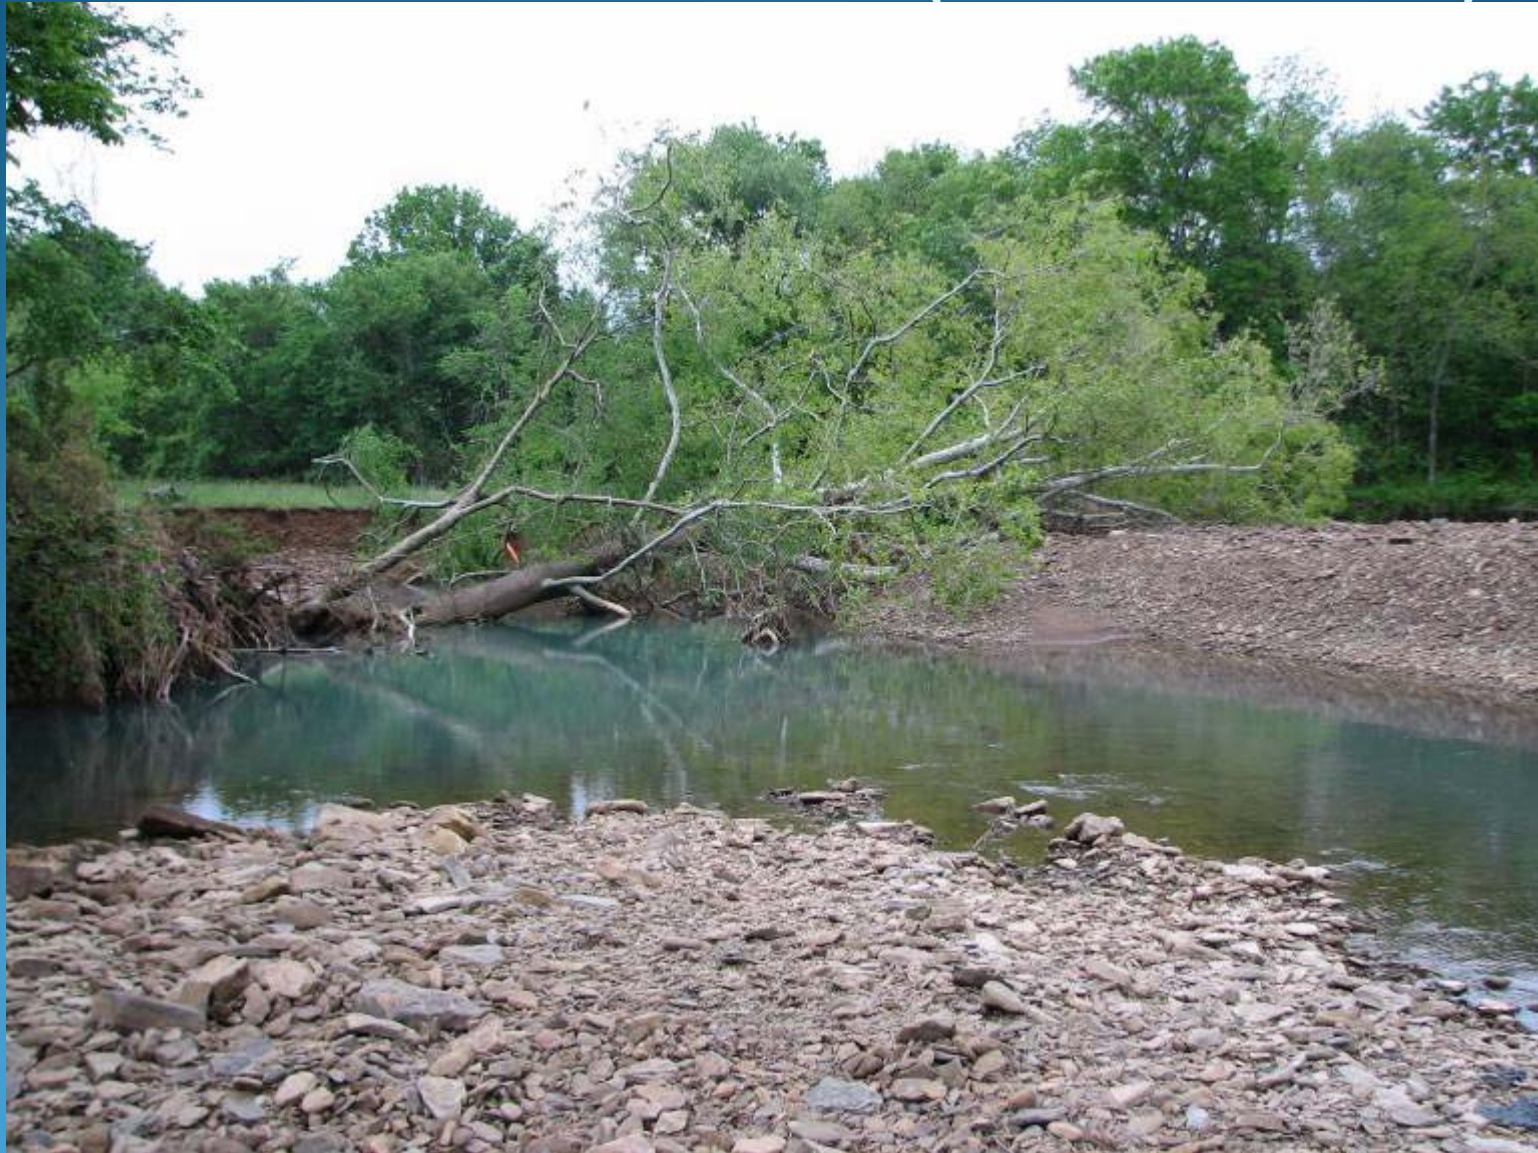
Site Photos Before Restoration (mid-section)

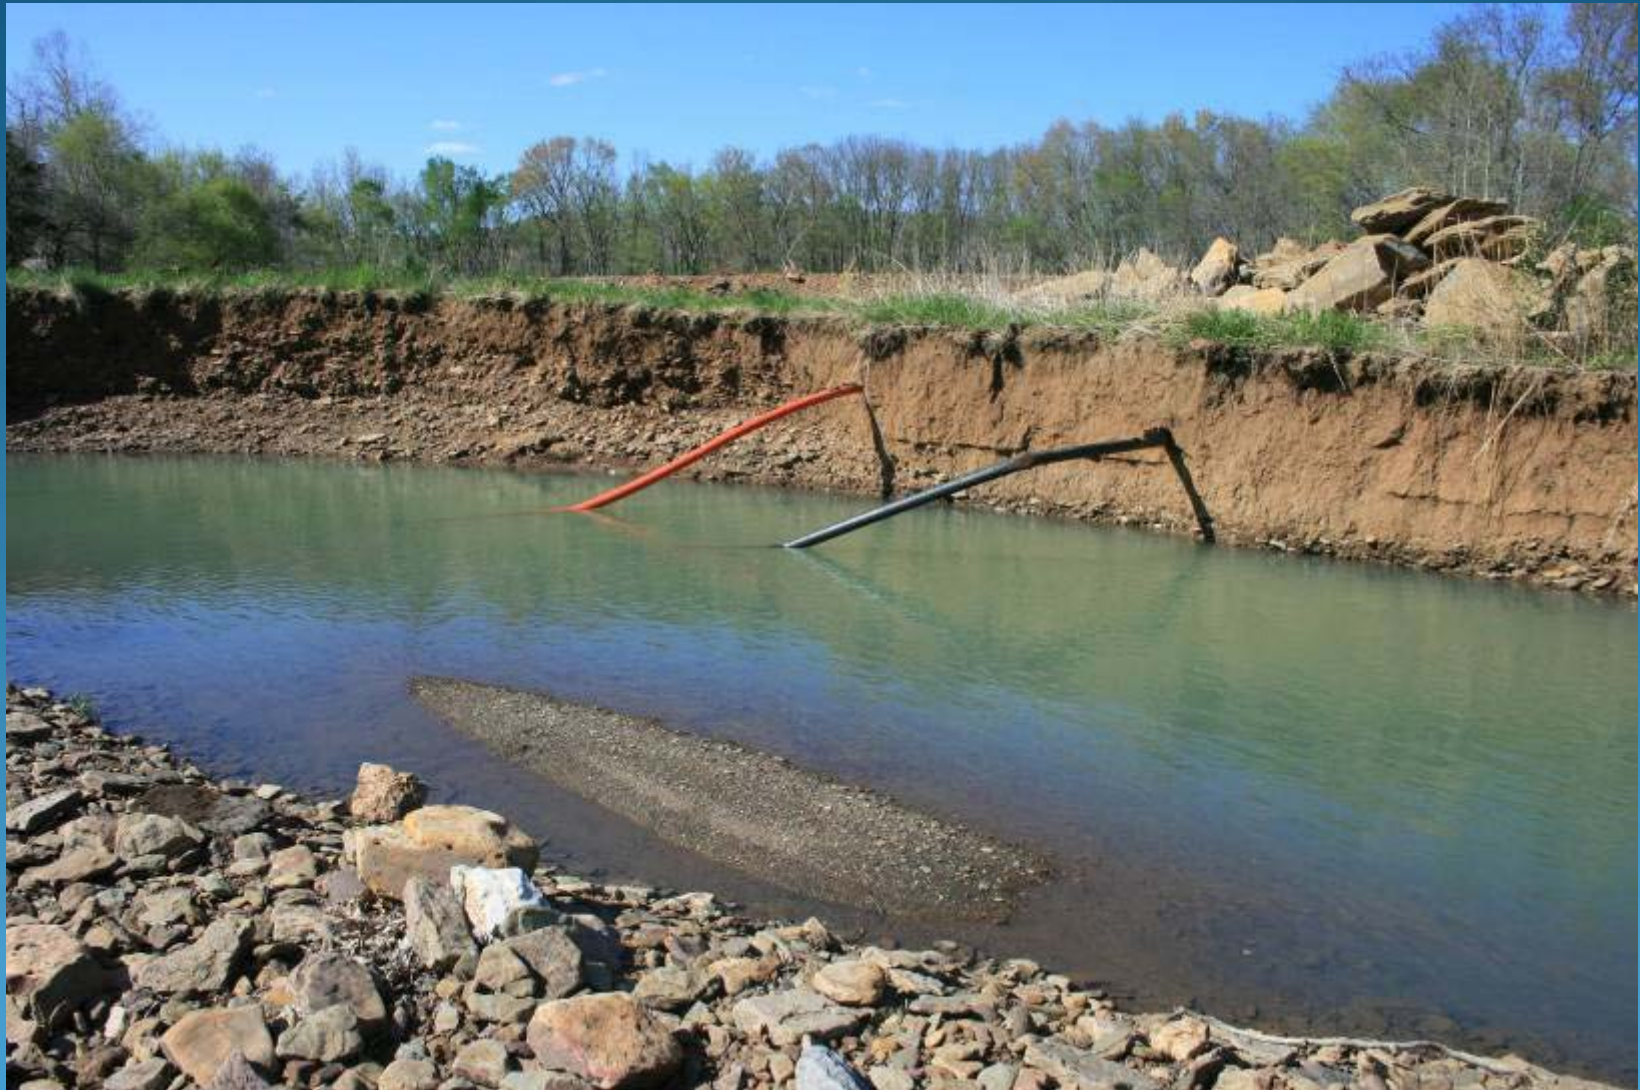
Site Photos Before Restoration (mid-section)

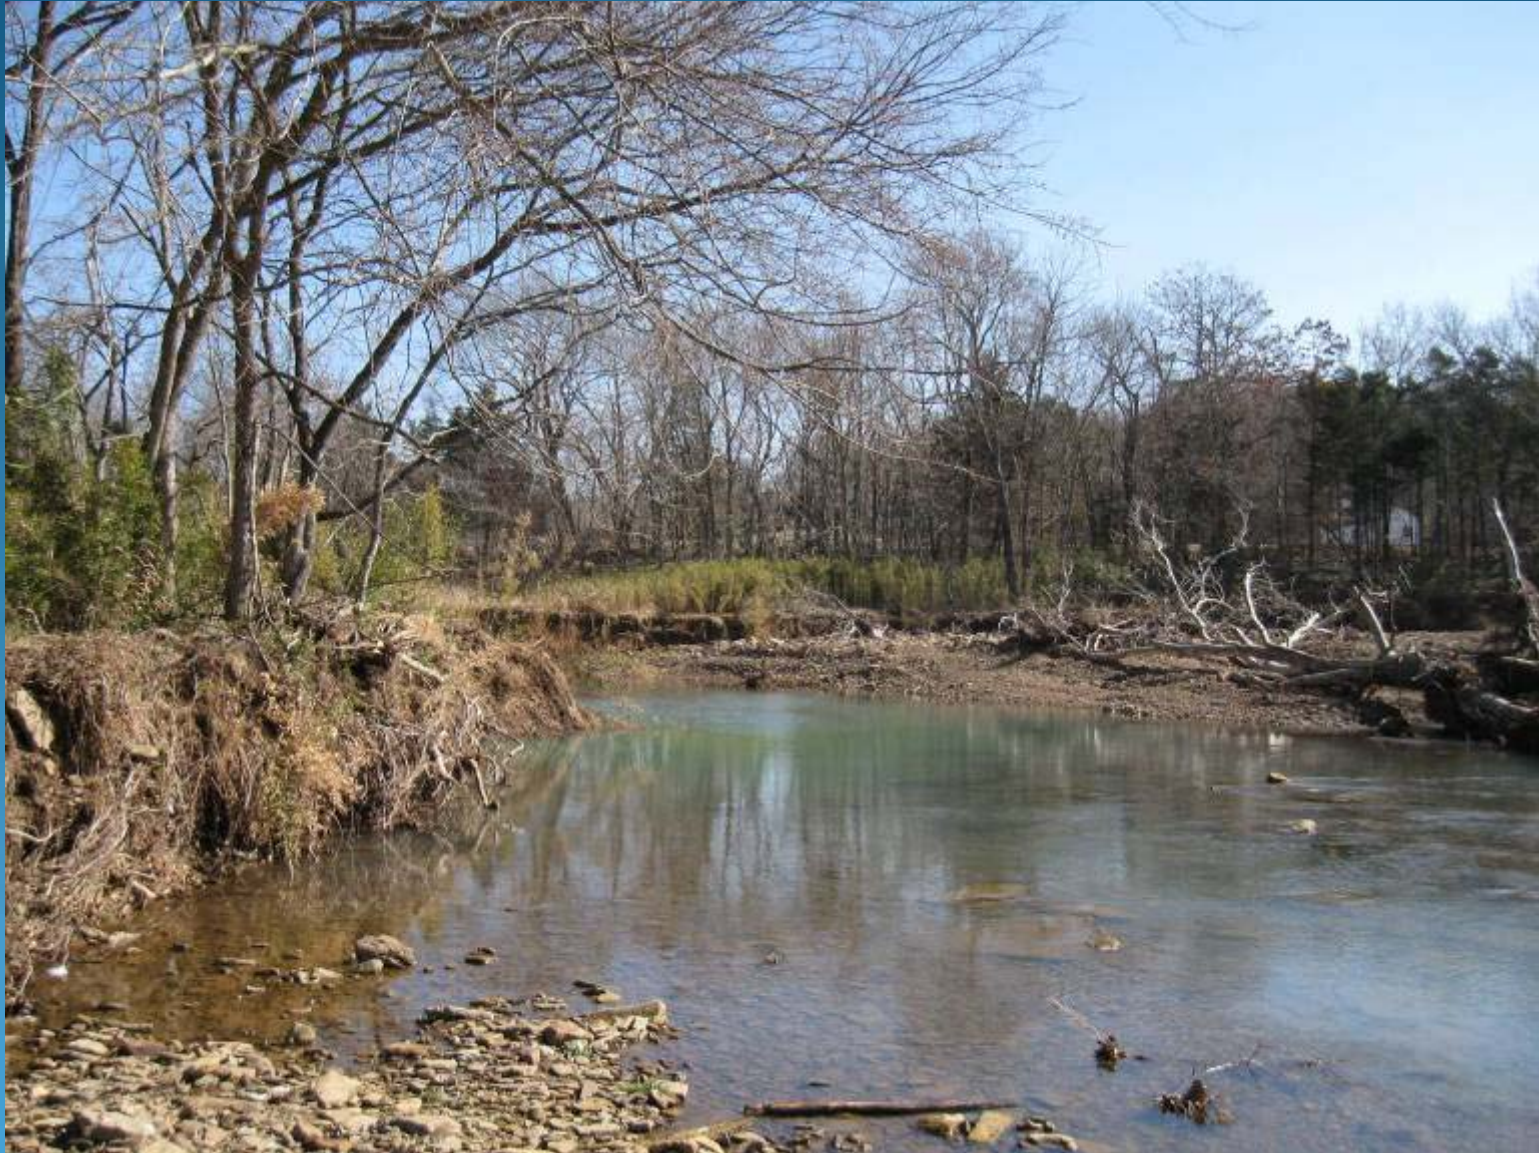
Site Photos Before Restoration (mid-section)

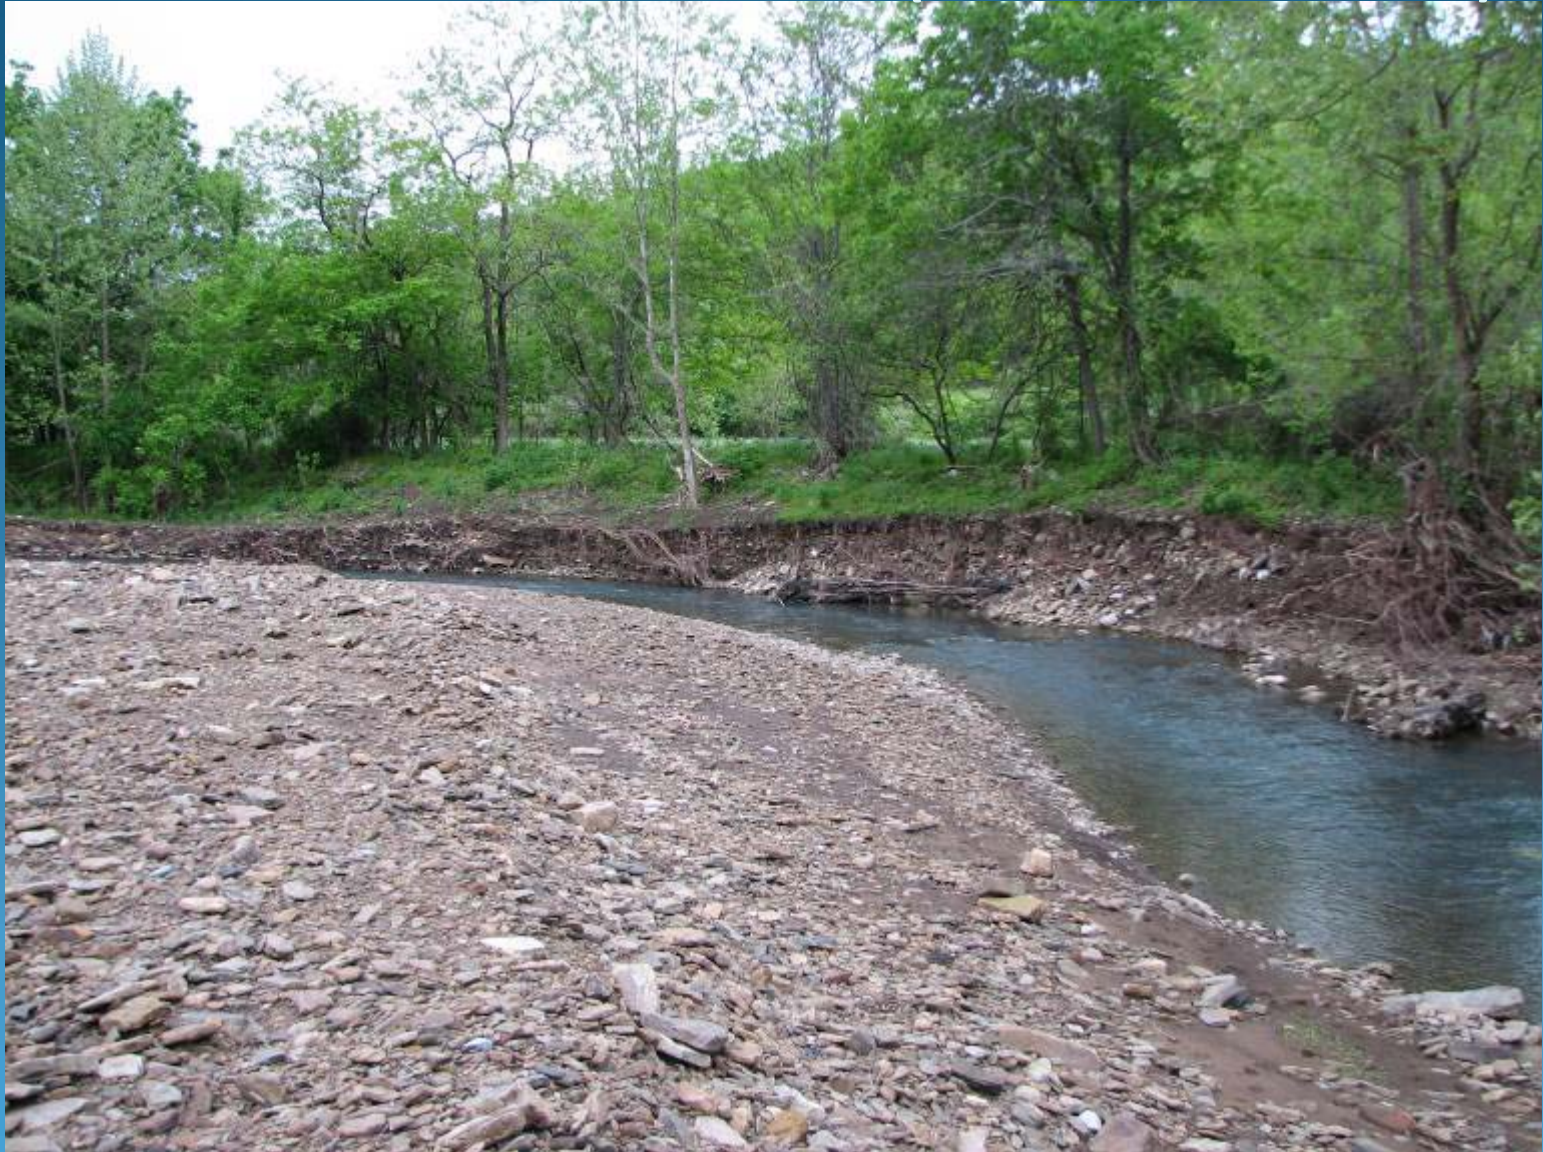
Site Photos Before Restoration (downstream)

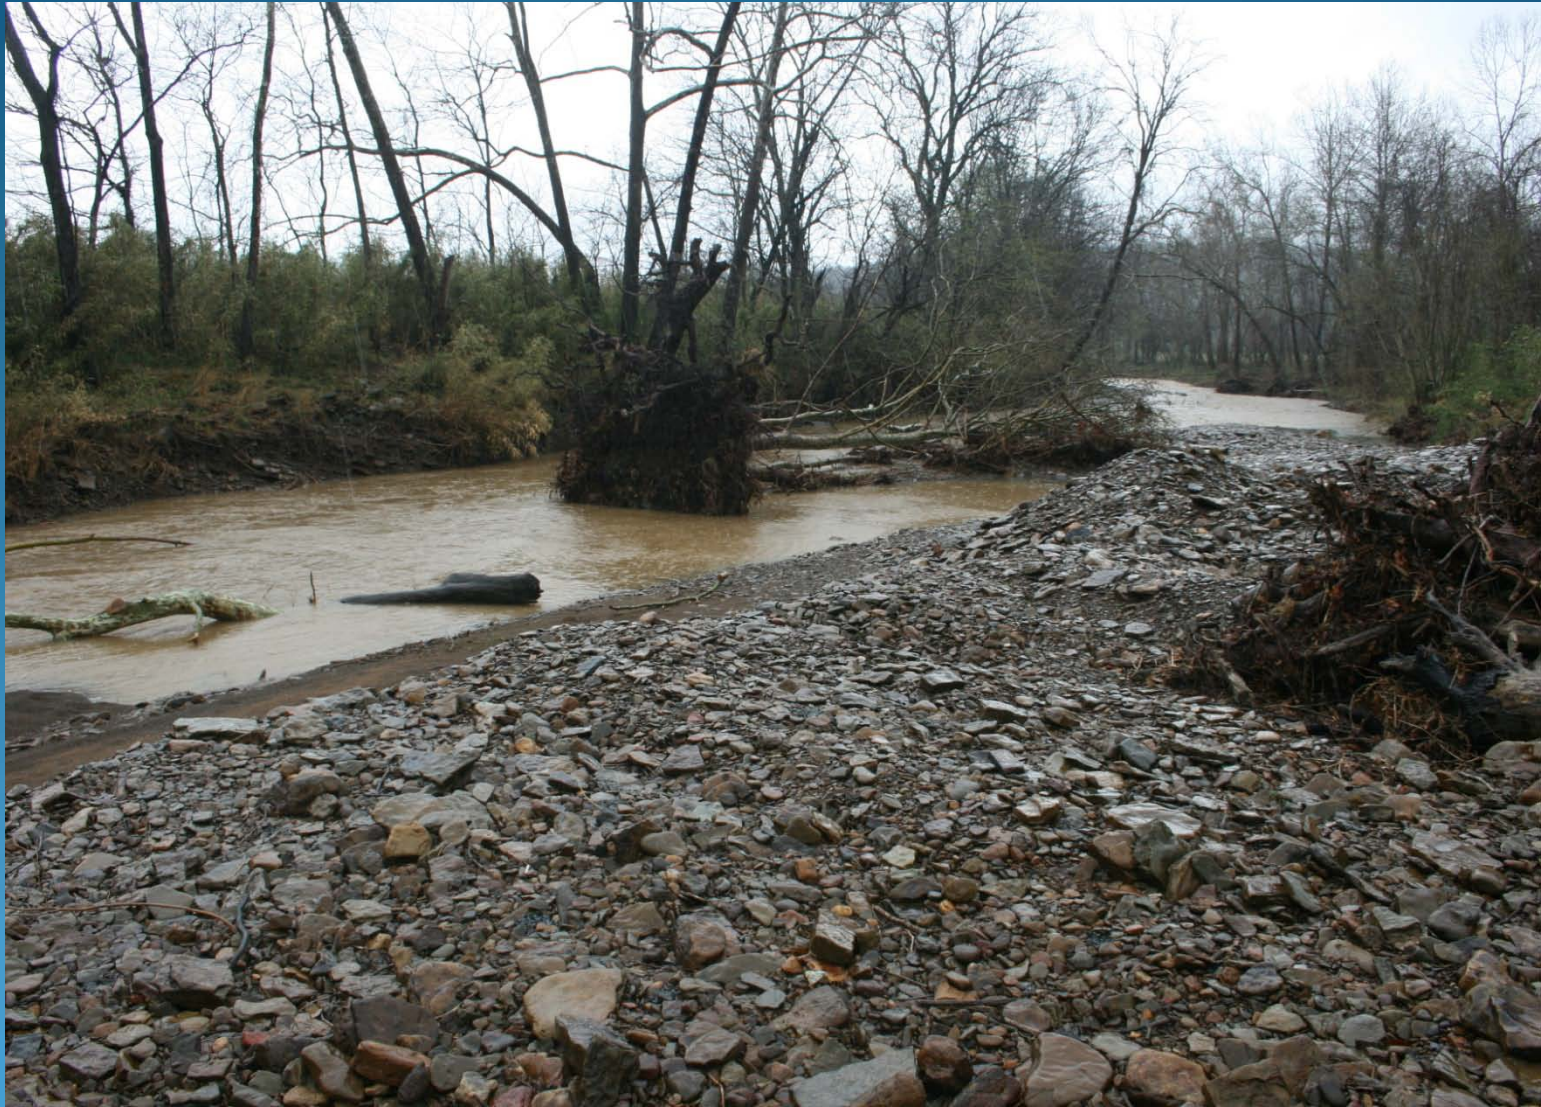
Site Photos Before Restoration (downstream)

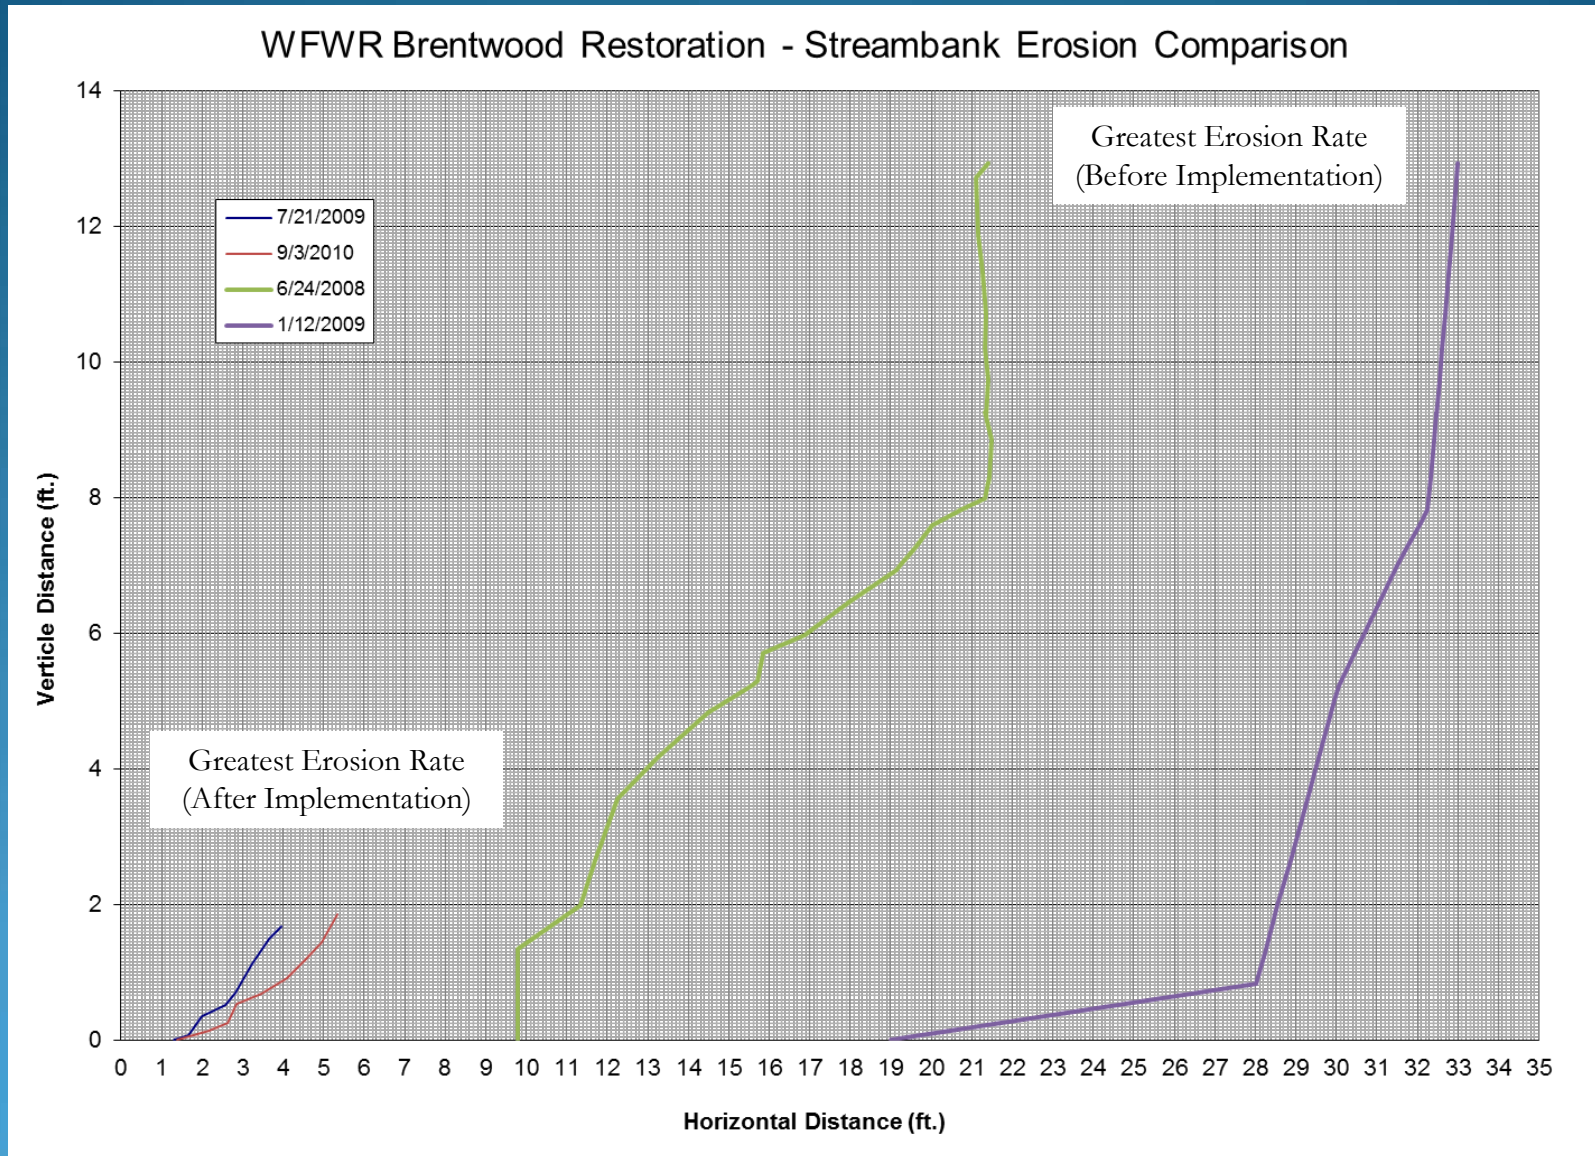
Comparison of Erosion for Before and After Implementation Monitoring
