Year Three Review of Water Quality Monitoring on the Upper Strawberry River Project 07-1000

Overview

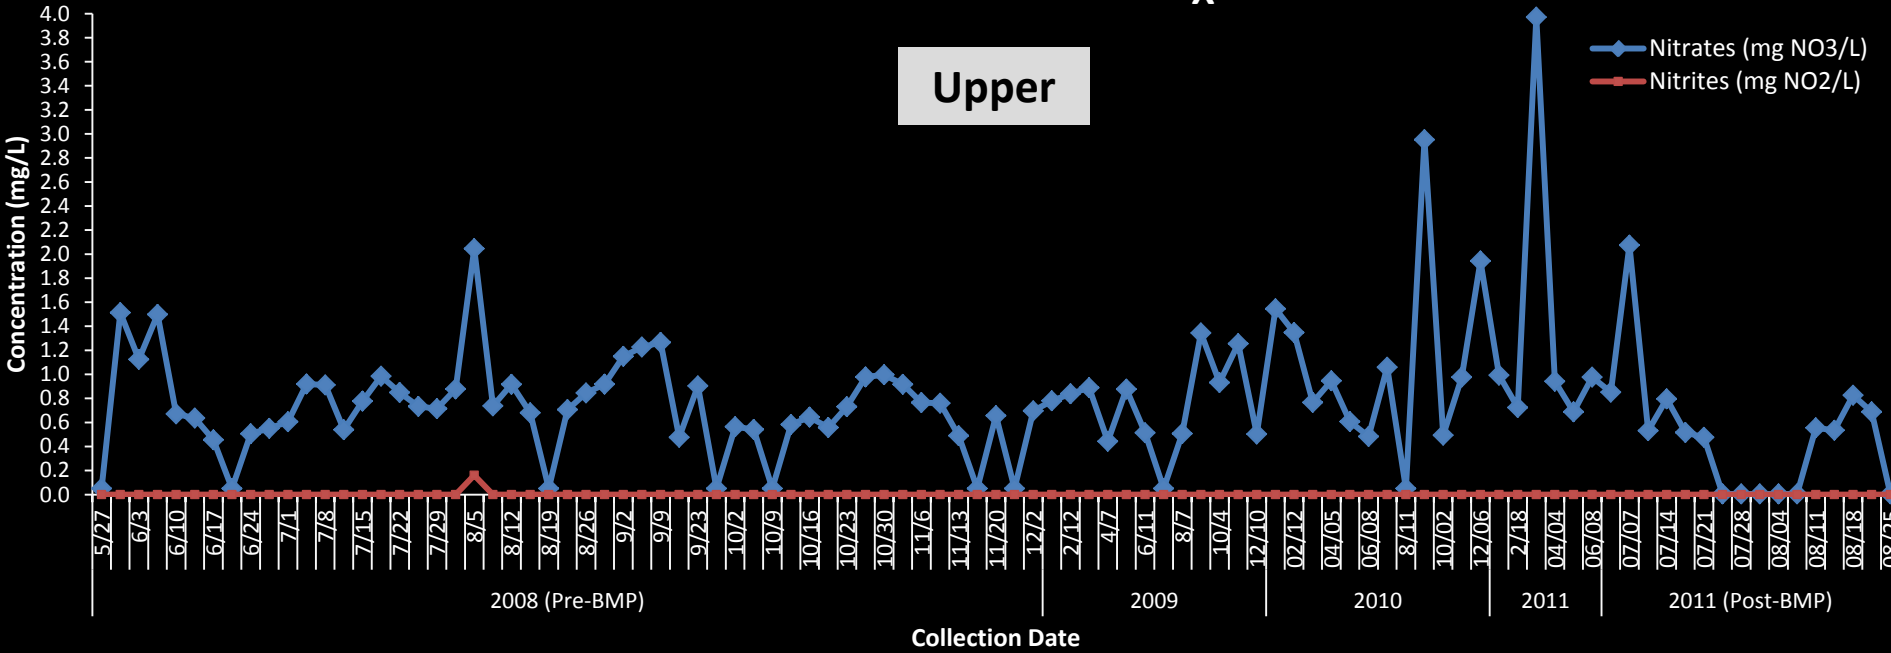
Little Strawberry (LS) NO_x Data

Upper

—◆— Nitrates (mg NO₃/L)
—■— Nitrites (mg NO₂/L)

Nitrate (mg/L)										
	Pre-BMP		2009		2010		2011 (Jan-June)		Post BMP (July-Aug 25)	
Site	High	Mean	High	Mean	High	Mean	High	Mean	High	Mean
LSUP	2.05	0.76	1.34	0.67	2.95	1.09	3.97	1.38	2.07	0.49
LSLO	2.37	0.56	0.90	0.58	1.18	0.43	1.34	0.57	1.26	0.13
GCUP	0.67	0.29	0.69	0.30	0.48	0.19	0.92	0.31	0.80	0.10
GCLO	1.28	0.29	0.73	0.34	0.71	0.24	0.89	0.19	BDL	BDL
SCUP	2.30	0.46	1.11	0.40	0.83	0.31	1.46	0.43	1.04	NA
SCLO	0.74	0.31	0.54	0.27	0.73	0.24	0.63	0.15	BDL	BDL

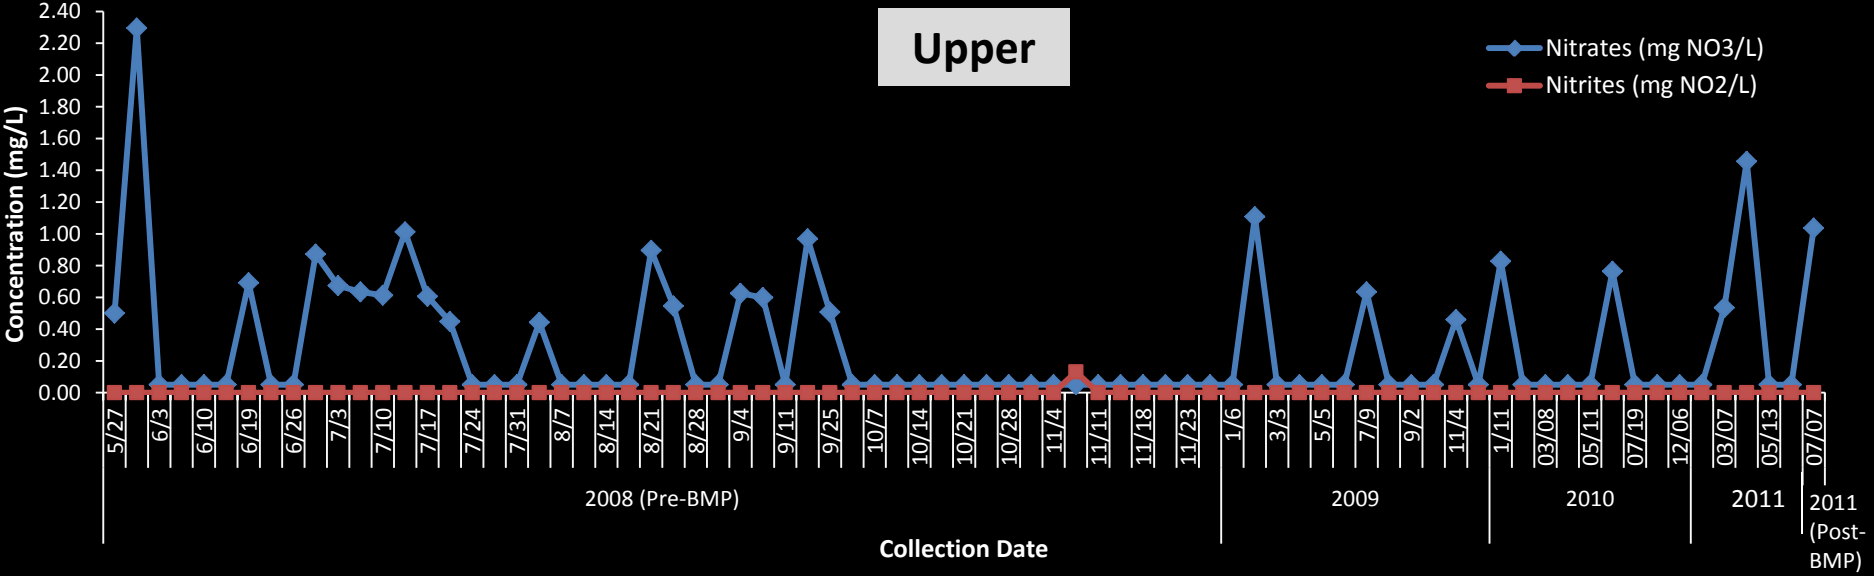
Sandy Creek (SC) NO_x Data

Upper

—◆— Nitrates (mg NO₃/L)
—■— Nitrites (mg NO₂/L)

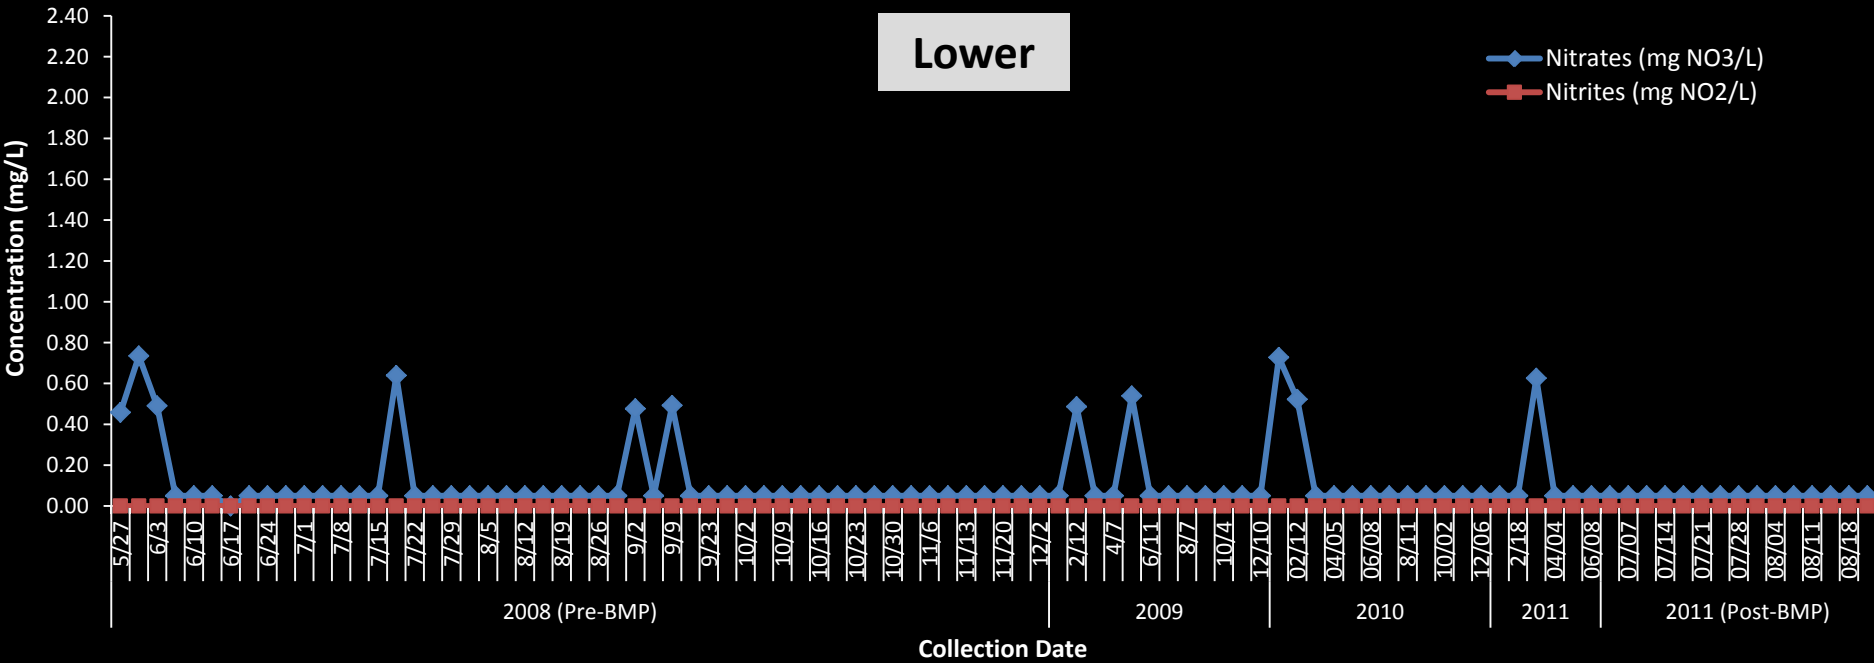
Lower

—◆— Nitrates (mg NO₃/L)
—■— Nitrites (mg NO₂/L)

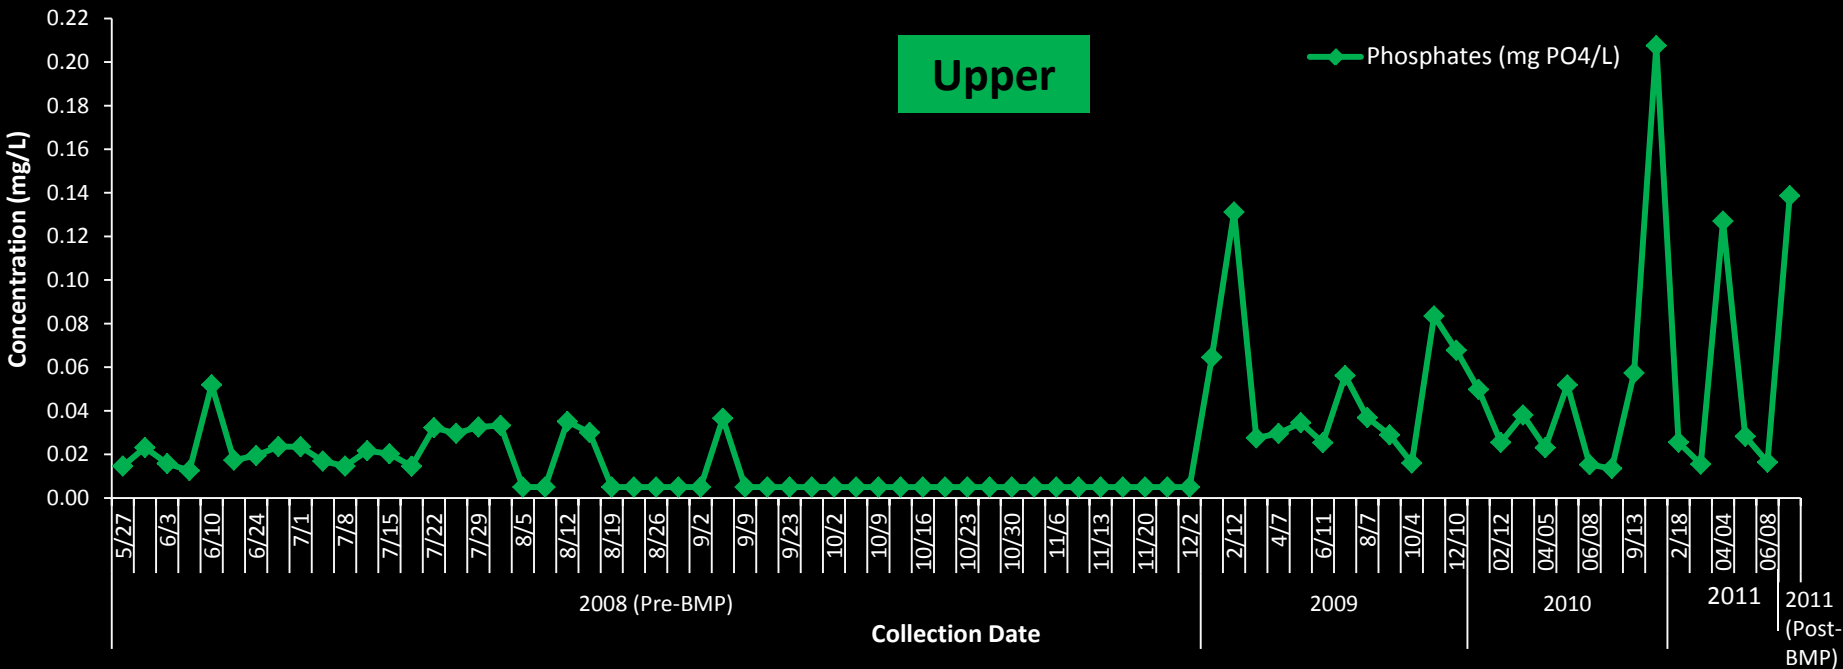
Sandy Creek (SC) Ortho-Phosphate Data

Upper

Phosphates (mg PO₄/L)

Site	Pre-BMP		2009		2010		2011 (Jan-June)		Post BMP (July-Aug 25)	
	High	Mean	High	Mean	High	Mean	High	Mean	High	Mean
LSUP	0.18	0.04	0.11	0.05	0.09	0.05	0.14	0.05	0.48	0.06
LSLO	0.06	0.01	0.12	0.05	0.09	0.04	0.09	0.03	0.14	0.04
GCUP	0.05	0.02	0.08	0.02	0.05	0.03	0.09	0.04	0.06	0.03
GCLO	0.08	0.03	0.13	0.05	0.05	0.03	0.18	0.05	0.14	0.04
SCUP	0.05	0.03	0.13	0.05	0.21	0.05	0.13	0.04	0.14	NA
SCLO	0.04	0.02	0.14	0.05	0.06	0.03	0.06	0.04	0.14	0.04

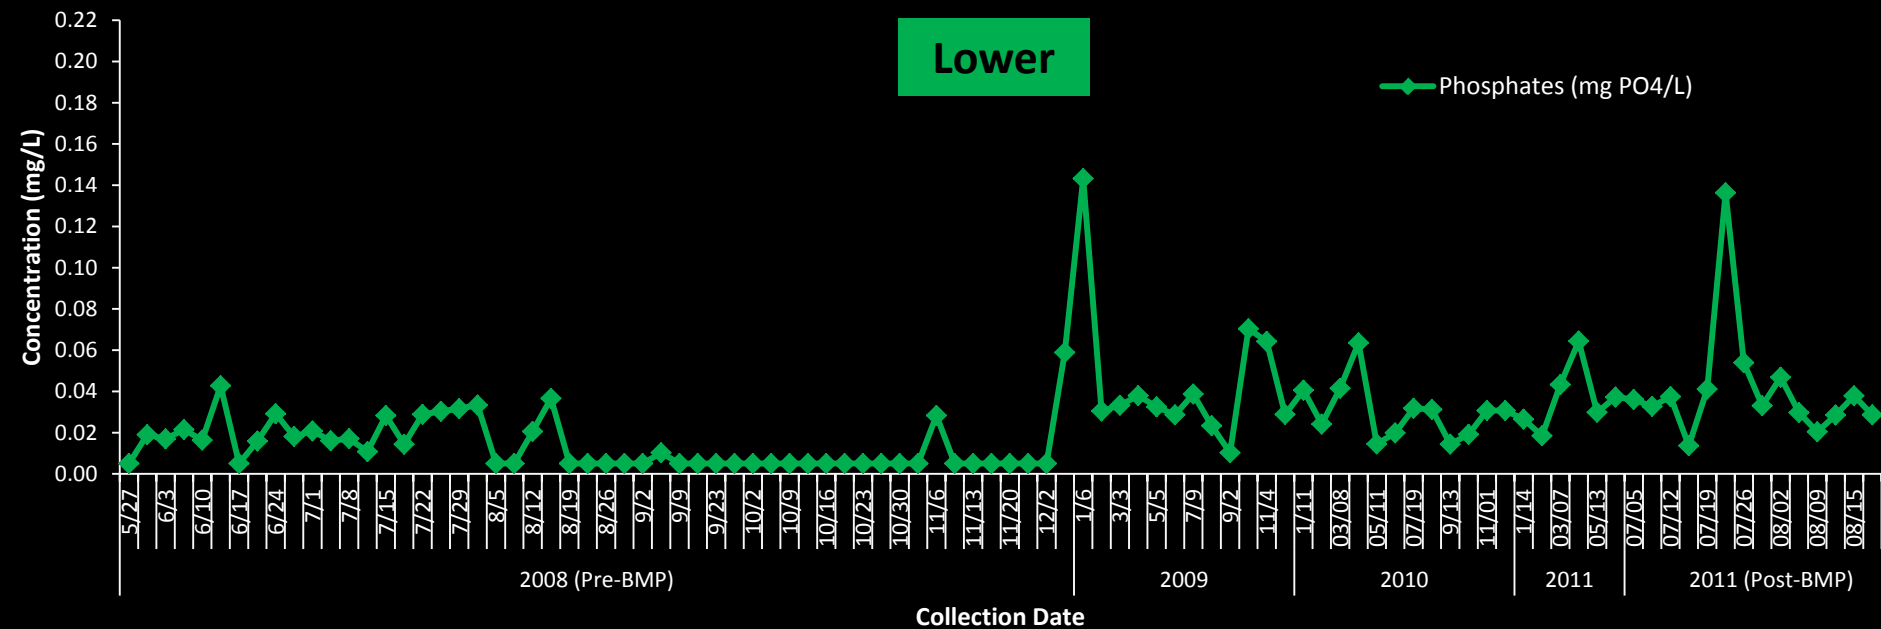
Lower

Phosphates (mg PO₄/L)

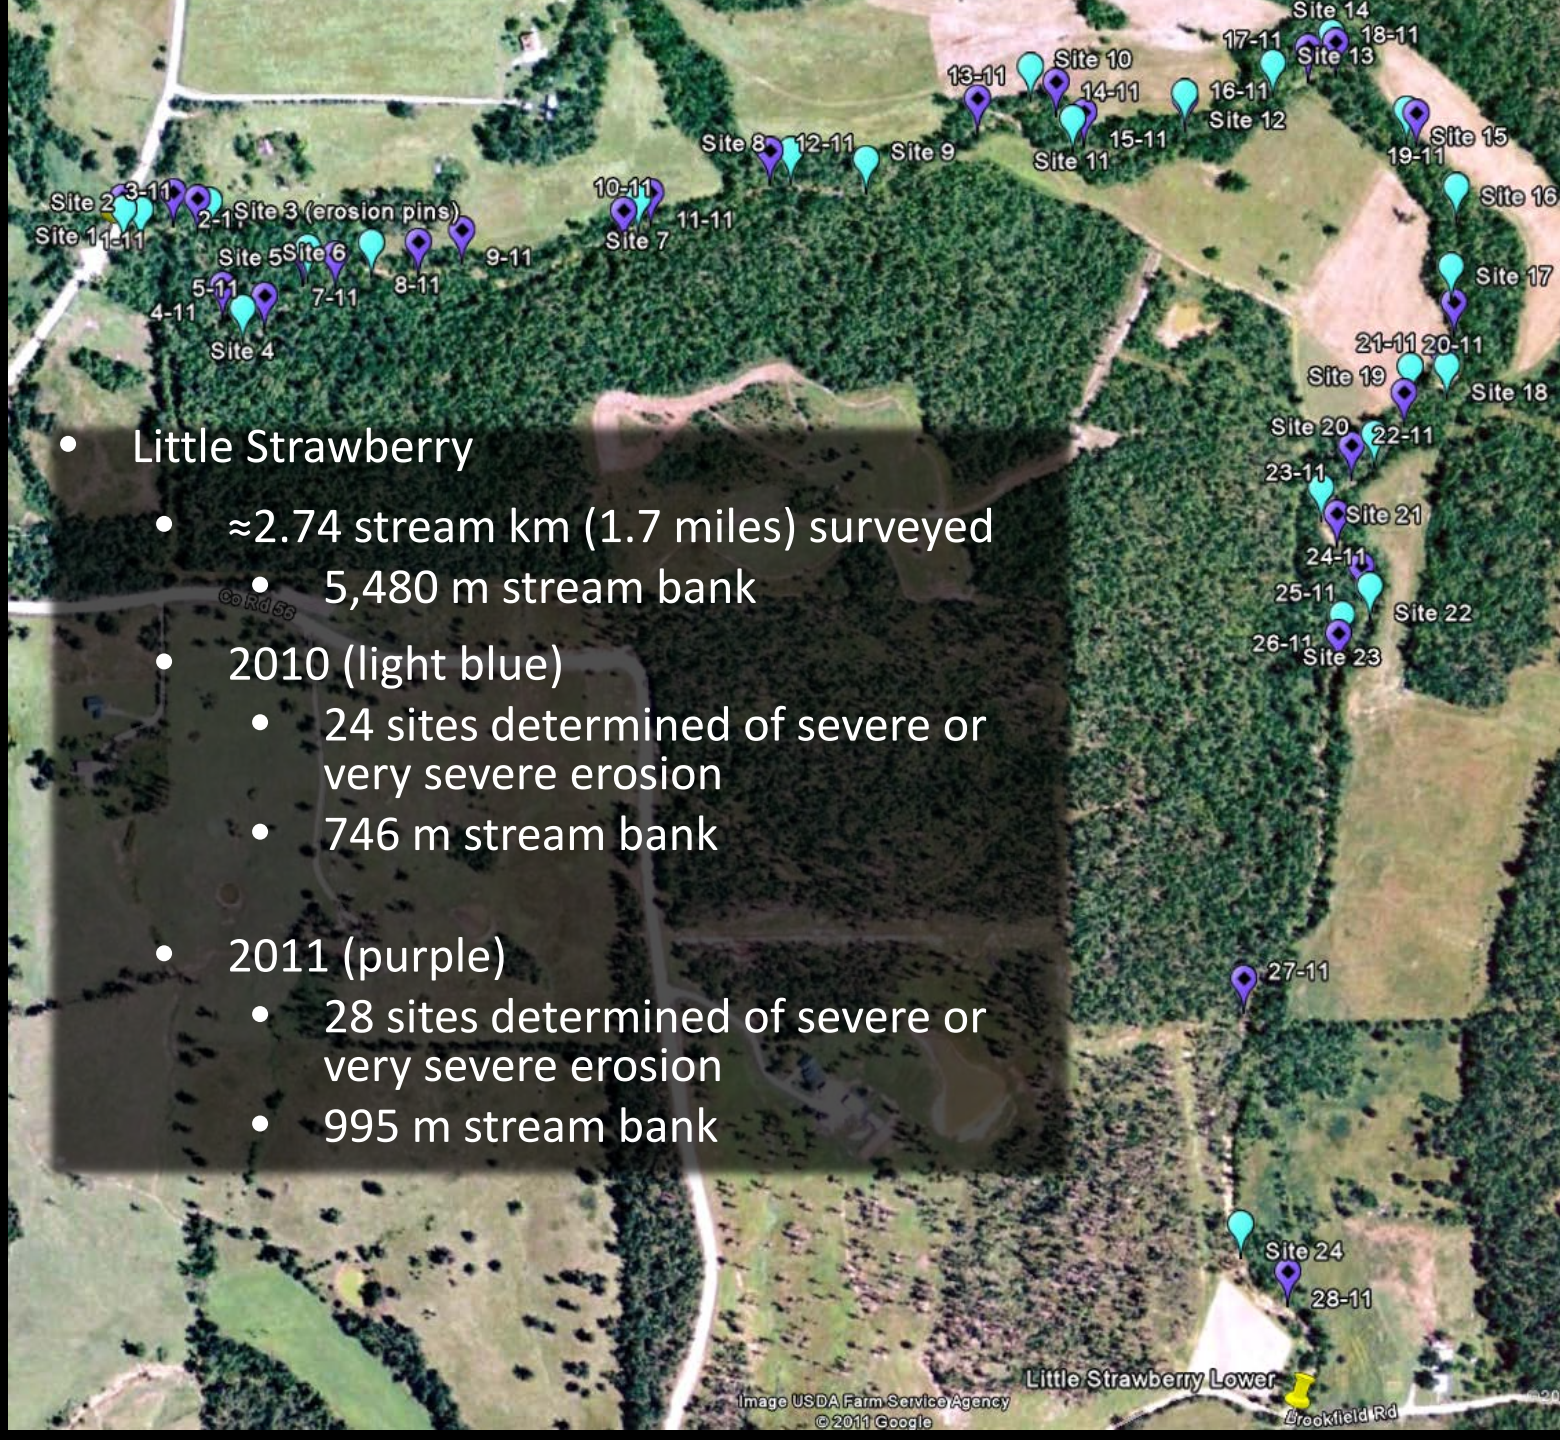
- Little Strawberry

- ≈2.74 stream km (1.7 miles) surveyed

- 5,480 m stream bank

- 2010 (light blue)

- 24 sites determined of severe or very severe erosion

- 746 m stream bank

- 2011 (purple)

- 28 sites determined of severe or very severe erosion

- 995 m stream bank

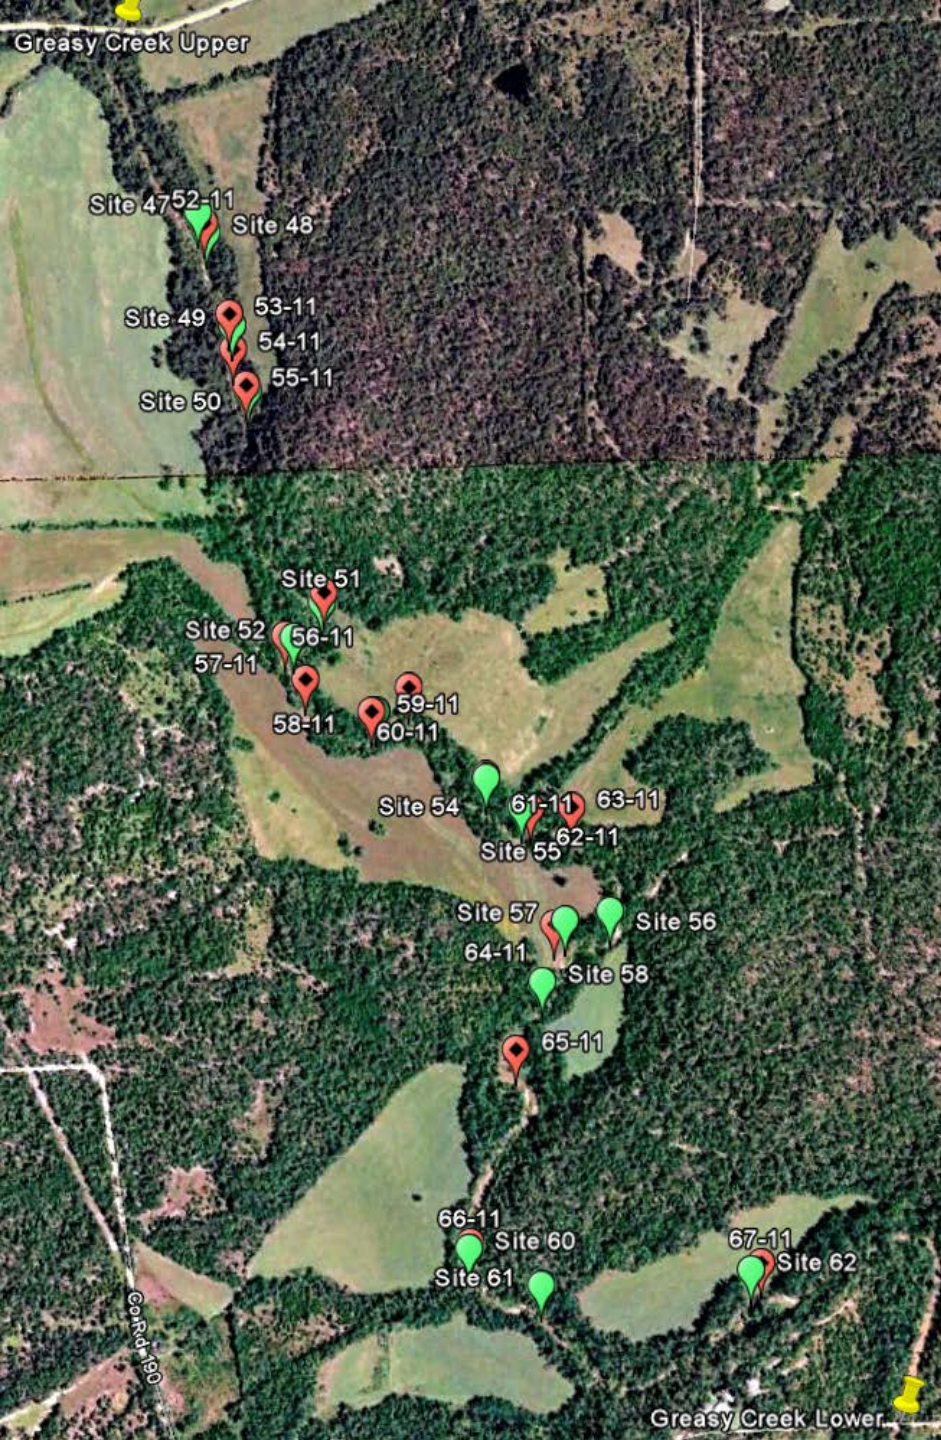
Greasy Creek

- ≈3.17 stream km (2.0 miles) surveyed
 - 6,340 m stream bank
- 2010 (green)
 - 16 sites determined of severe or very severe erosion
 - 500 m stream bank
- 2011 (red)
 - 16 sites determined of severe or very severe erosion
 - 575 m stream bank

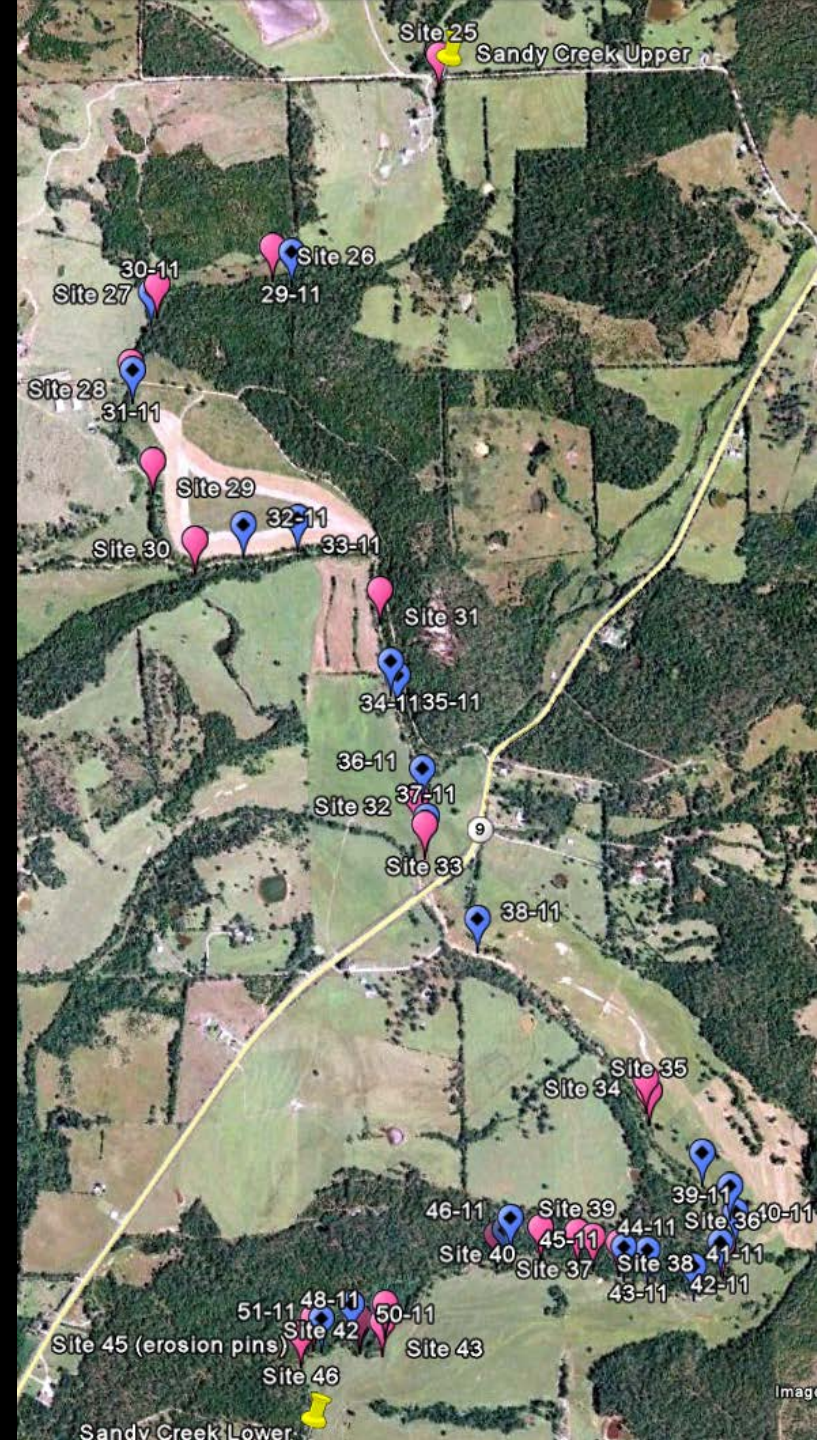
- Sandy Creek
 - ≈6.63 stream km (4.1 miles) surveyed
 - 13,260 m stream bank
 - 2010 (pink)
 - 22 sites determined of severe or very severe erosion
 - 505 m stream bank
 - 2011 (blue)
 - 21 sites determined of severe or very severe erosion
 - 525 m stream bank

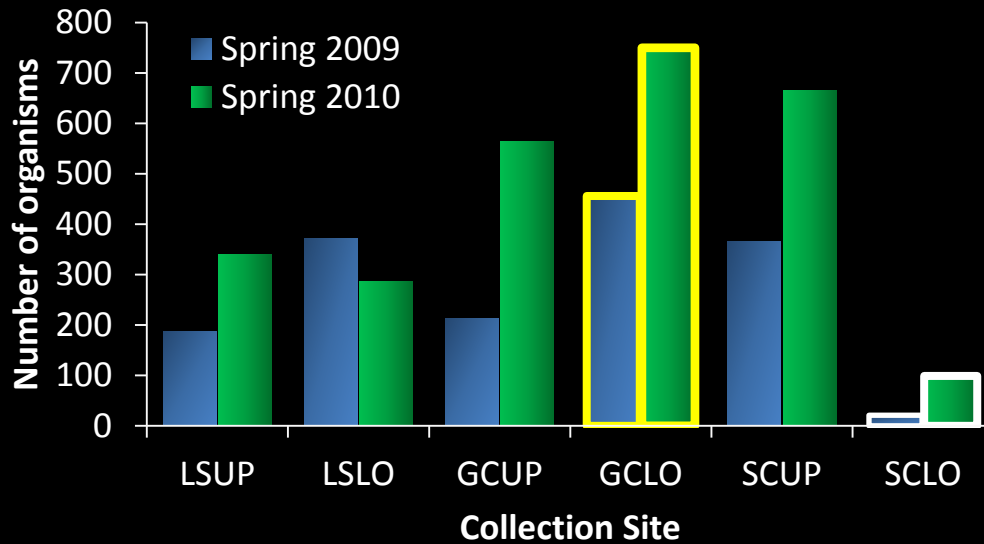
Benthic Macroinvertebrates Abundance

Spring 2009	Spring 2010
High (yellow)	456	750*
Low (white)	21	99

*704 Chironomidae

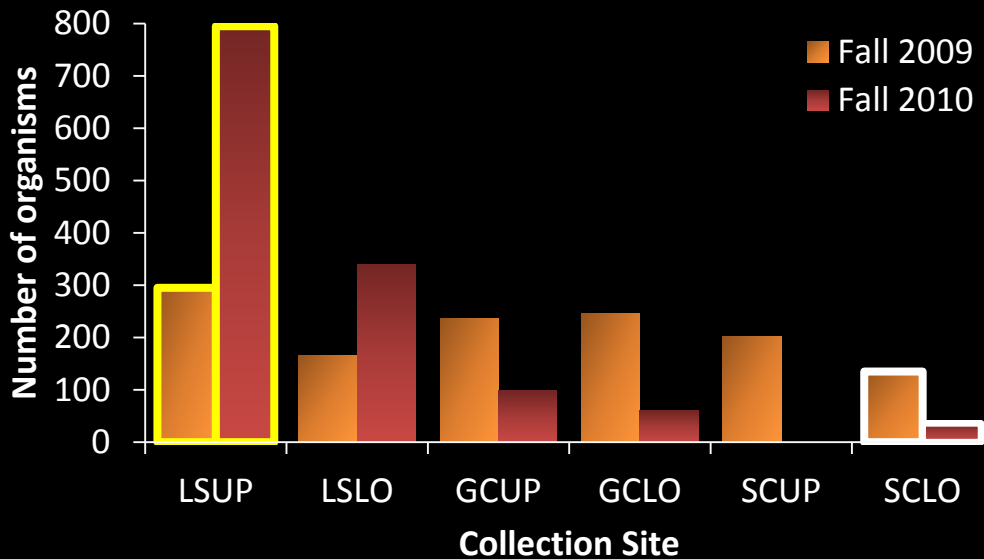
Fall 2009	Fall 2010
High (yellow)	295	795*
Low (white)	135	36

*715 Chironomidae

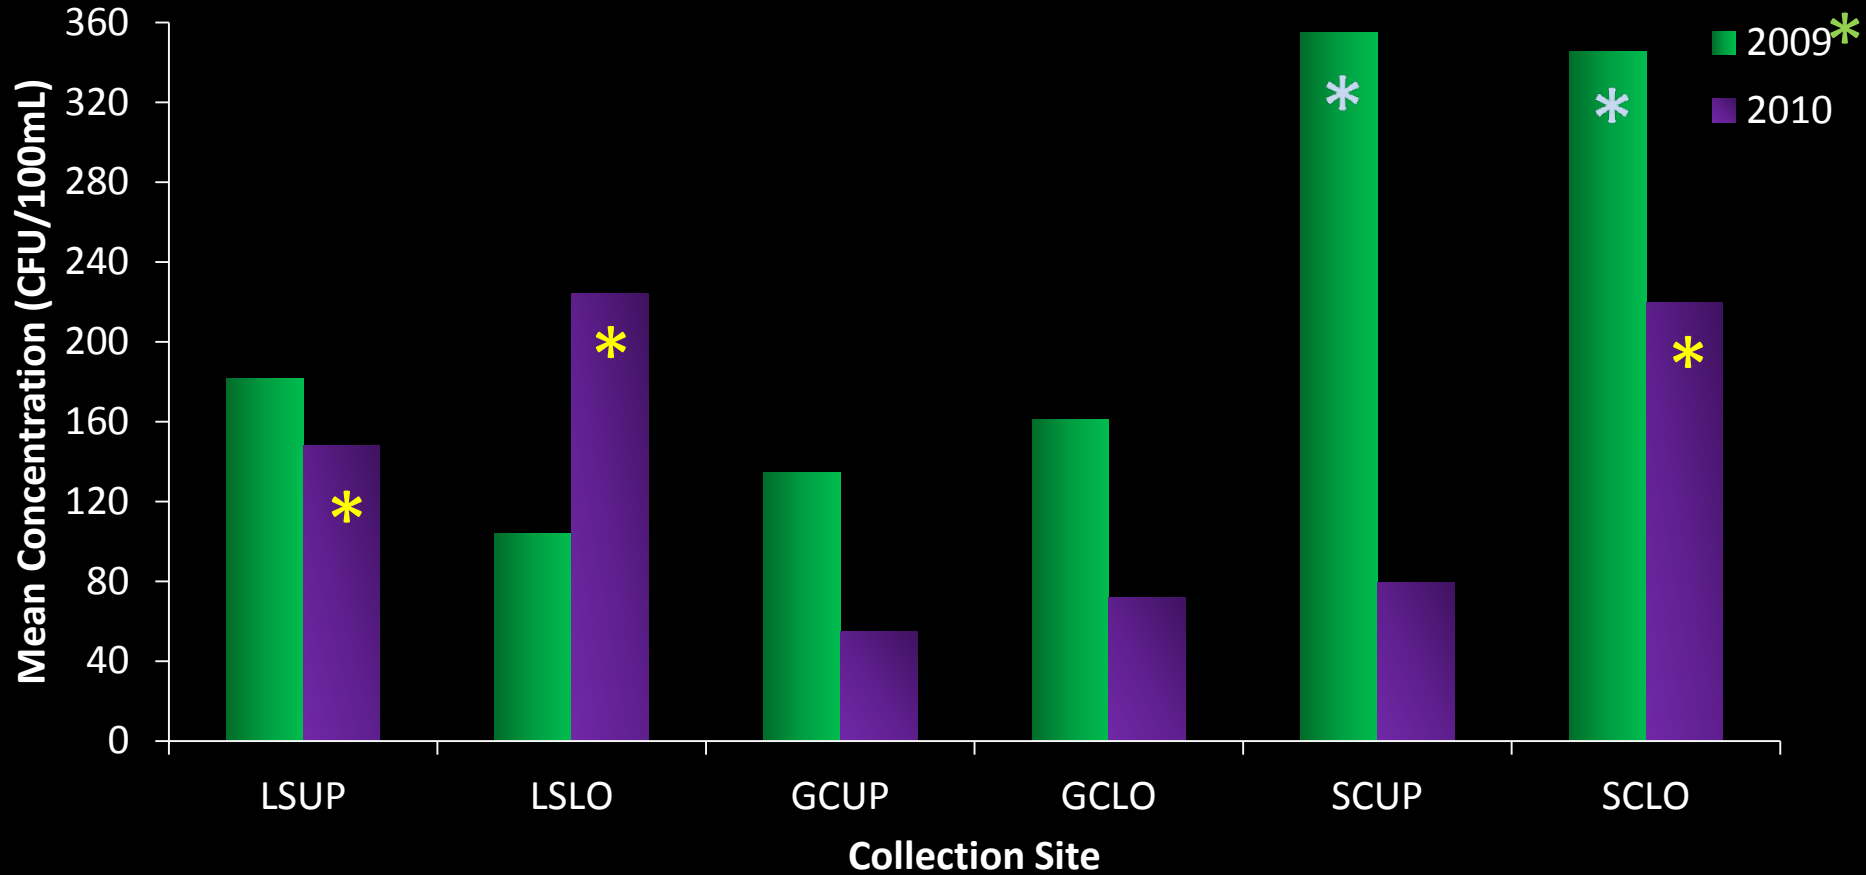
Escherichia coli

* No values for June, July, August 2009

* Samples exceeded 298 CFU/100mL maximum for single samples for ERW, ESW, and NSW

* Samples exceeded 1490 CFU/100mL max for single sample during the remainder of the year for ERW, ESW, and NSW
