**Upper Sager Creek
Regional Treatment
319 Grant Project No. 13-800**

**Funded by: EPA Region 6, ANRC and the City
of Siloam Springs**

Now; Upper Sager Creek Regional Treatment Project

Project Goal

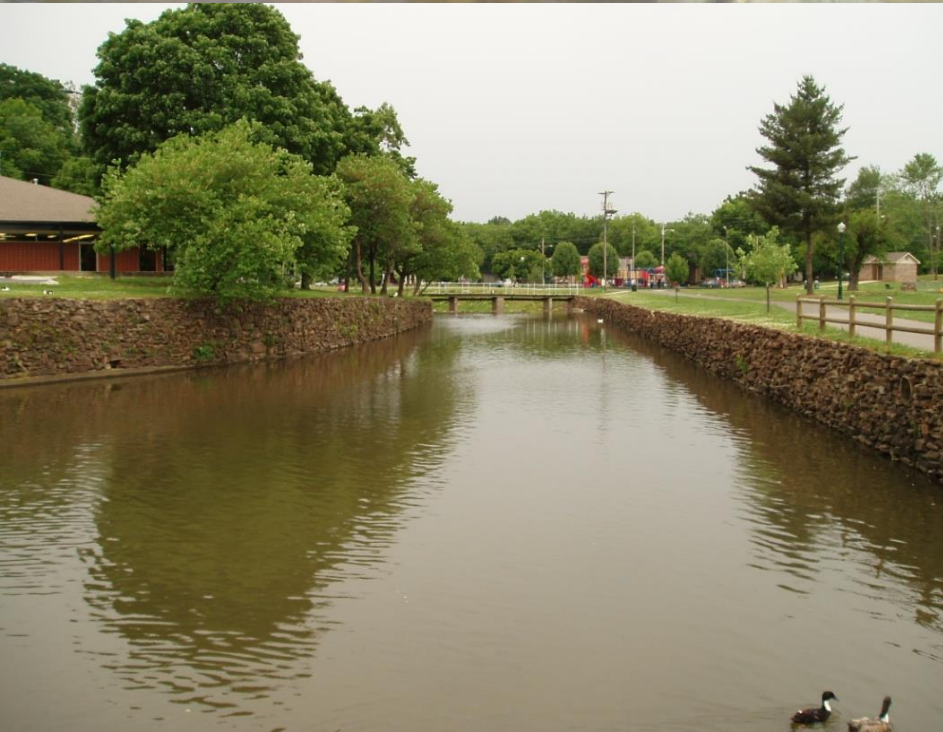
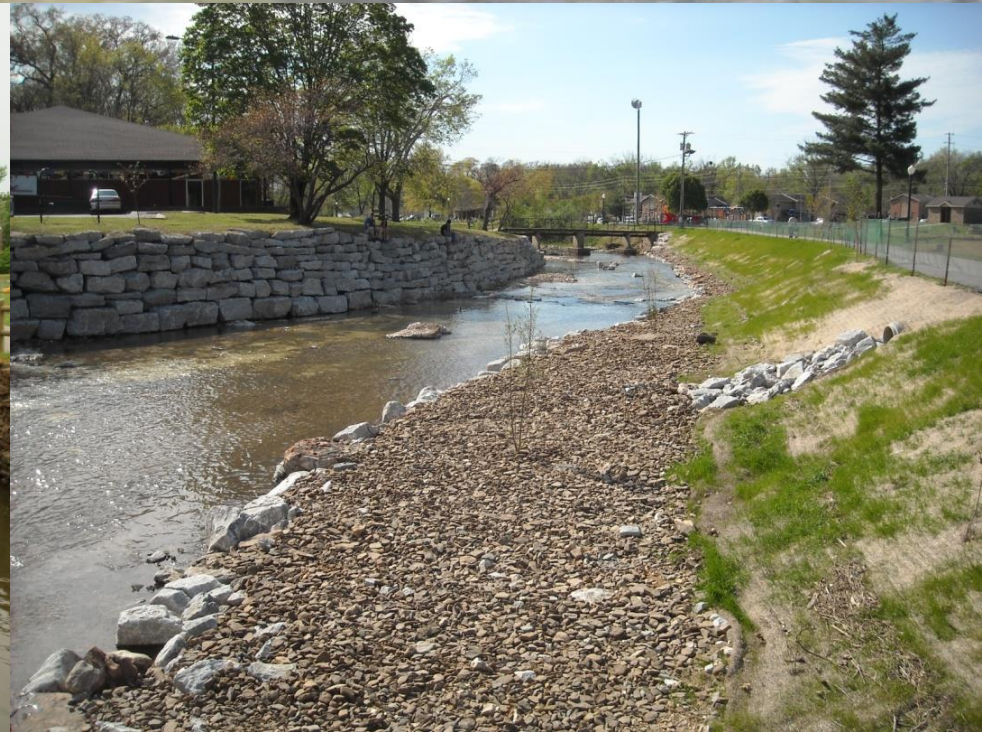
Restoration in Sager Creek (Before and After)

- ◆ **Stream channel restoration, bank stabilization and dam removal.**
- ◆ **Sub-watershed UTS-1 regional treatment through detention and wetland creation.**
- ◆ **Local ordinances**
- ◆ **Creation of stream side buffers**

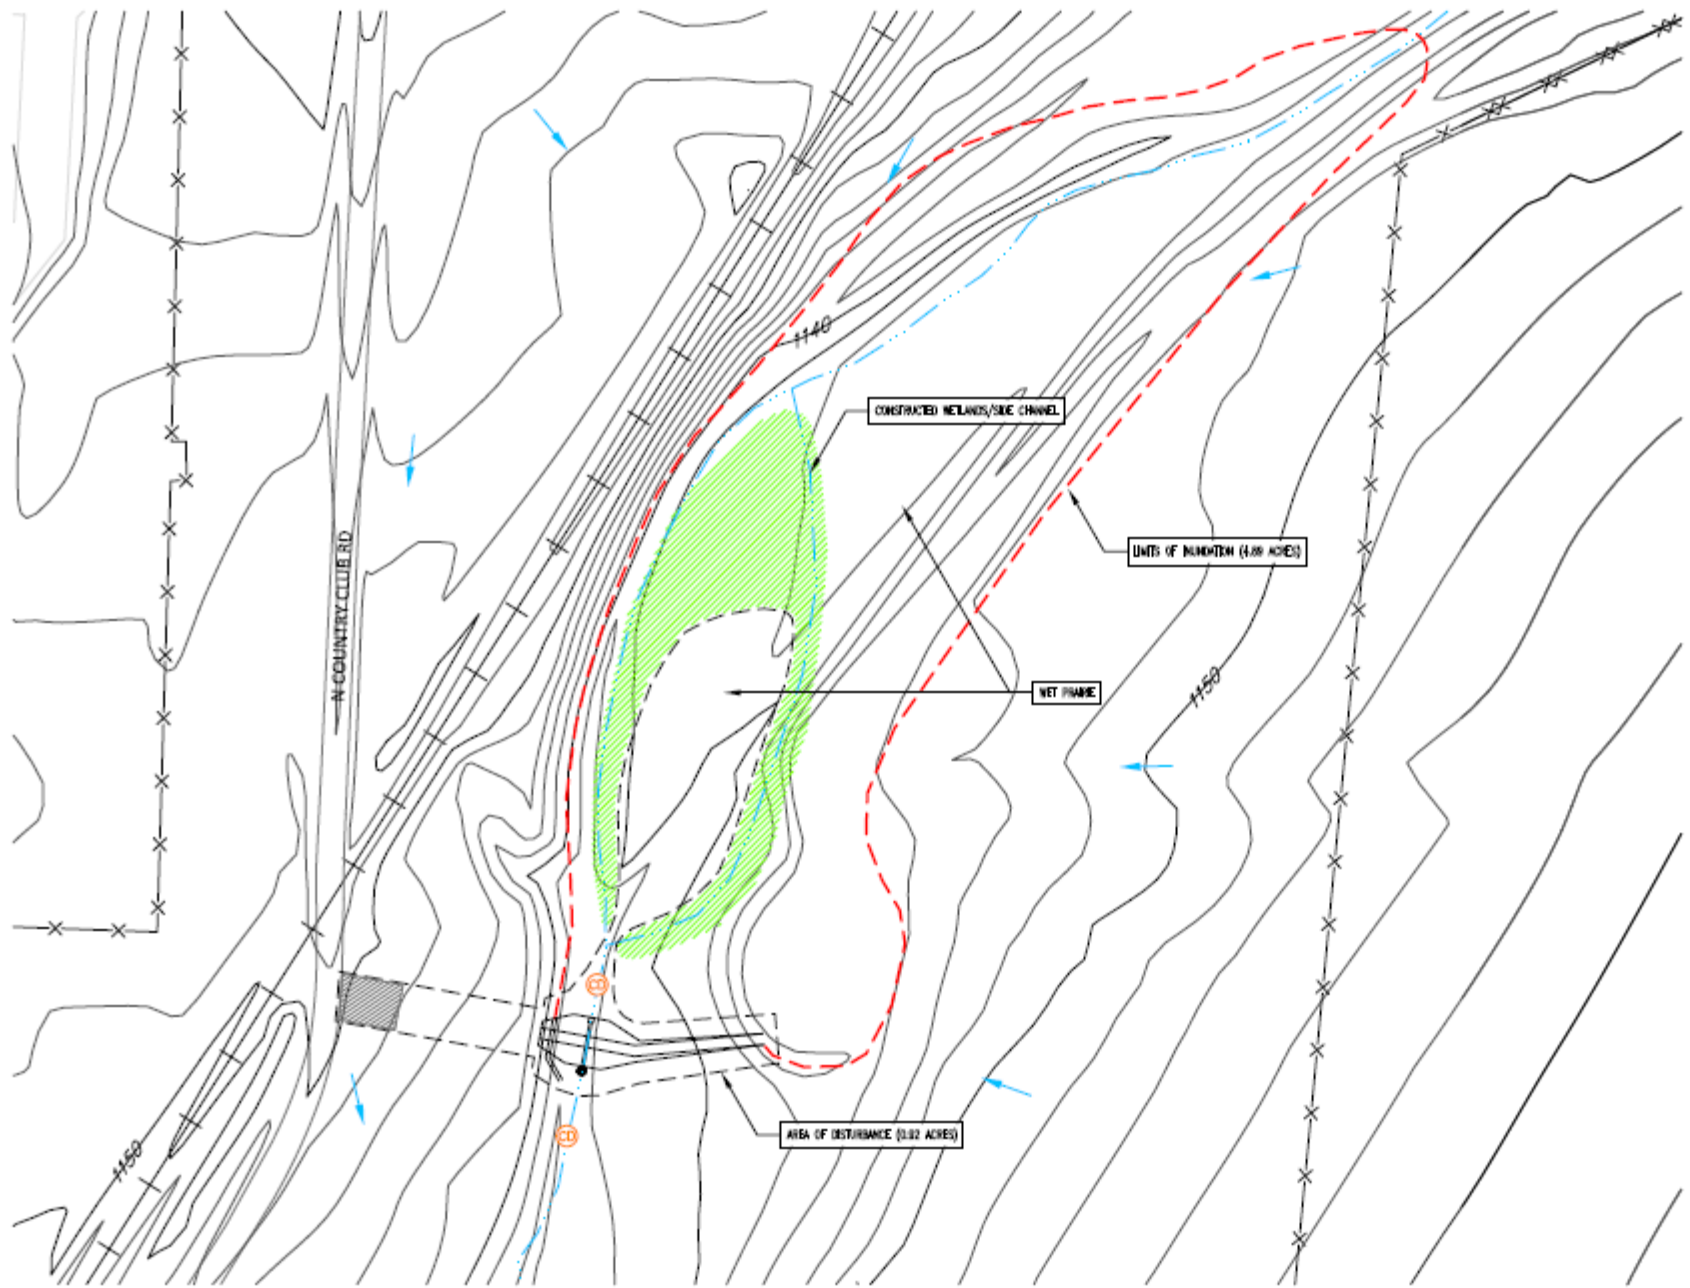
OVERALL SITE MAP

UPPER SAGER REGIONAL WETLANDS

- ◆ **Establish a regional treatment feature in the SC-1 sub-watershed (upper Sager Creek)**
- ◆ **Project funded through 319 program**
- ◆ **Land for project donated by local citizen**
- ◆ **City of Siloam Springs completed the construction and maintain the feature**

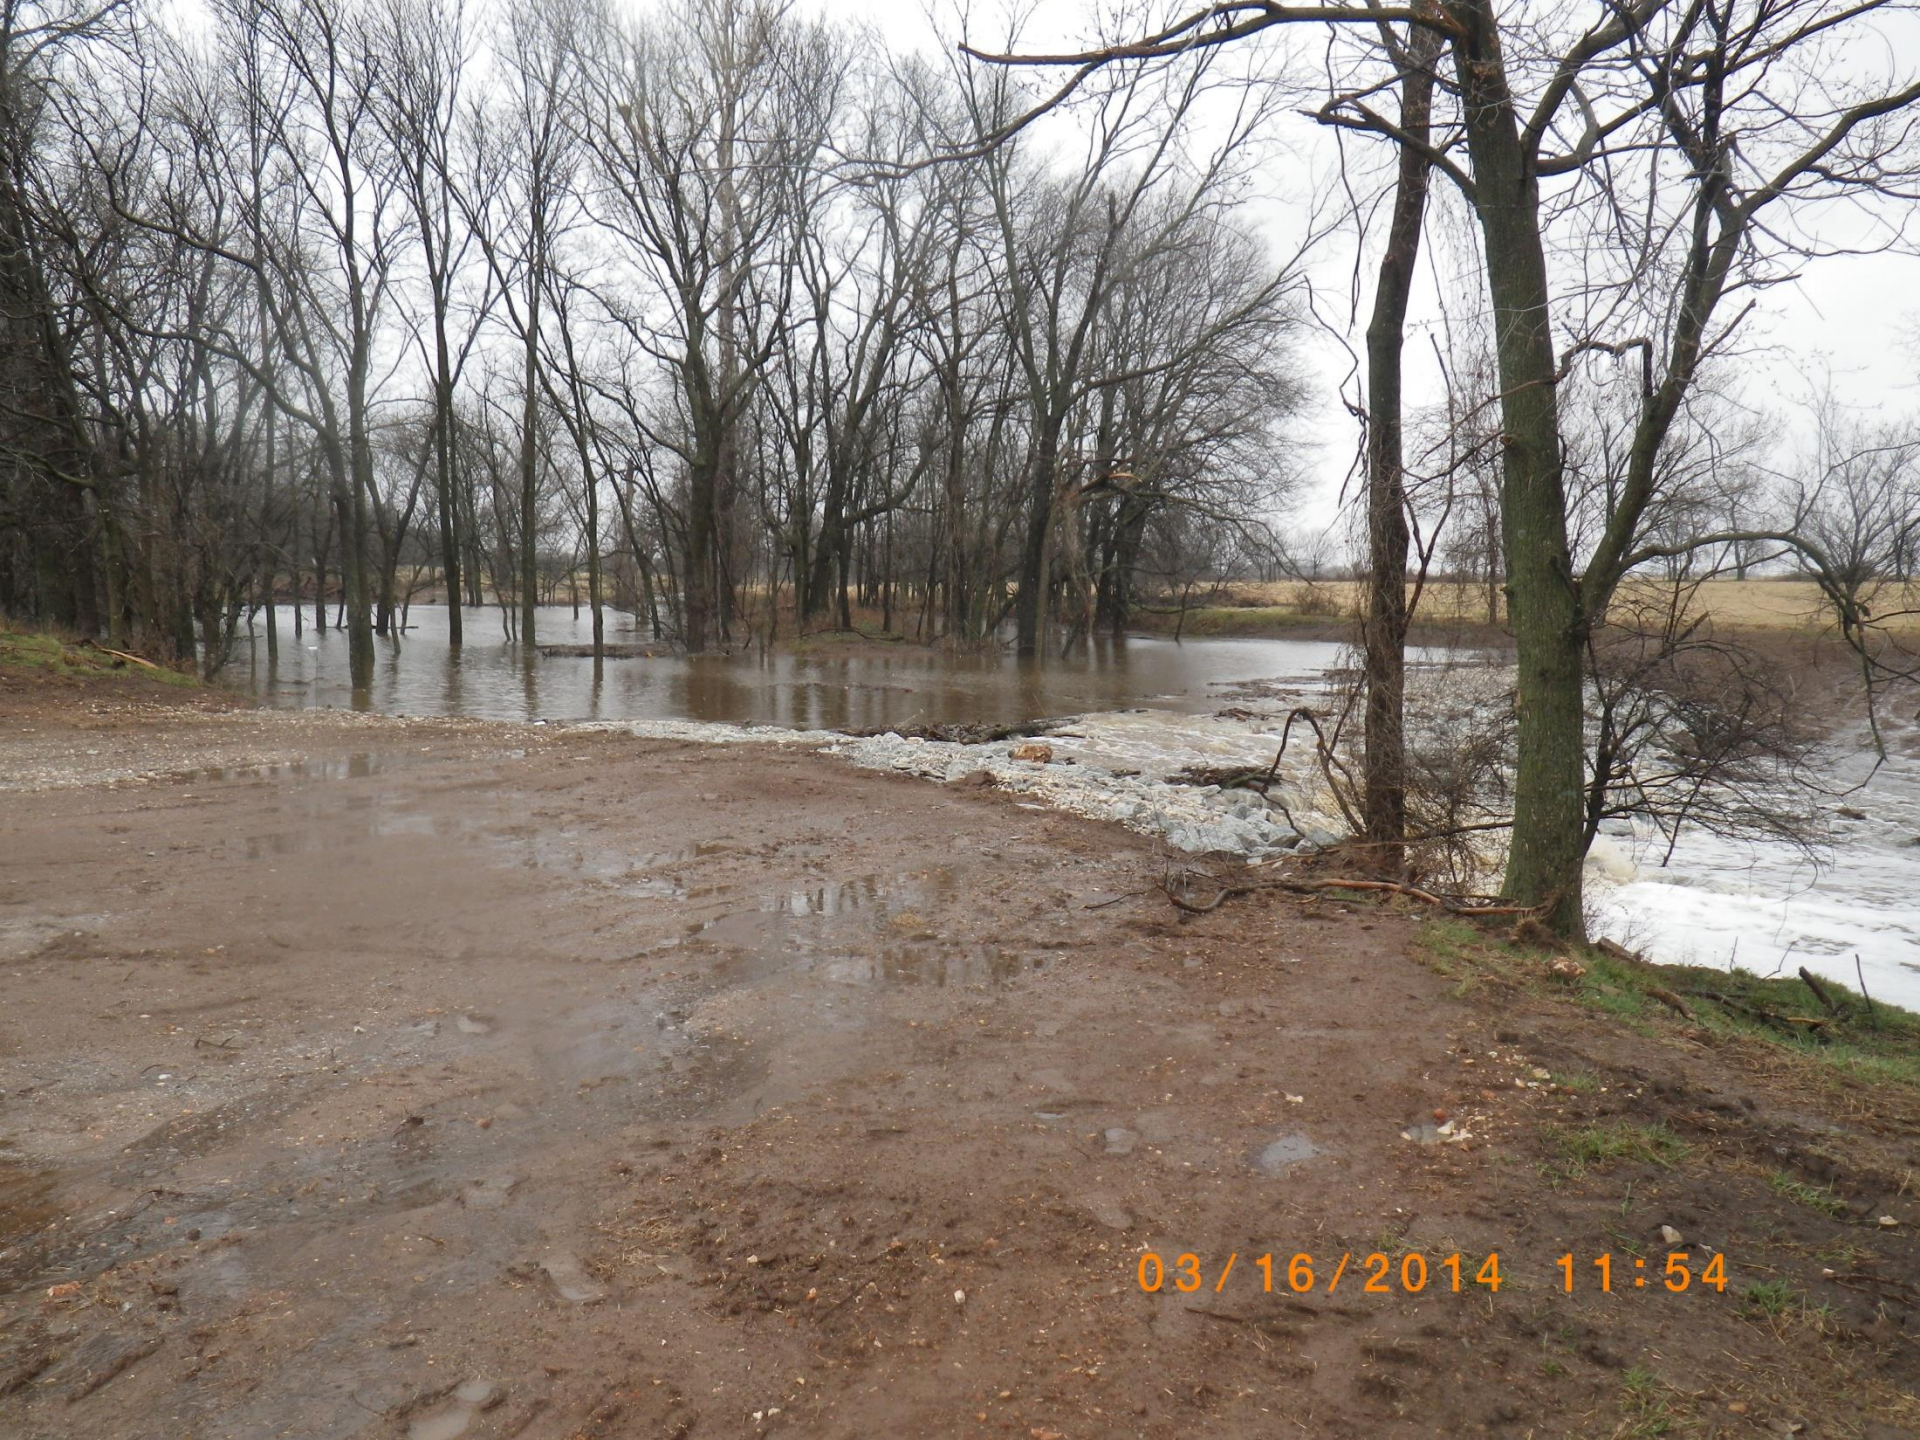
**Sediment
deposition**

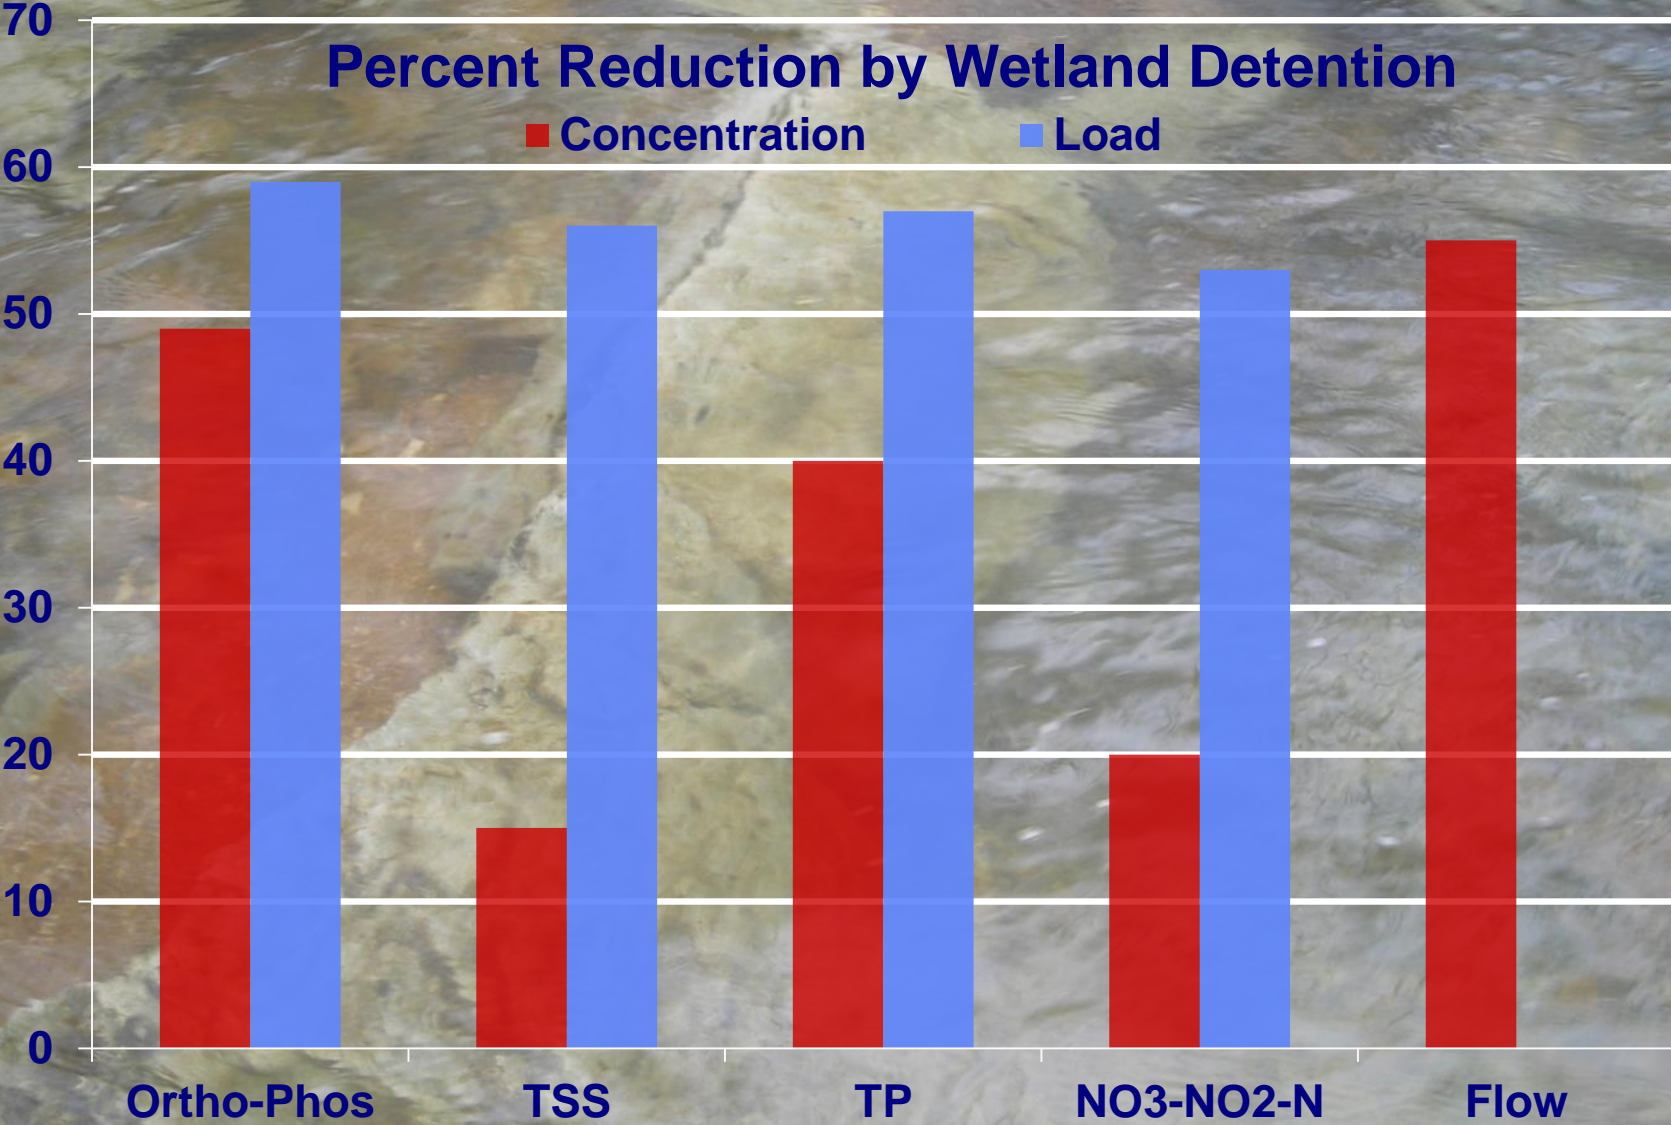
Percent Reduction by Wetland Detention

■ Concentration ■ Load

- ◆ Sediment (TSS), nitrate and phosphorus loading has been shown by the monitoring to have decreased by as much as 57%.
- ◆ Downstream flow during storm events has been reduced as much as 55% by the active detention of water in the SC-1 system and the low flow release structure.
