# White River Bank Restoration and Monitoring Project

## ANRC Project No. 13-1100

Matt Van Eps, Watershed Conservation Resource Center  
ANRC 2015 NPS Program Annual Meeting  
September 23 and 24, 2015

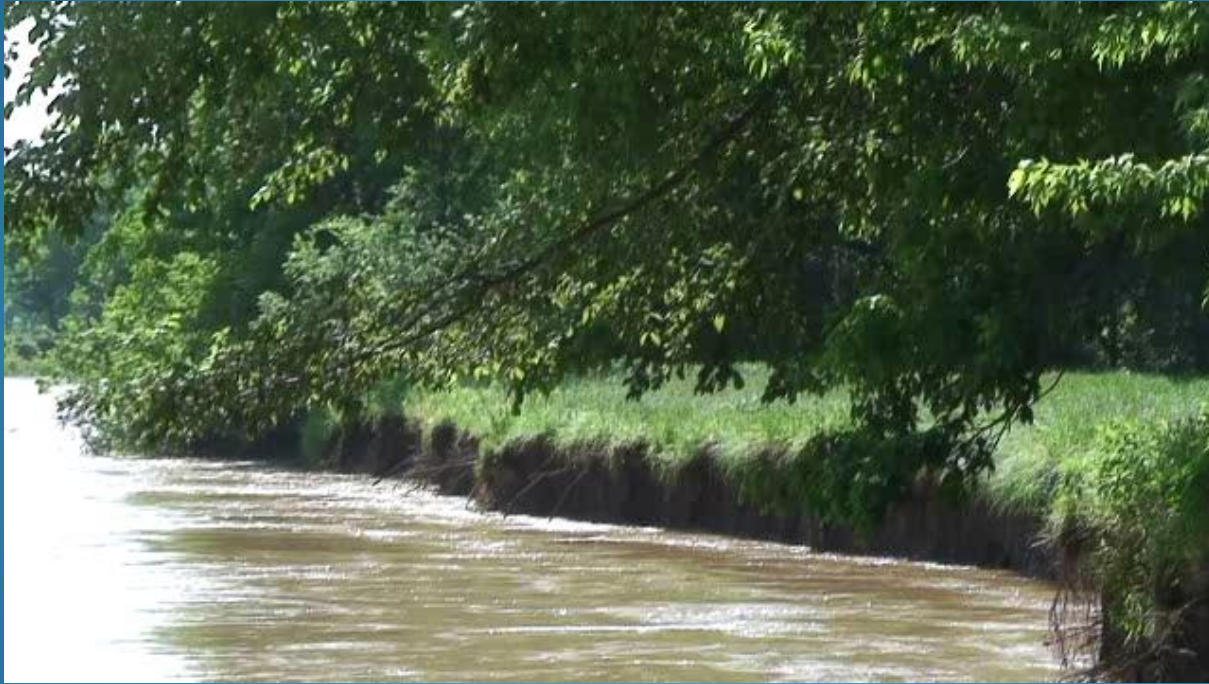
# Severe Streambank Erosion Source of Sediment and Nutrients to Rivers

What does bank erosion look like?

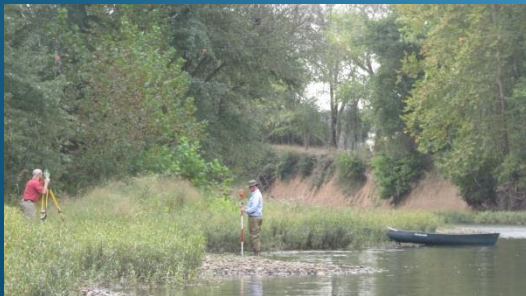
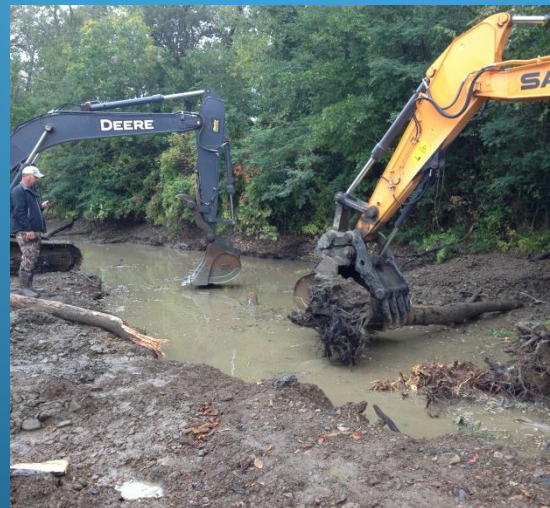
## Restoration Plan Development

- Site Geomorphology Data Collected
- Topographical and Other Survey Data Collected
- Toe-wood structure will be the basic design technique

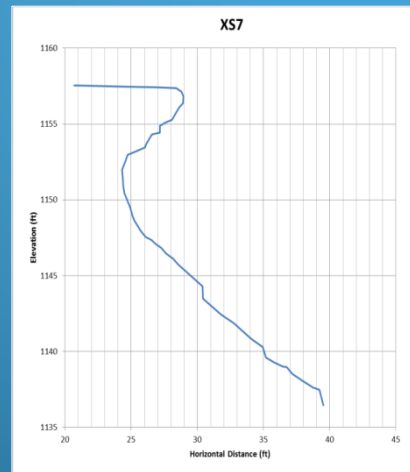
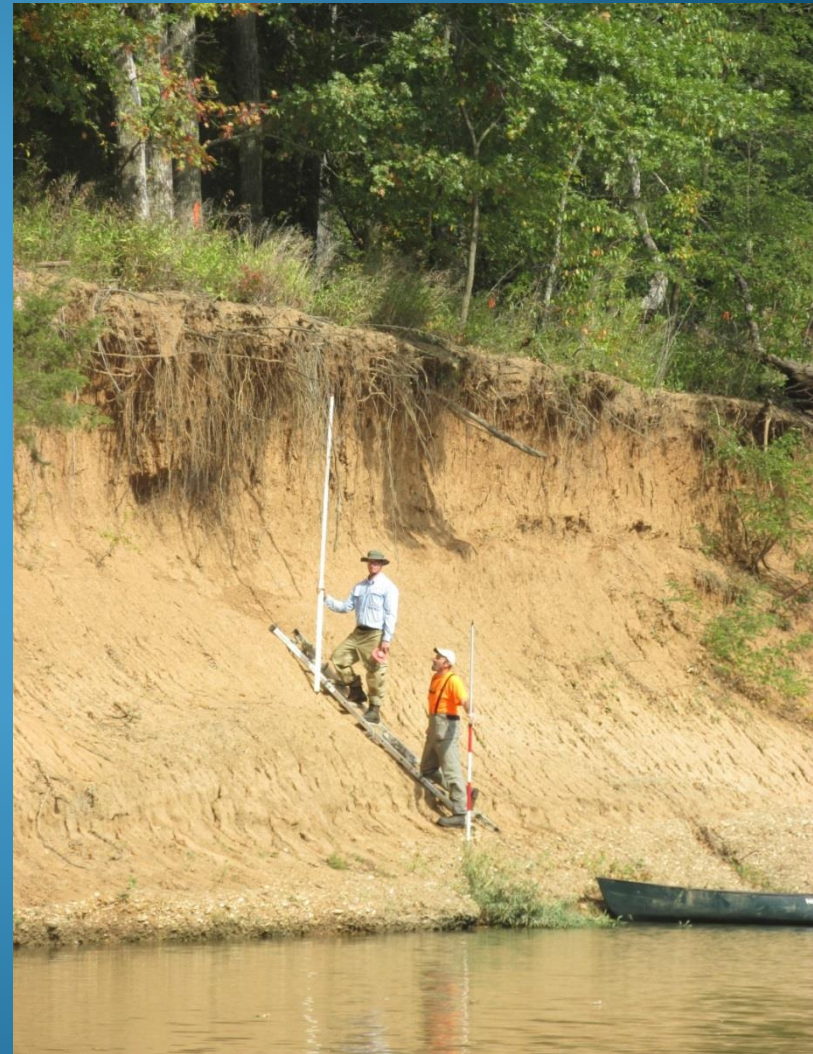
- Streambank Profiles Collected
  - Seven Sites Evaluated
- Determined
  - Bank Erosion Hazard Index
  - Near Bank Shear Stress

Bank ID	XS7
Bank Location	Bend
Root Depth (ft)	1.5
Root Density	20%
Bank Angle	64°
Surface Protection	0%
Bank Material Points	0
Stratification Adjustment	0
Bank Height Ratio	1.5
Bank Length(ft)	270
Bank Height (ft)	21
NBS	MODERATE
BEHI Rating	VERY HIGH

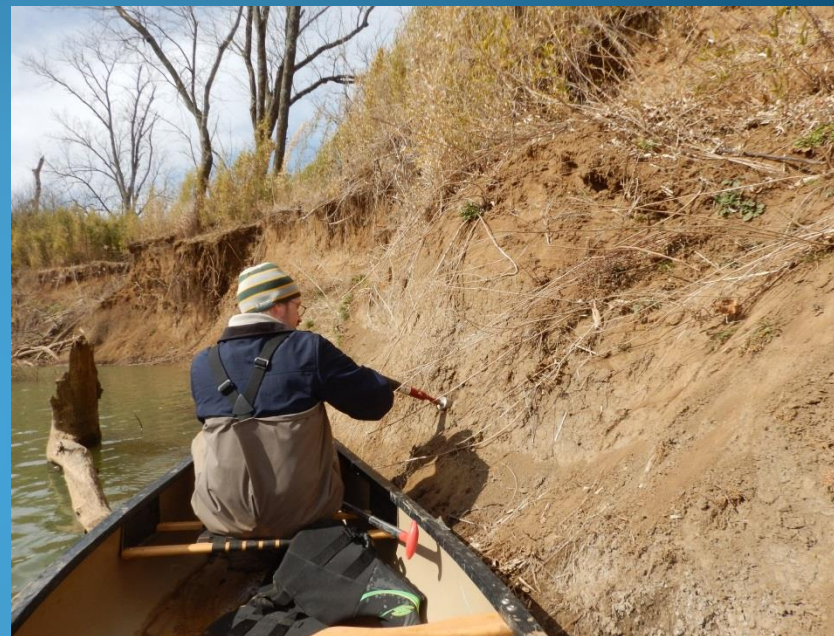
- Streambank Soil Samples Collected
  - 17 samples collected

Parameter	Min	Max
Bulk Density (lb/ft <sup>3</sup> )	74.9	93.1
T. Phosphorus (lb/ton of sediment)	0.55	1.2
T. Nitrogen (lb/ton of sediment)	1.5	3.3

Sample ID	WWTP 03-02
Bulk Density (lb/ft <sup>3</sup> )	82.8
Clay Fraction %	28.0
Soil Type	Clay Loam
Total N (lb/ton)	1.94
Total P (lb/ton)	0.86

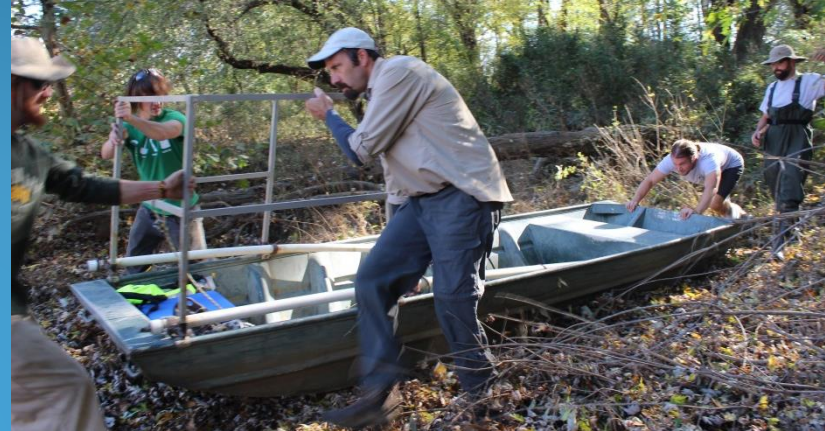
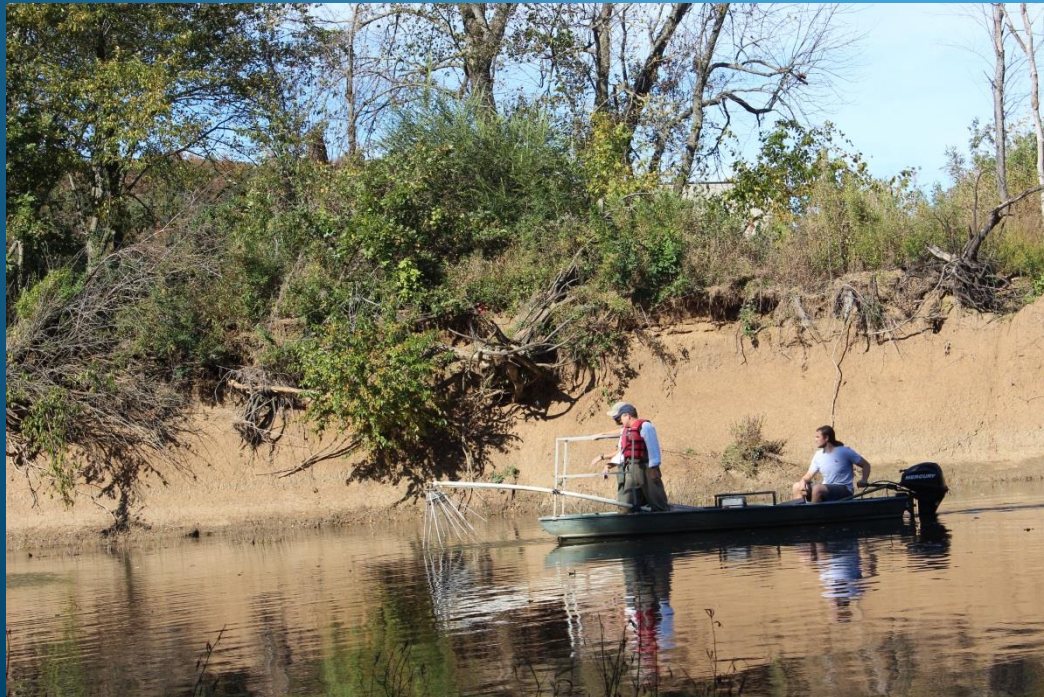
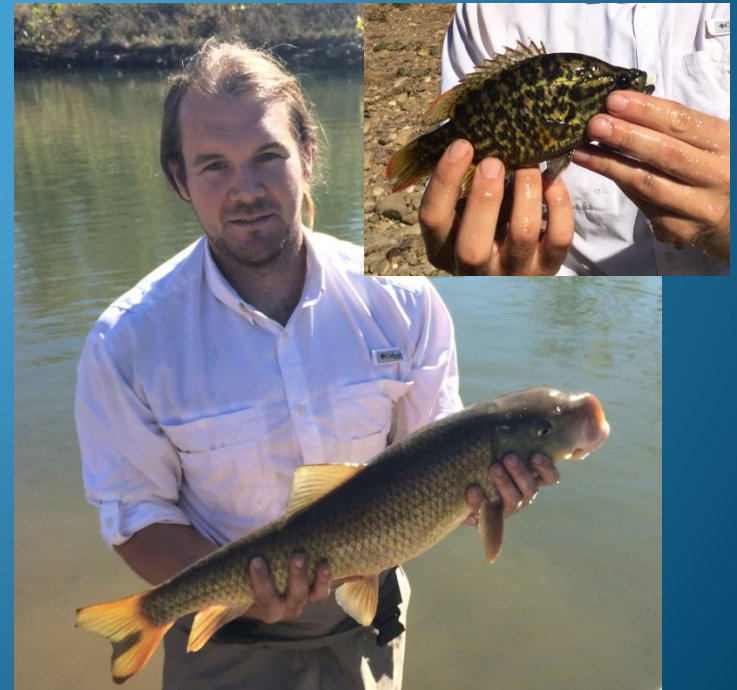
- Initial Fish Sampling Conducted
- October 2014

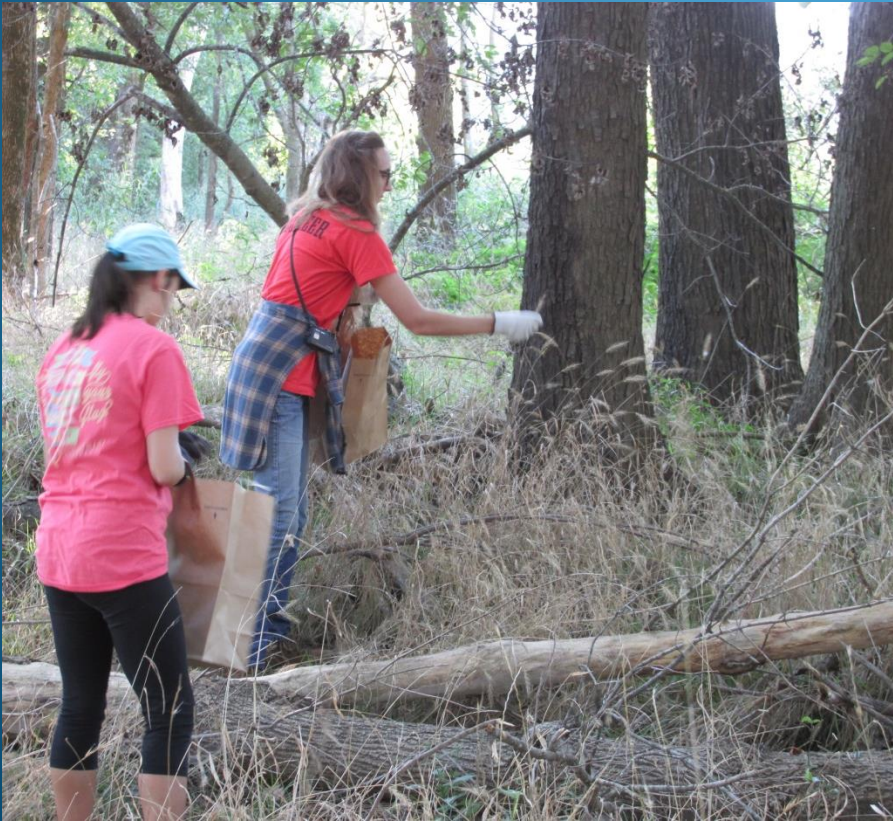
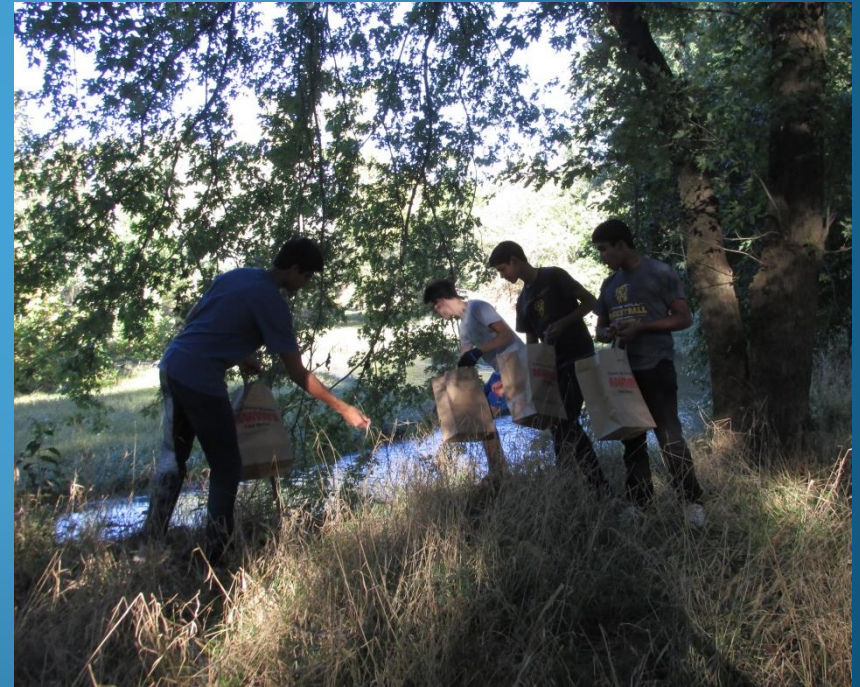
Volunteers collecting wild ryes on the White River

- Scheduling two native seed collection events with volunteers to be used at restoration site

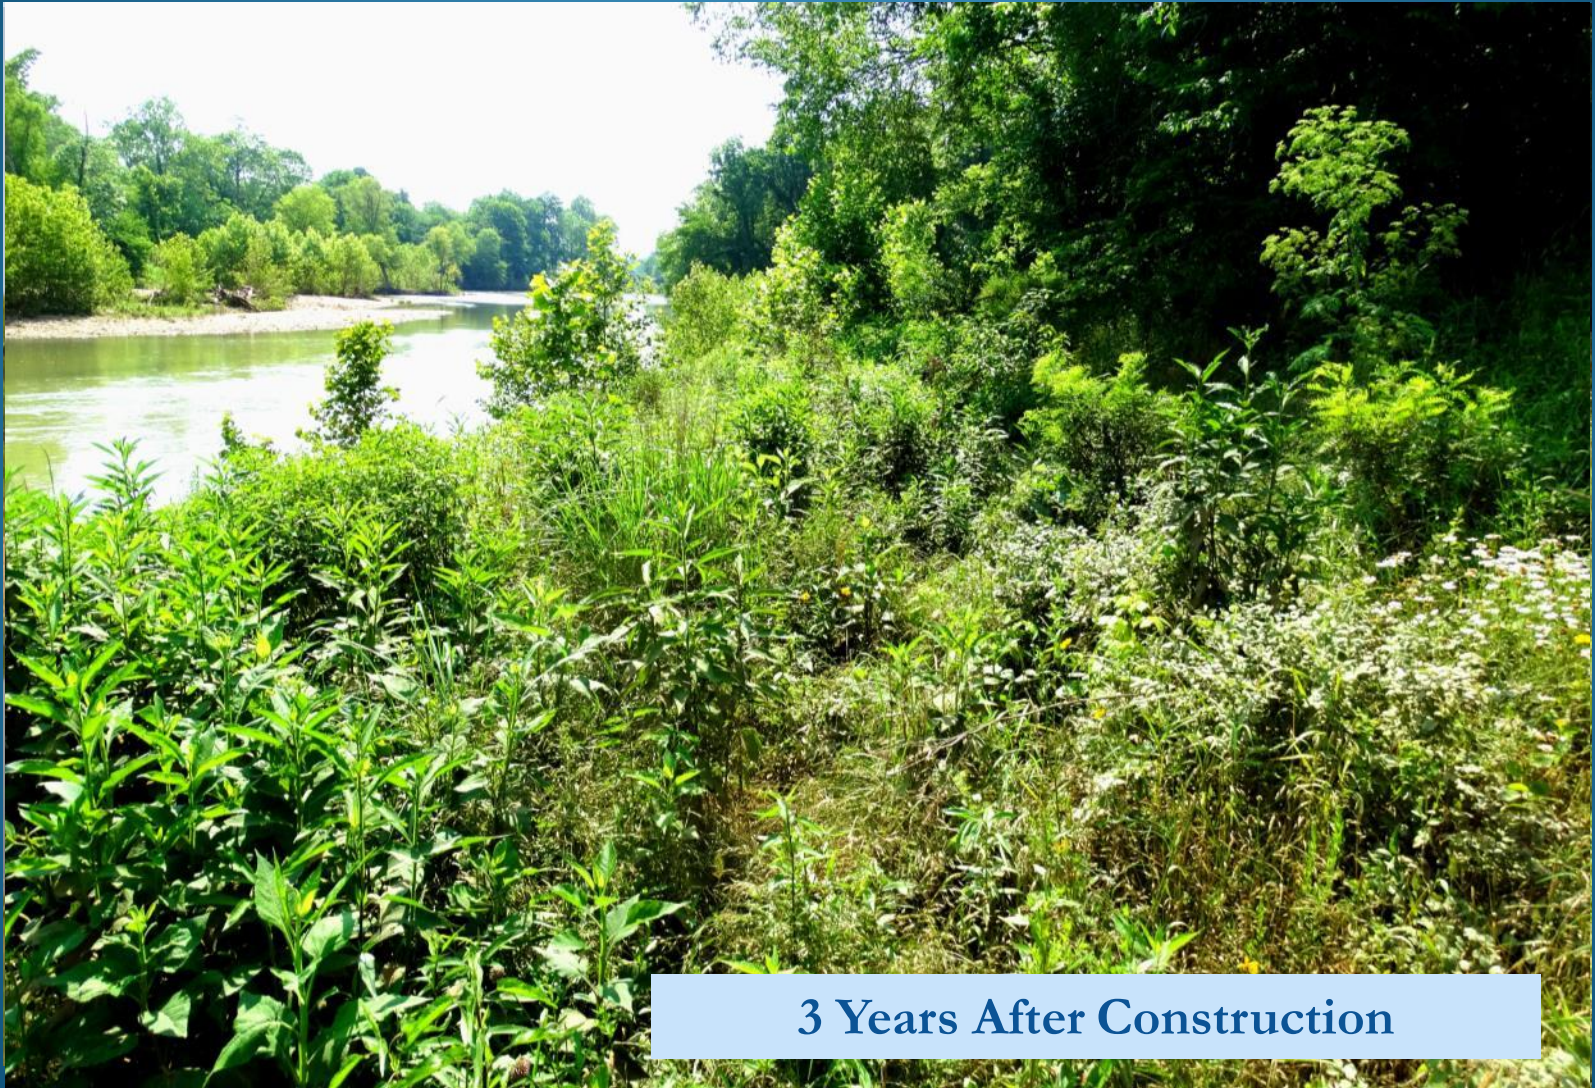
**3 Years After Construction**
