White River Bank Restoration and Monitoring Project ANRC Project No. 13-1100

**Matt Van Eps, Watershed Conservation Resource Center
ANRC 2016 NPS Program Annual Meeting
September 27 and 28, 2017**

Project Goal

Reduce streambank erosion and associated sedimentation along a minimum of 1,250 feet of riverbank on the White River

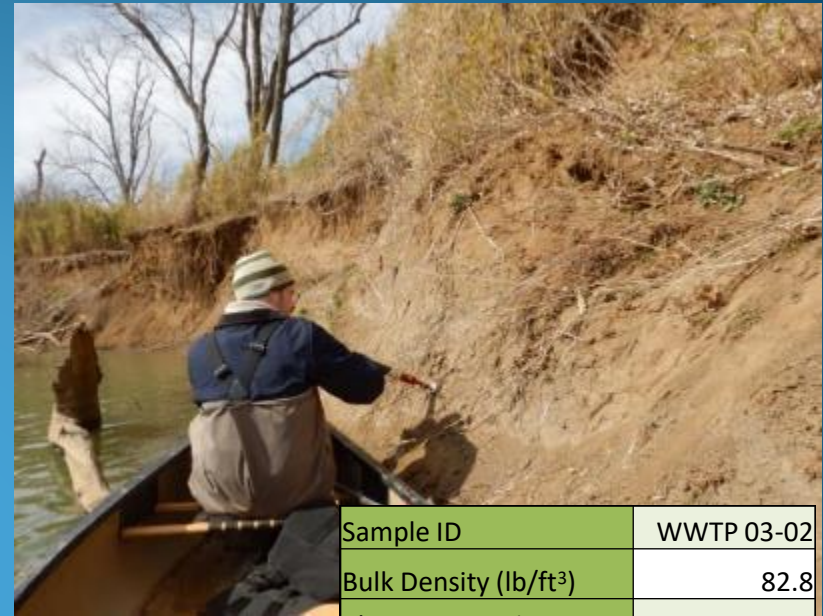
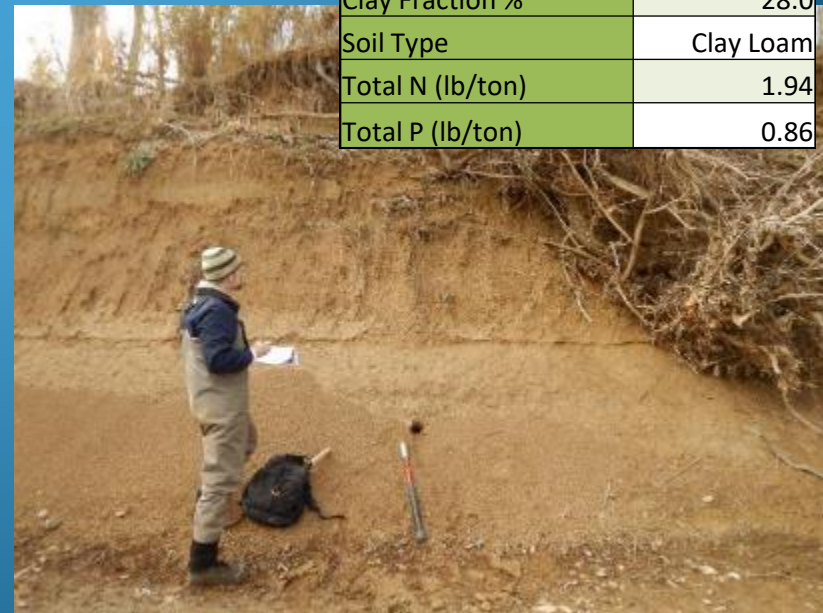
Streambank Material Sampling

- Streambank Soil Samples Collected
 - 17 samples collected

Sample ID	WWTP 03-02
Bulk Density (lb/ft ³)	82.8
Clay Fraction %	28.0
Soil Type	Clay Loam
Total N (lb/ton)	1.94
Total P (lb/ton)	0.86

Parameter	Min	Max
Bulk Density (lb/ft ³)	74.9	93.1
T. Phosphorus (lb/ton of sediment)	0.55	1.2
T. Nitrogen (lb/ton of sediment)	1.5	3.3

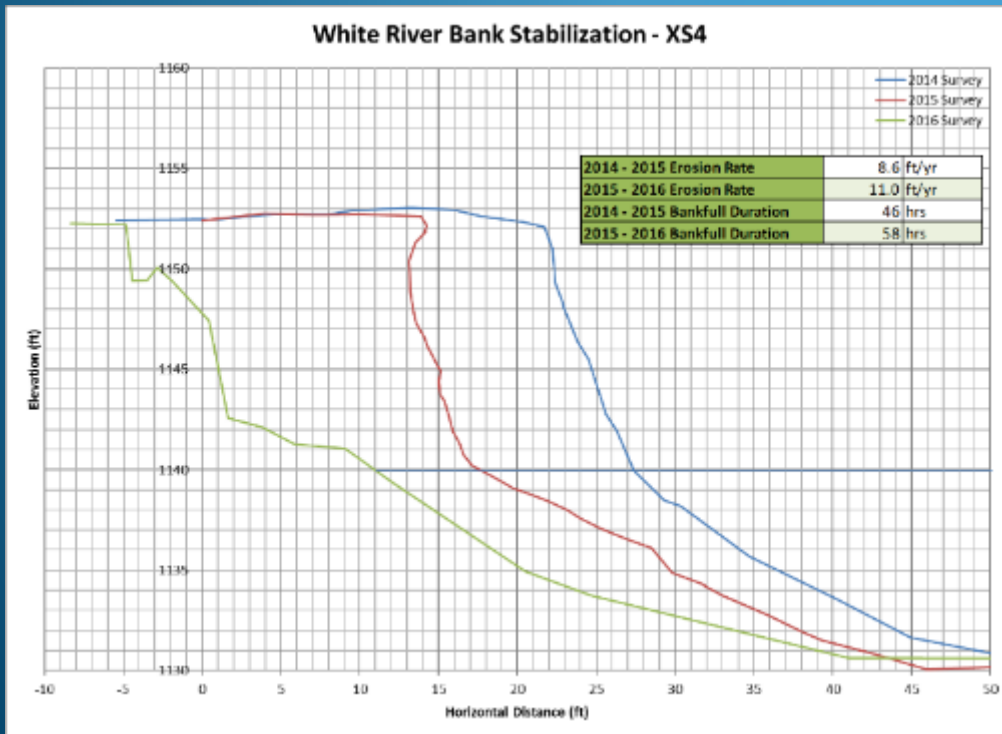
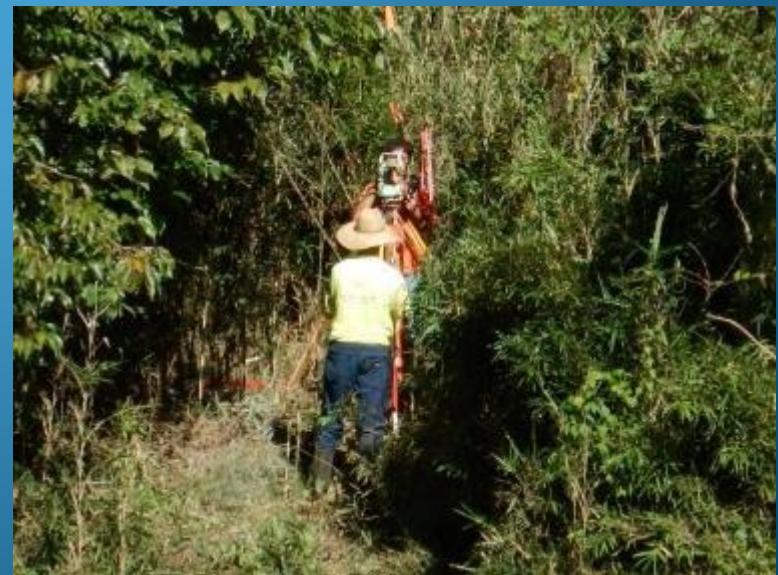
Streambank Profile Measurements

- Streambank Profiles Collected
 - Seven Sites Evaluated
 - Bank Profiles Surveyed 3 times
 - 2014, 2015, 2016
 - Erosion Rates Determined
 - Potential Load Reduction Estimated

Erosion Rate (ft/yr)	2014-2015	2015-2016
xs1	5.3	3.8
xs2	1.6	7.2
xs3	1.0	10.8
xs4	8.6	11
xs5	12.7	5.3

Sediment Load (ton/yr)	3,618	4,862
Total P Load (ton/yr)	3,184	4,278

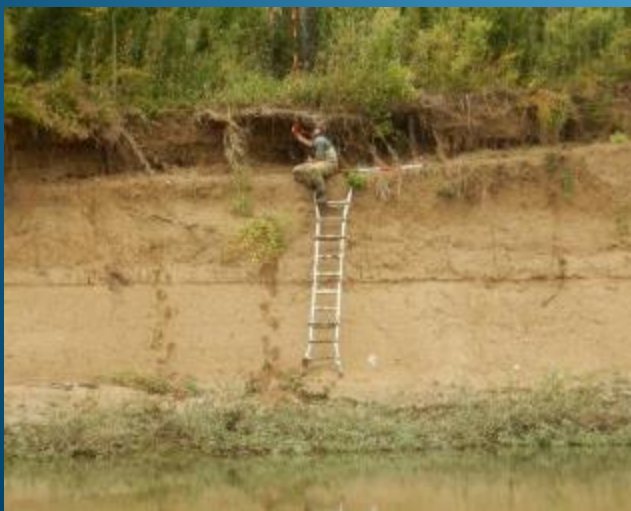
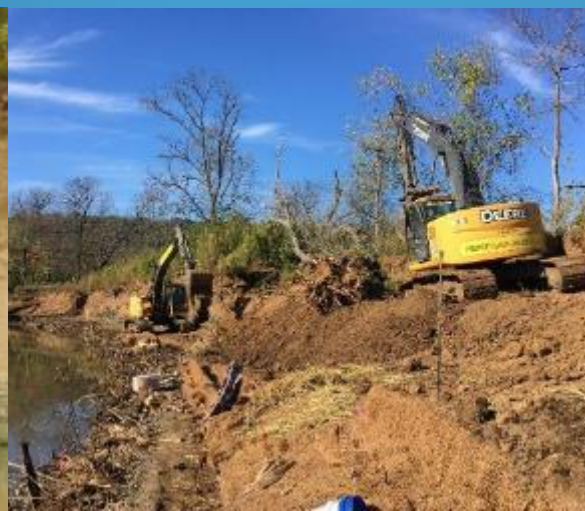
Restoration Plan Development

- Site Geomorphology Data Collected
- Topographical and Other Survey Data Collected
- Restoration Design Complete
- Permits Were Received
- Construction Bids Received

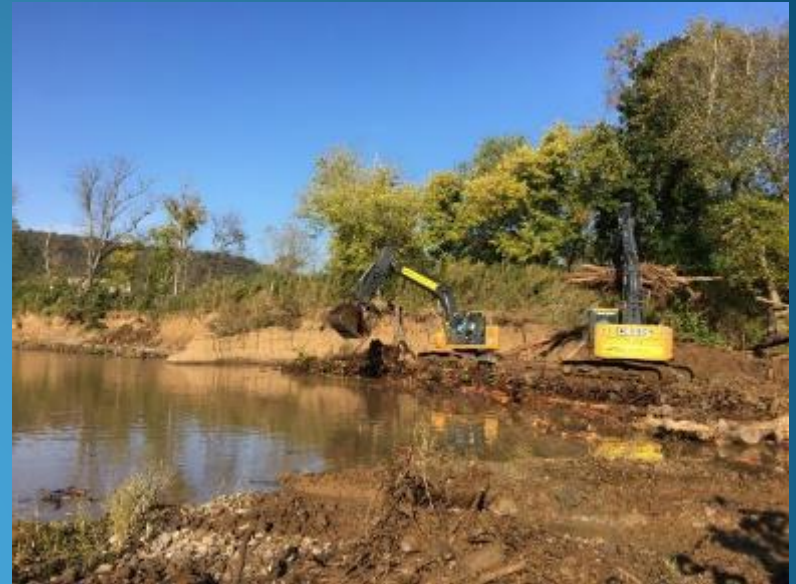
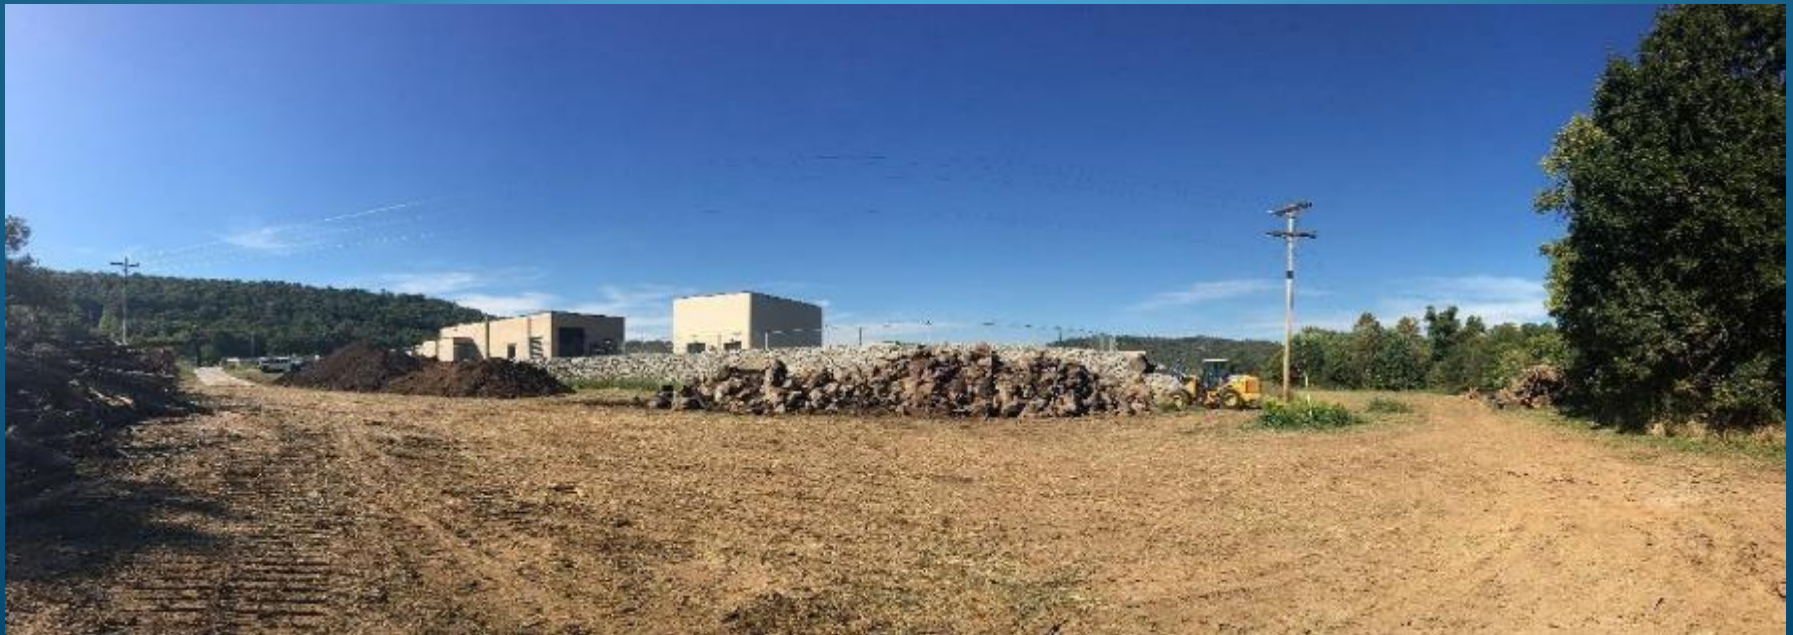
Restoration Plan Implementation

- 600 Trees (reclaimed)
- 4,000 yd³ of Fill Earth
- 1,000 yd³ of Rock
- Construction Began October 14, 2016
- Heavy Construction Completed December 12, 2016
- 4,500 Tree and Shrub Seedlings
- 1,000 Grass Plugs
- Planting continued through March 2017

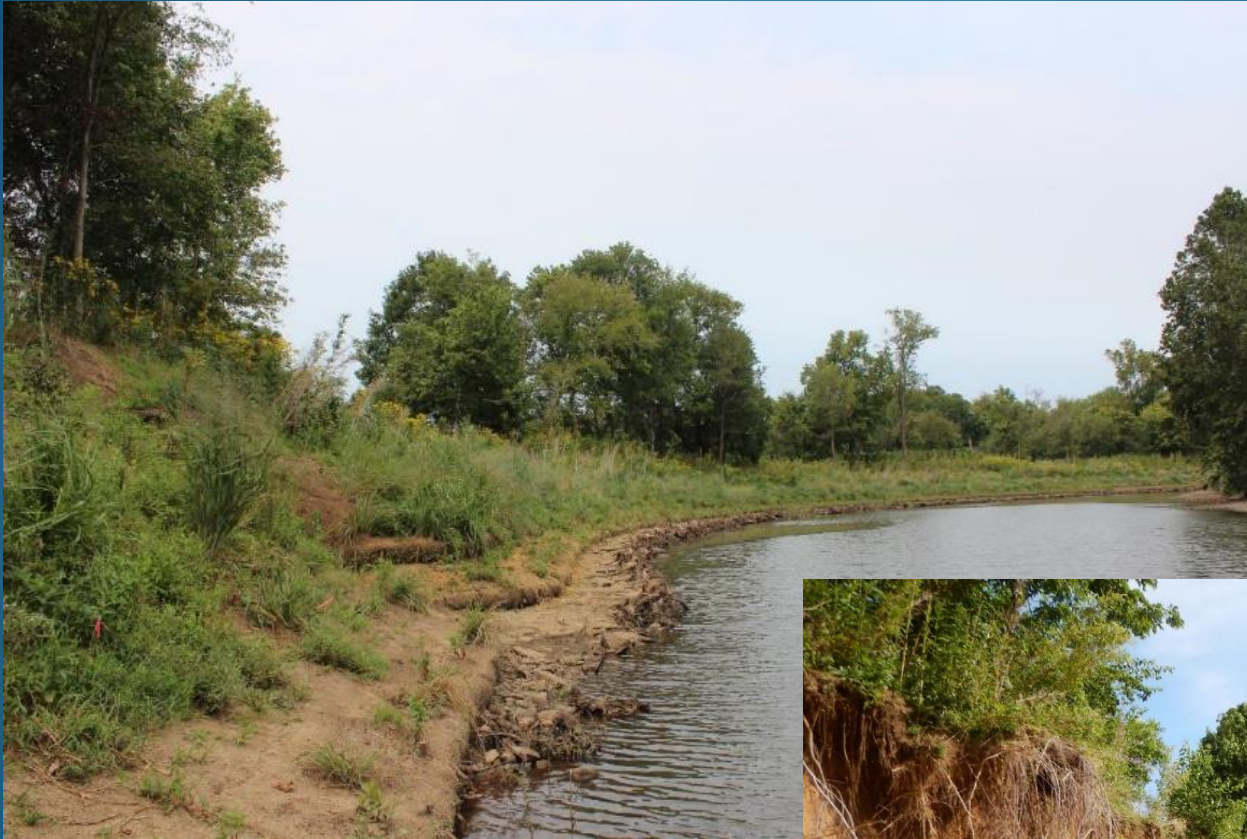
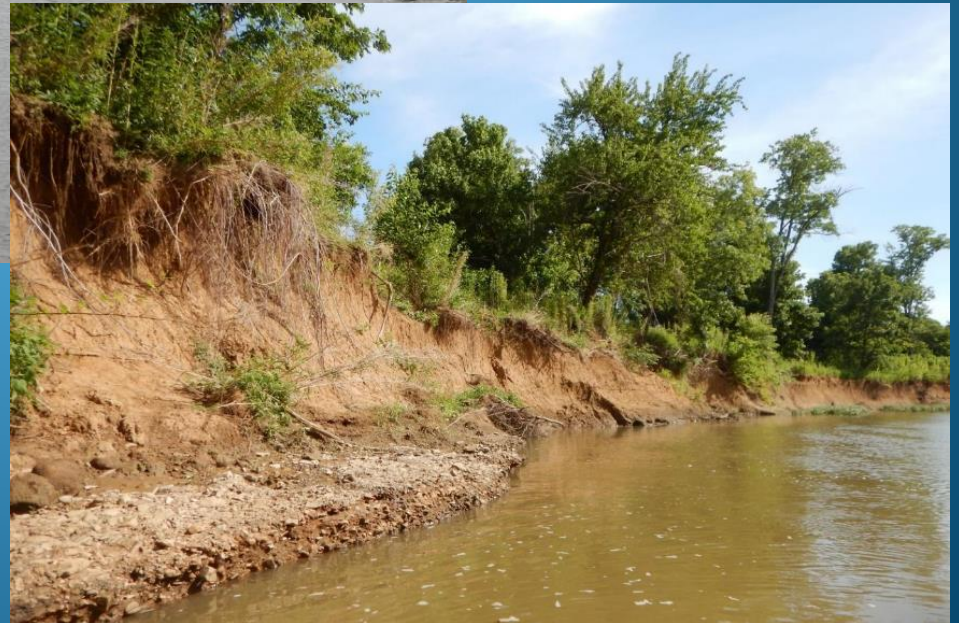
XS1 After

White River: Before and After

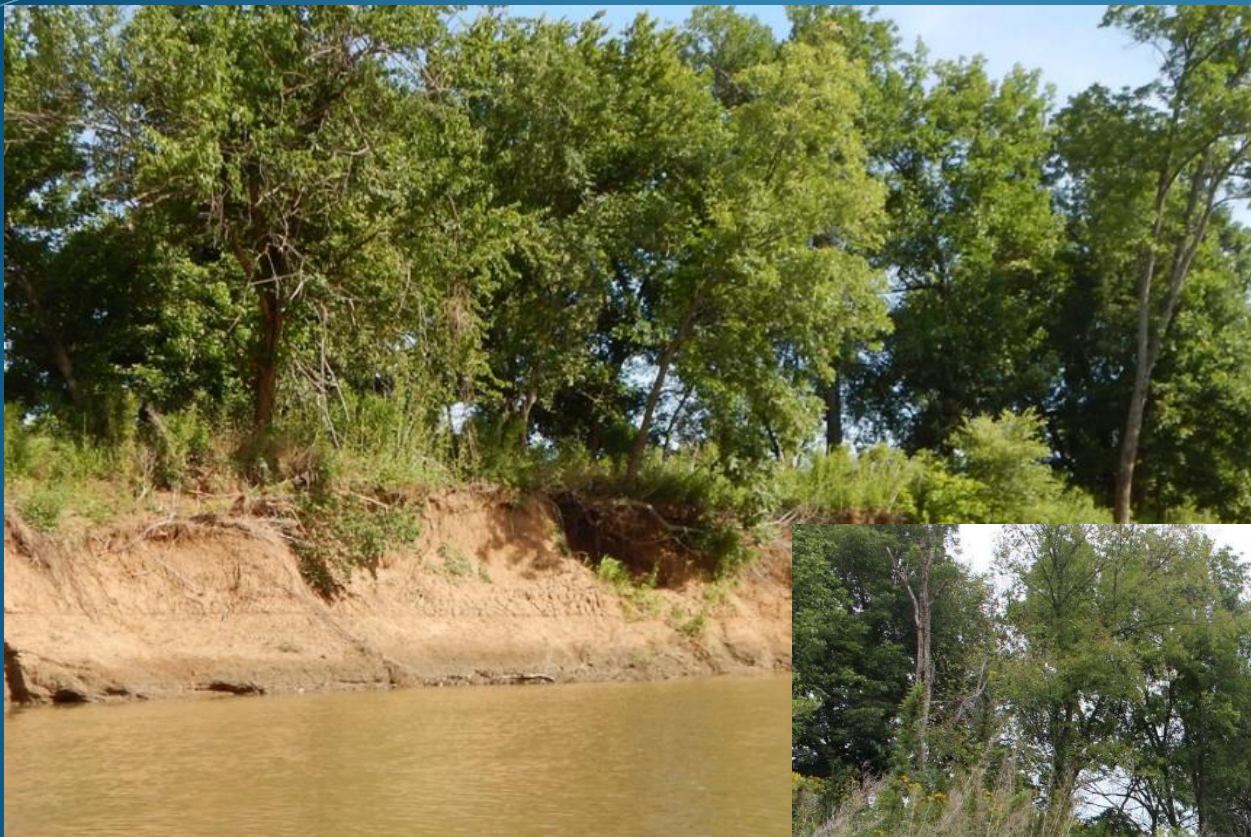
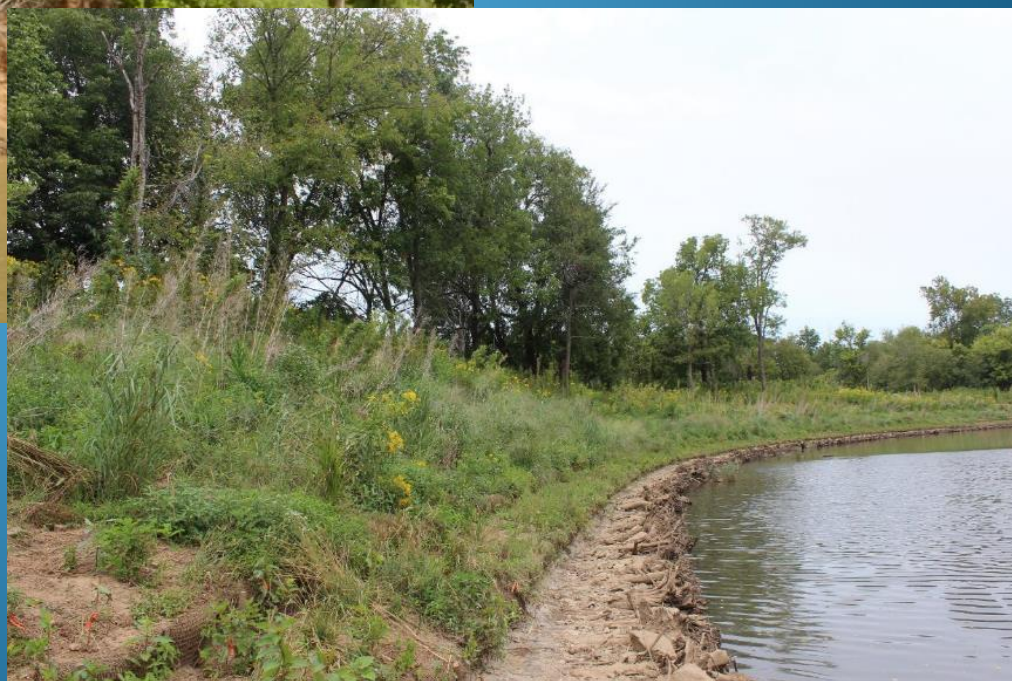
XS2 After

White River: Before and After

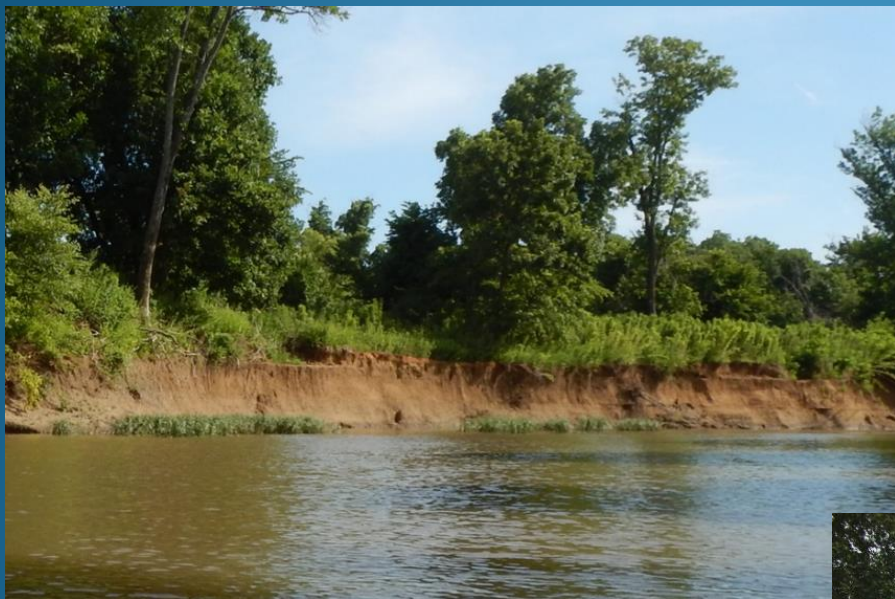
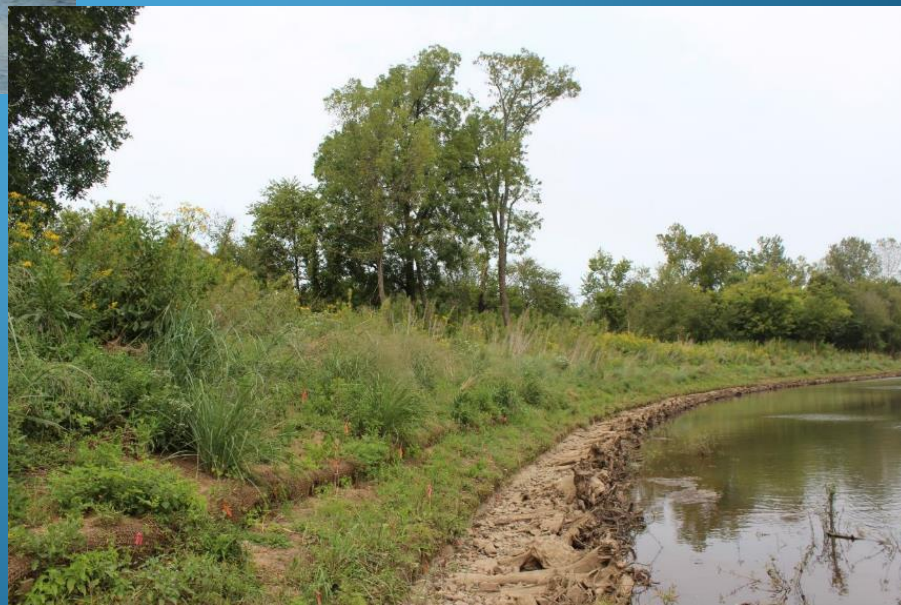
XS3 After

White River: Before and After

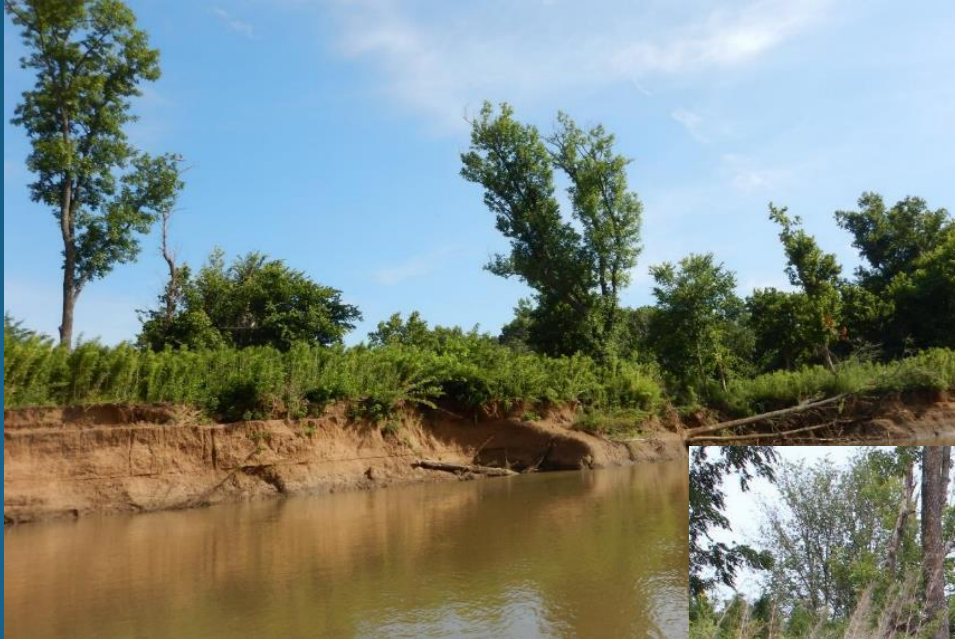
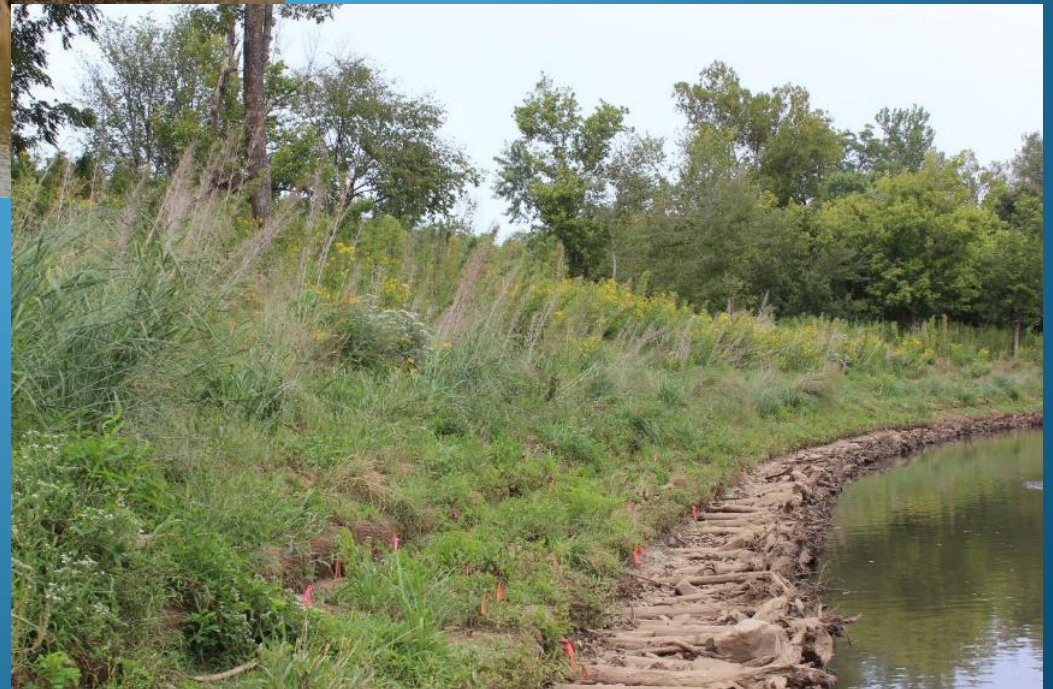
XS4 After

White River: Before and After

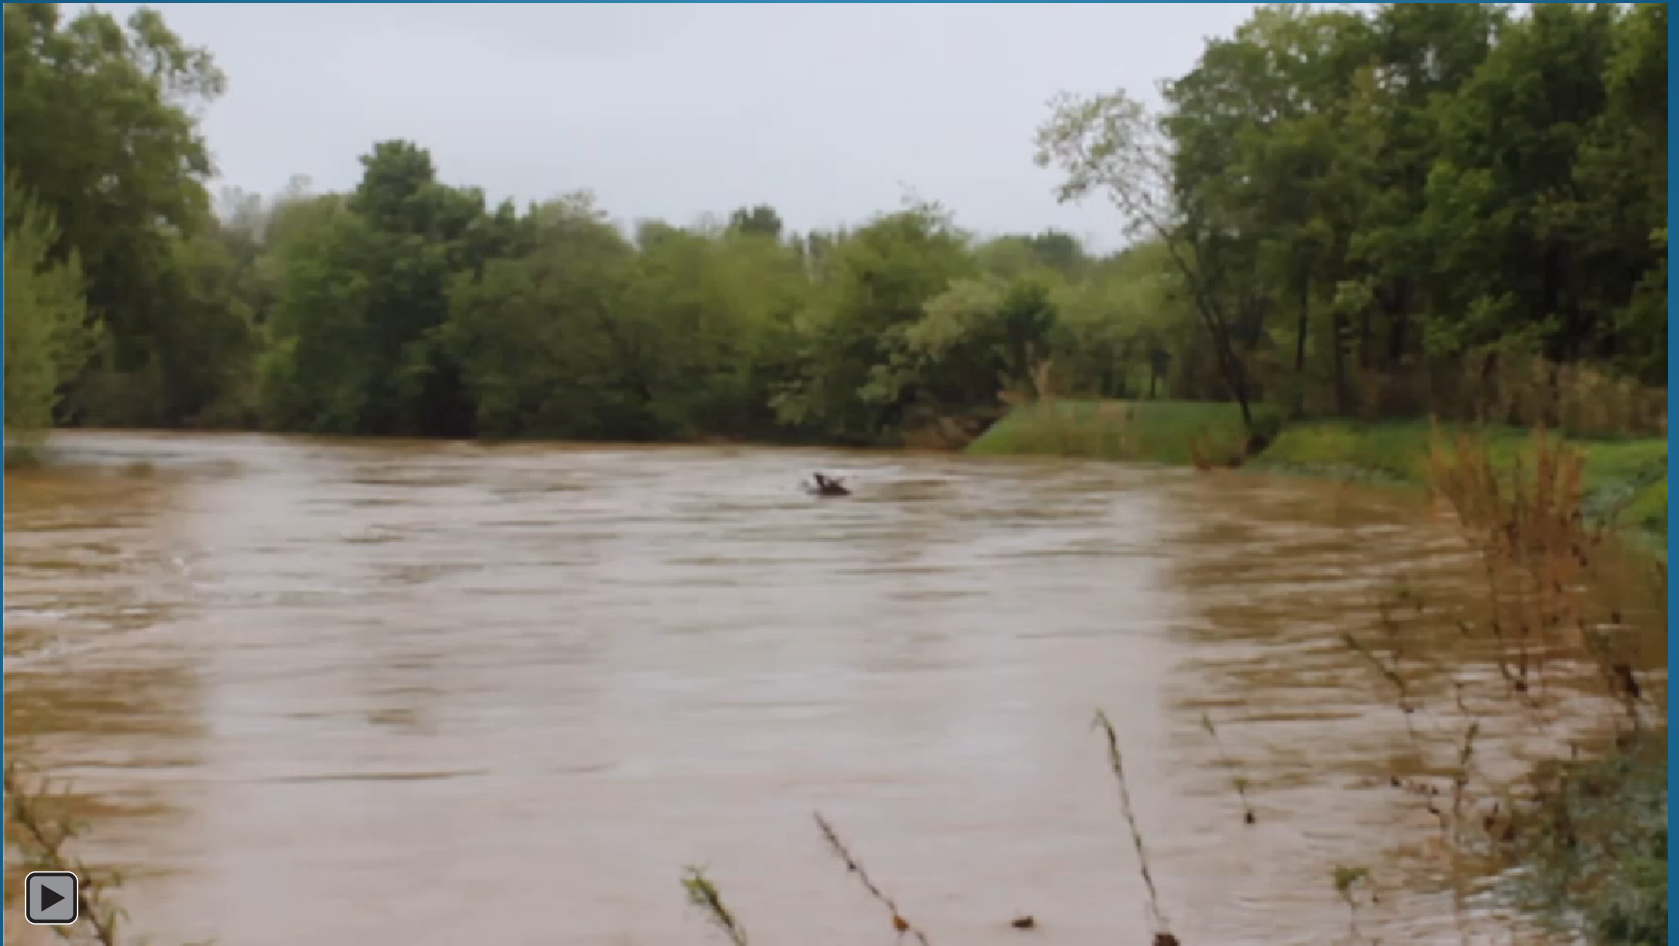
The Floods Did Come

March 25, 2017 (6,000 cfs)

April 26, 2017 (29,400 cfs)

April 30, 2017 (28,300 cfs)
