# Best Management Practices for Streambank Protection

**Project 05-400 FY 05 CWA Section 319(h)**

# Blossom Way Creek

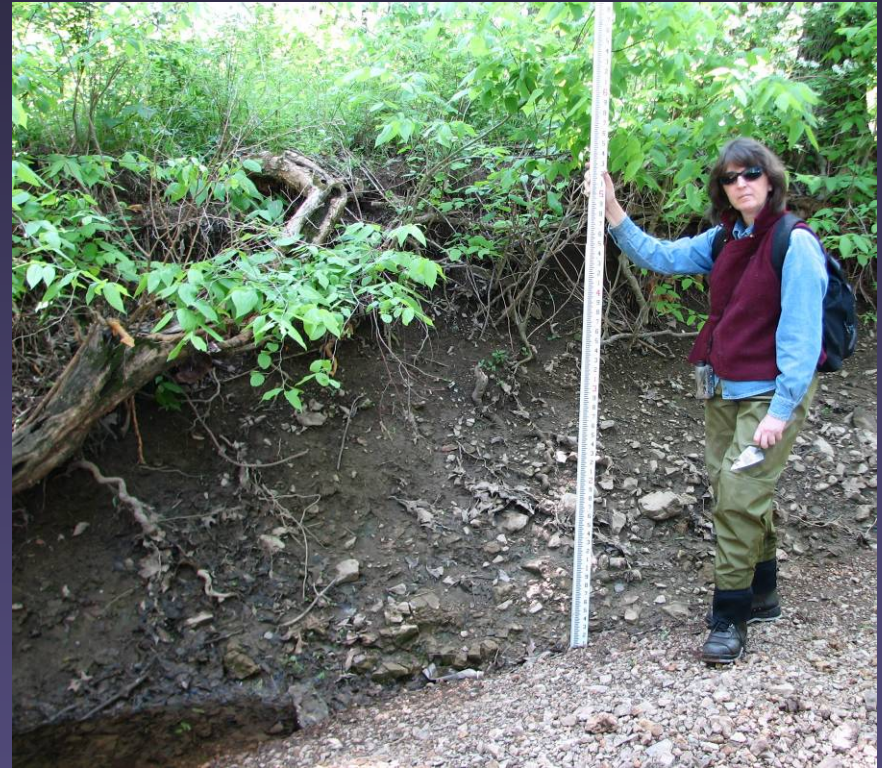
# Streambank Inventory

- Bank Erosion Hazard Index (BEHI)
- Near-bank Sheer Stress
- Osage Creek and tributaries within the project area
- 400 individual streambanks evaluated

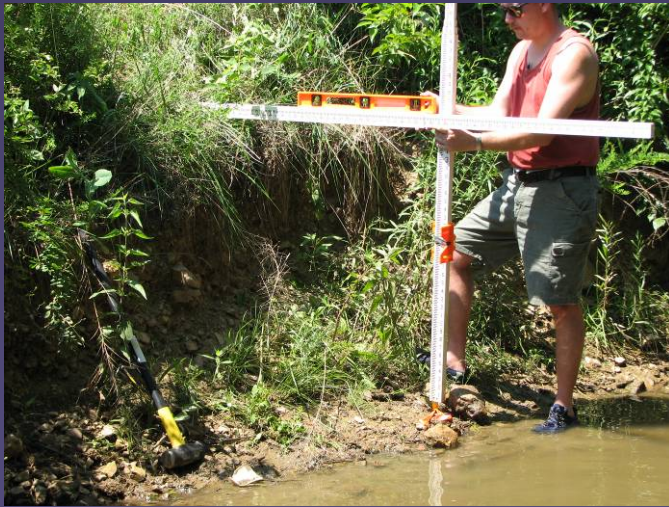
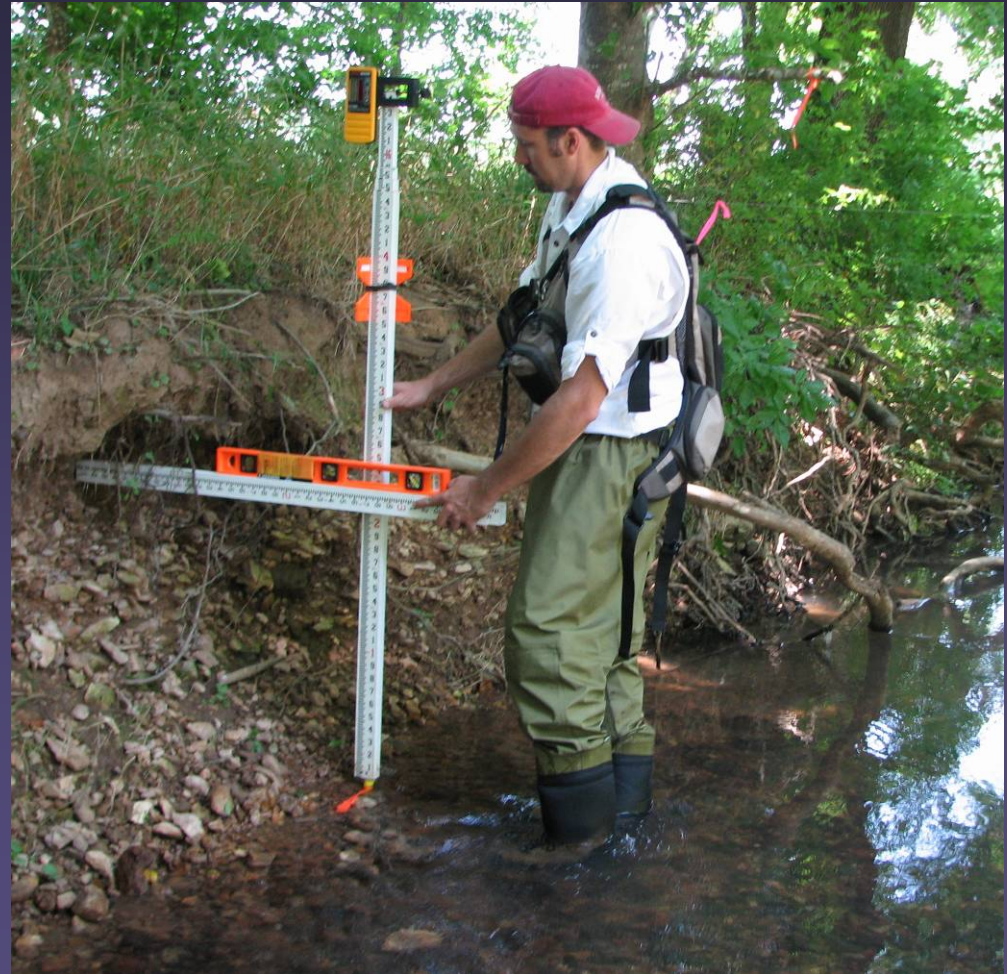
# Toe Pin Installation

- 9 sites
- 30 cross-sections
- 39 toe pins

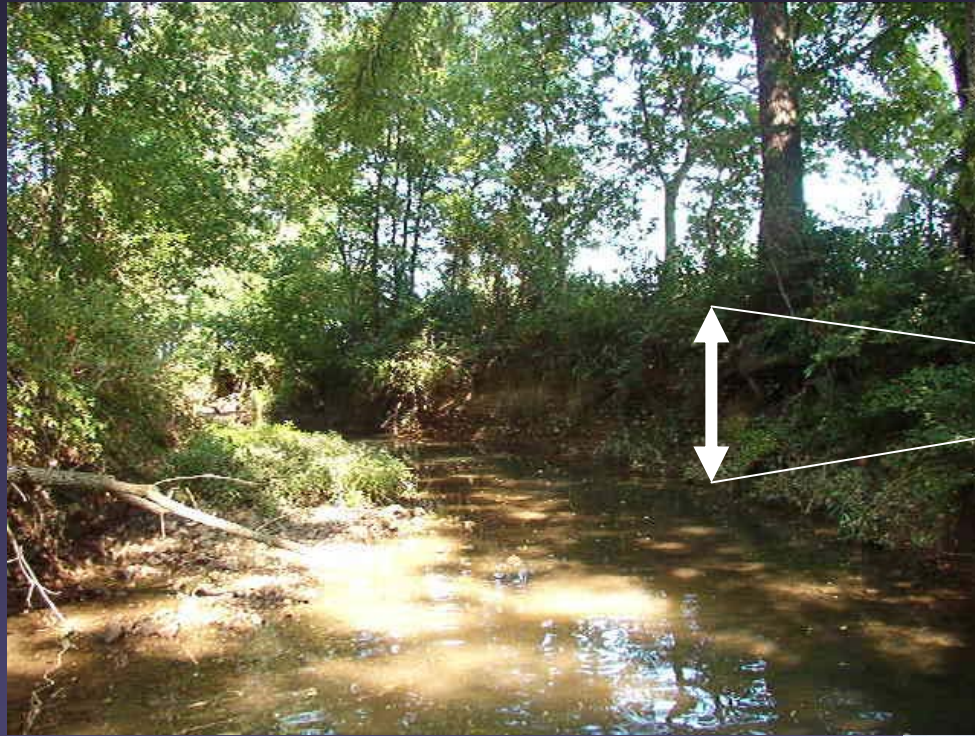
# Geomorphic Characterization

- Incised channel
- Eroded Bank

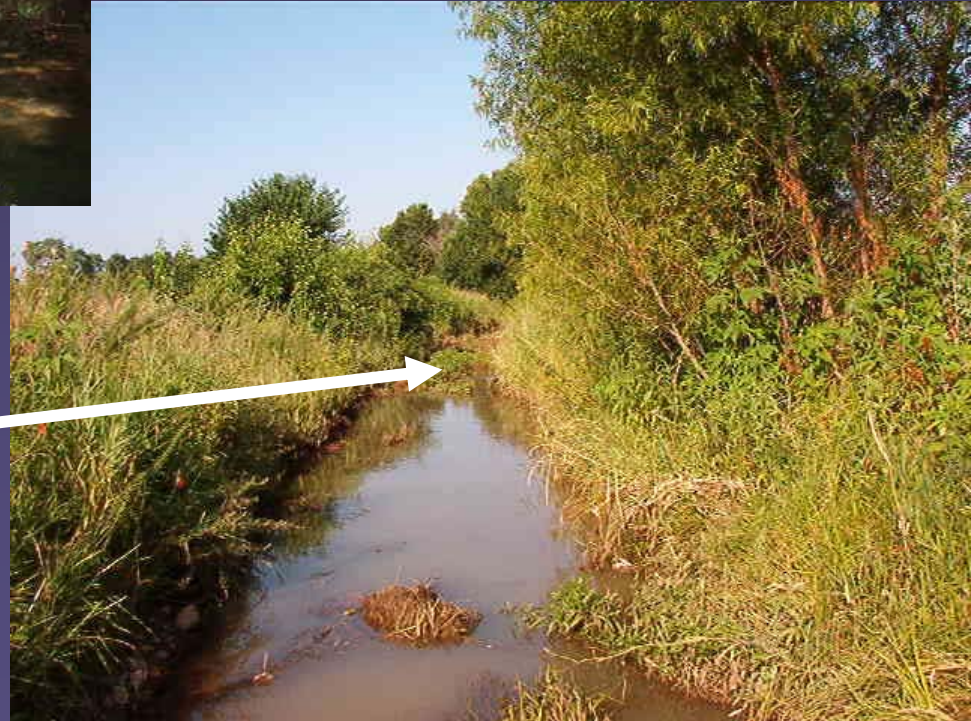
Head cut

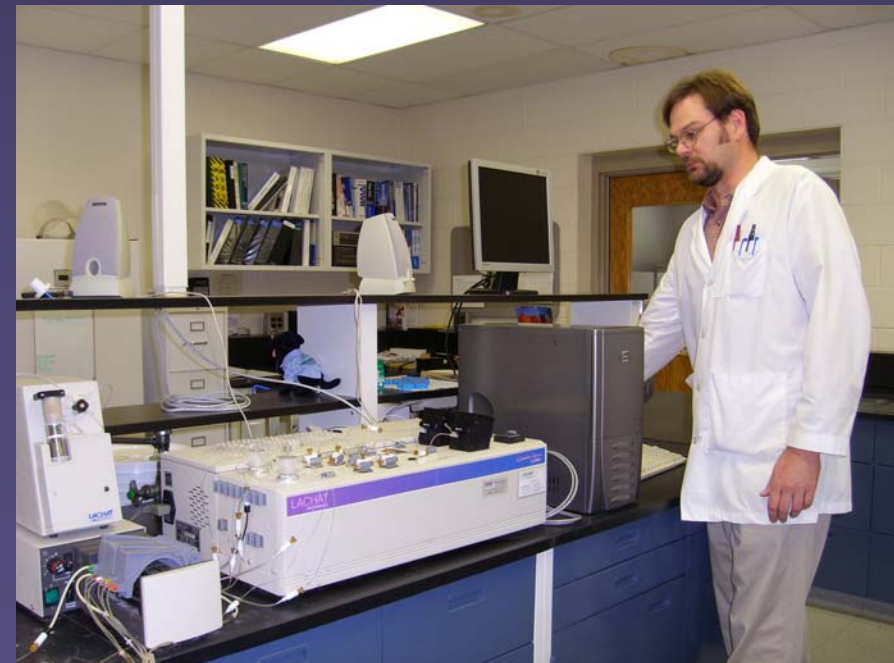
# Water Quality and Quantity Monitoring

- NO<sub>3</sub>-N
- NH<sub>3</sub>-N
- TN
- TP
- PO<sub>4</sub>
- TSS
- Conductivity
- Turbidity
- Temperature
- pH
- Flow
