Project Activity Report

OHV Trails 319 Project

ANRC Project 06-700
September 17 & 18, 2008

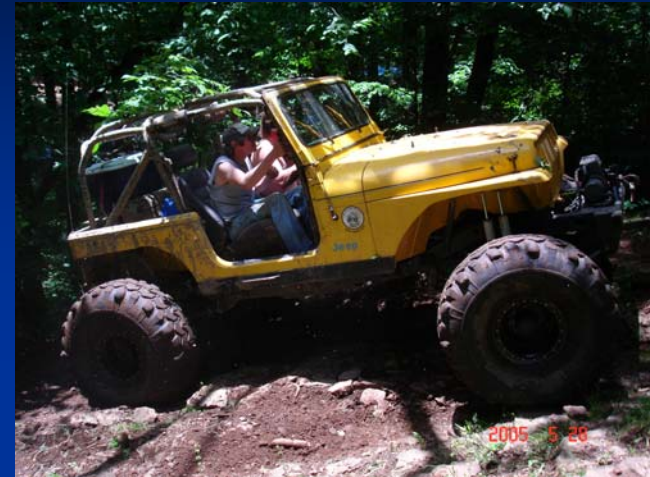
- ✓ **Conduct Trail & Road Inventory using GPS – completed 2007**
- ✓ **Evaluate soil erosion**
 - ✓ Measure in the field – selected, installed, & surveyed monitoring sites – initial completed 2008; resurvey is ongoing & final will be early 2009
 - ✓ WEPP modeling – data collection scheduled for fall 2008; modeling schedule for 2009
 - ✓ Both will be used to estimate sediment loads from OHV trails and sediment load reduction from BMP implementation

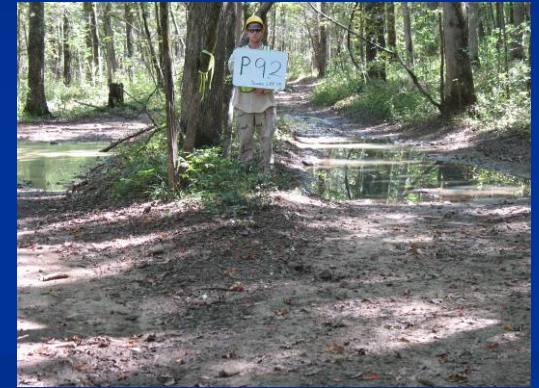
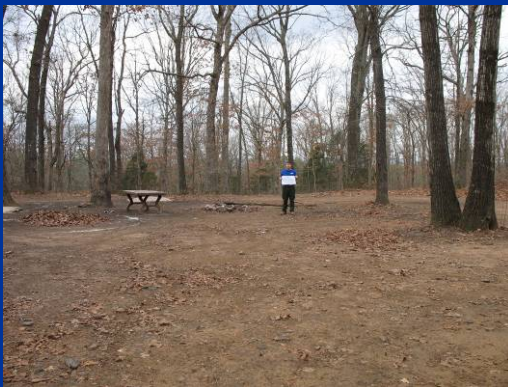
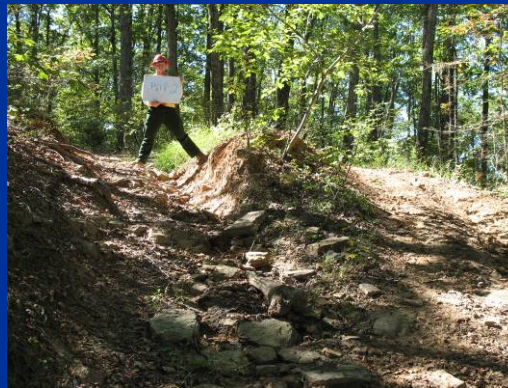
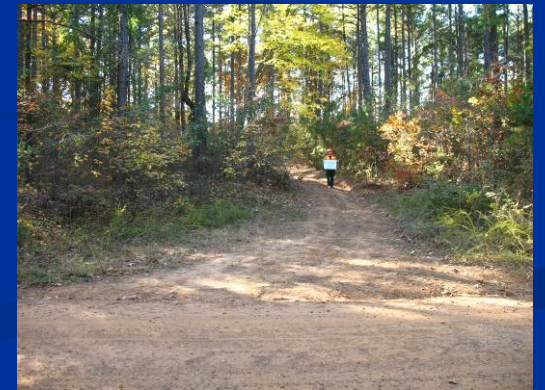
- Data Collection – Evaluate Soil Erosion
 - Cross Section Measurements
 - Photopoint Monitoring
 - Soil Disturbance Monitoring

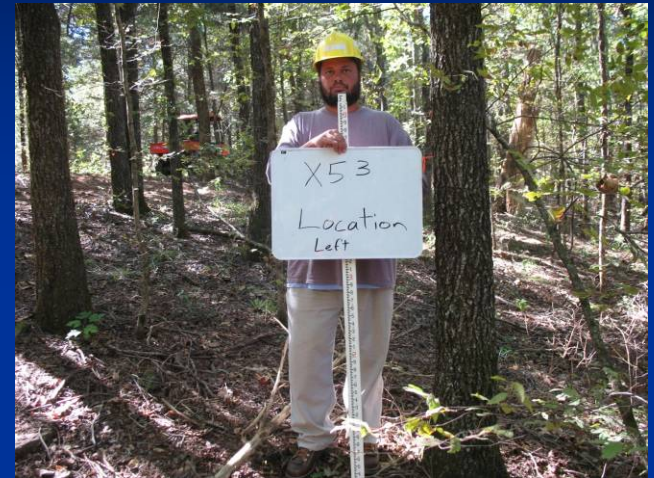
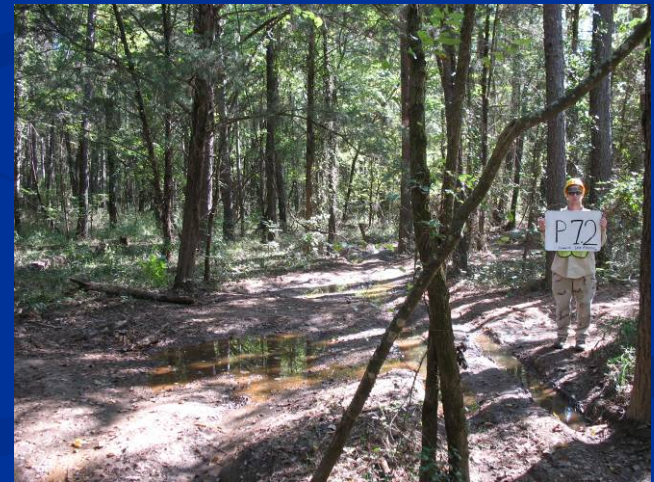
■ Cross Section Measurements

- Measure erosion of trails
- 4 Terrain Types
 - ✓ Hillside
 - ✓ Mountain Tops
 - ✓ Steep Grade
 - ✓ Riparian
- Multiple cross sections per site
- 14 sites
- 34 cross-sections established
- Follow-up measurements

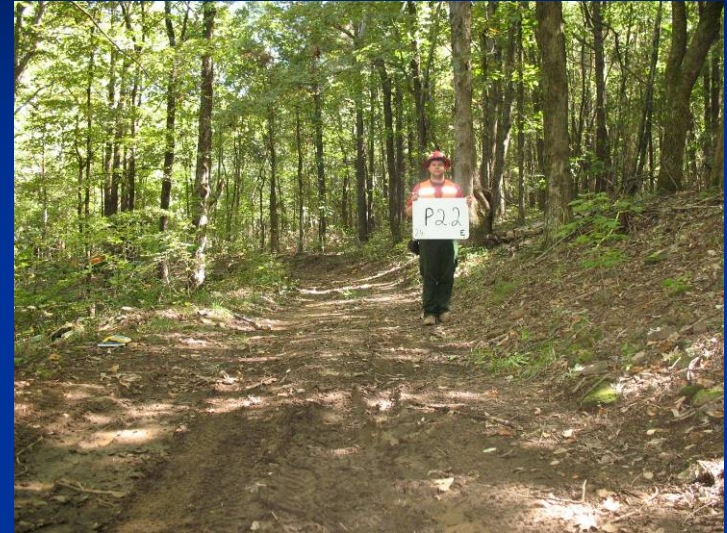
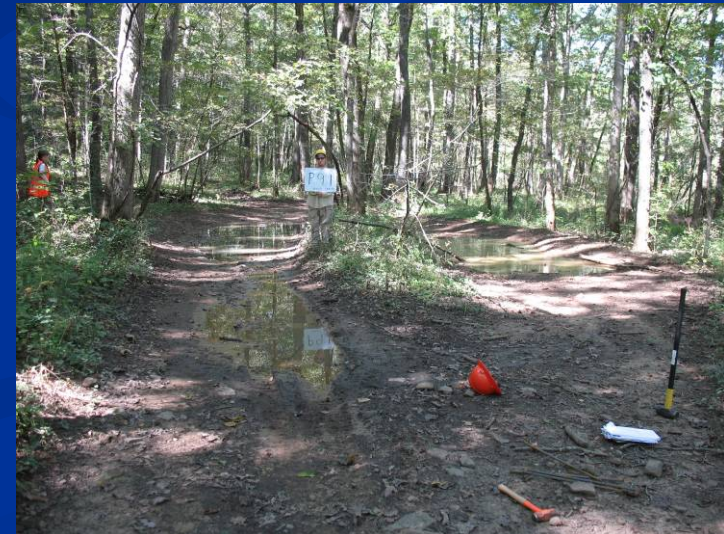
- Photopoint Monitoring
 - Detect Changes in Trail Conditions
 - Before and After Photos
 - Photos taken at:
 - Cross-Sections
 - BMP Sites

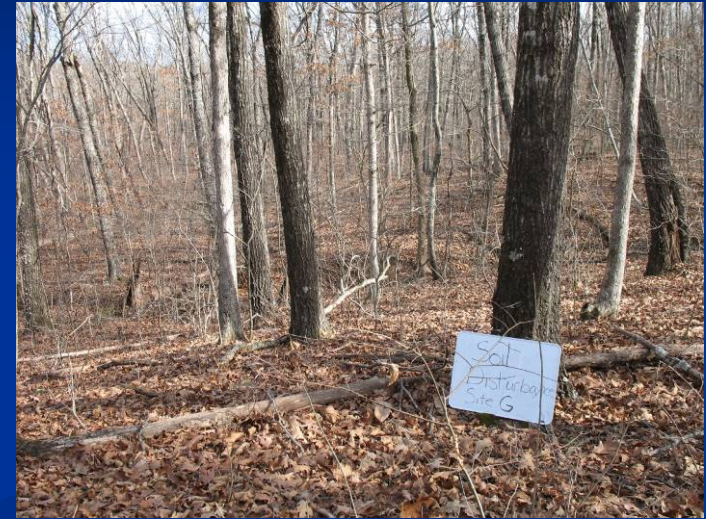
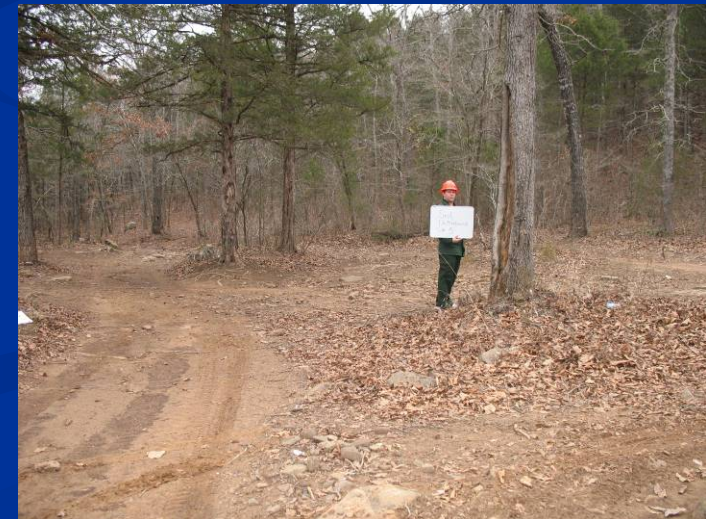
- Soil Disturbance Monitoring
 - Detect changes in soil disturbance
 - 15 Sites
 - 10 Randomly Selected
 - 5 Pre-determined
 - 10 transects at each site

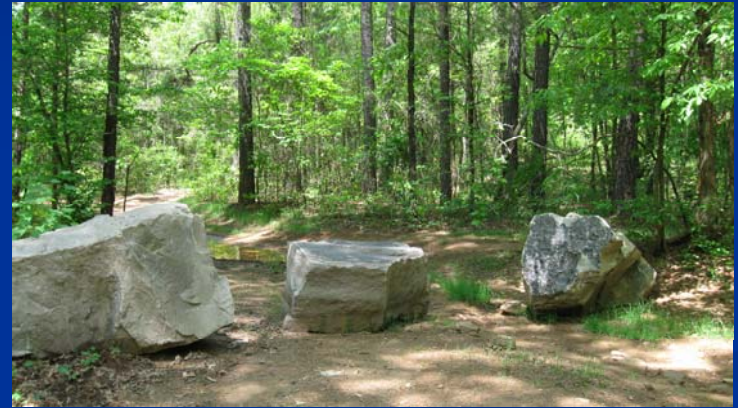
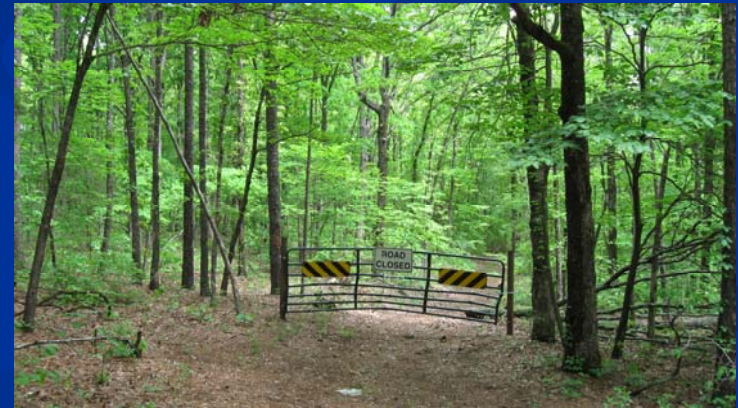
- **Road Closure** – select areas physically closed to OHV use in order to reduce erosion, lower road density, and to enhance wildlife habitat values.
- **Install physical barriers to road:**
 - Rocks
 - Vegetation
 - Gates
- **Physically remove roads from the ground**
- **Planting road prisms with native vegetation**
- **Enhance vegetation**
- **Signage**
- **Increasing user awareness and enforcement**

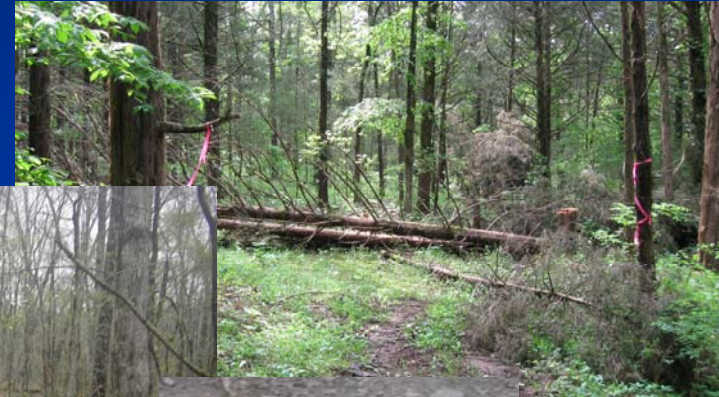
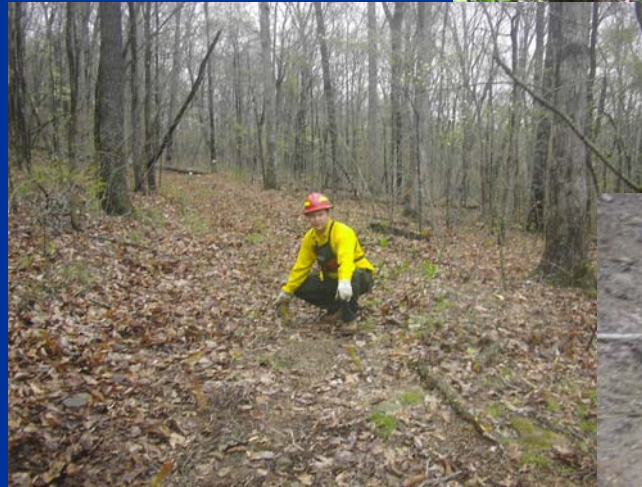
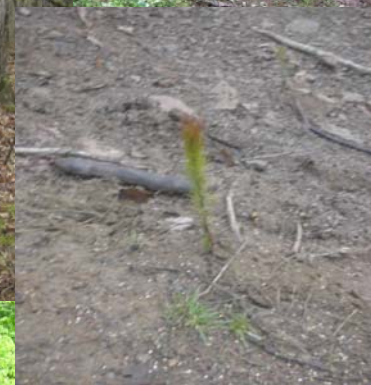
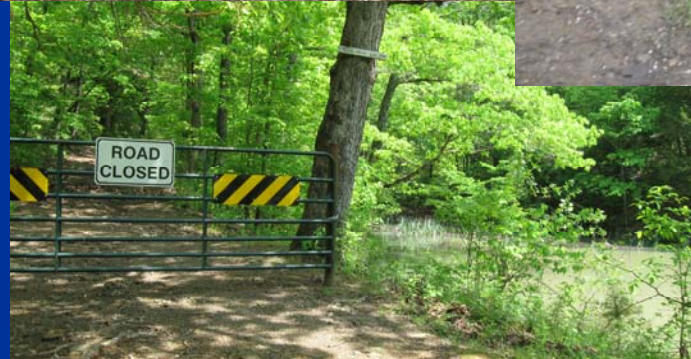
Decommissioned and Closed Roads

- 12 miles of Roads Decommissioned

- Seeding
- Fertilizing
- Tree Planting
- Limit Access

- 4 miles of Closed Roads

- Gates (4)
- Trees (8)
- Boulders

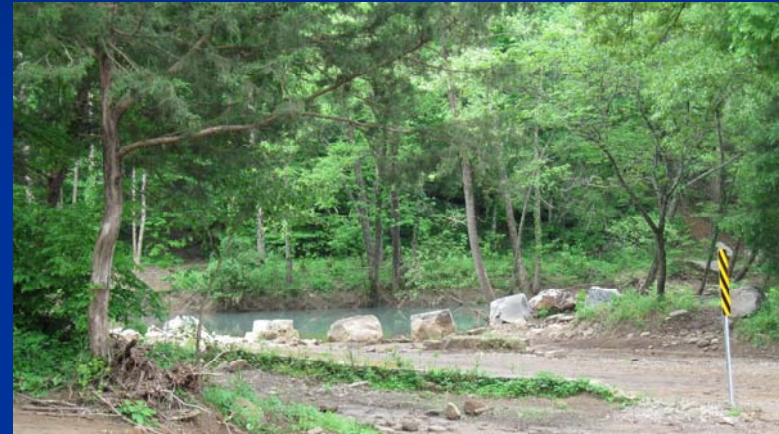
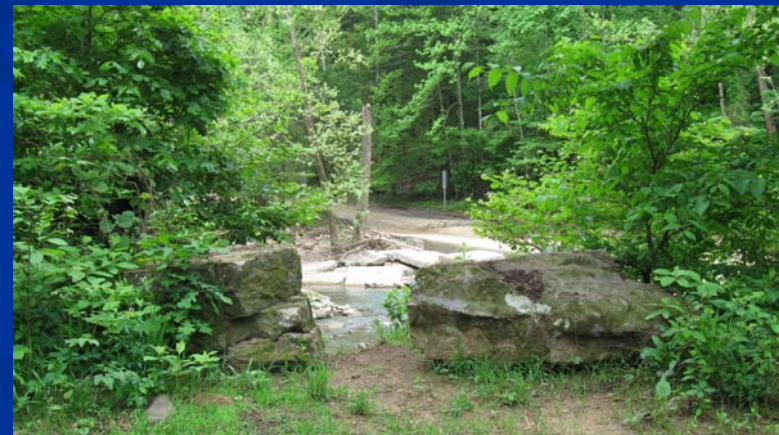
- **Reduce access to streams** – to improve water quality, reduce soil loss and erosion, and to improve riparian function
 - Minimize access to the stream through one or more of the following
 - Rocks
 - Vegetation
 - Trail Route/Re-route
 - Road Closure
 - Utilize construction process to create barriers
 - Design and create acceptable stream crossings
 - Stimulate riparian revegetation
 - Signage showing stream access is restricted.
 - Enhance the ability for enforcement

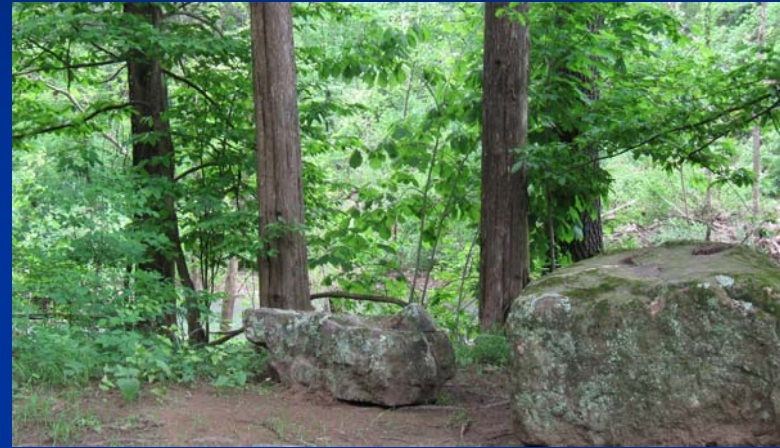
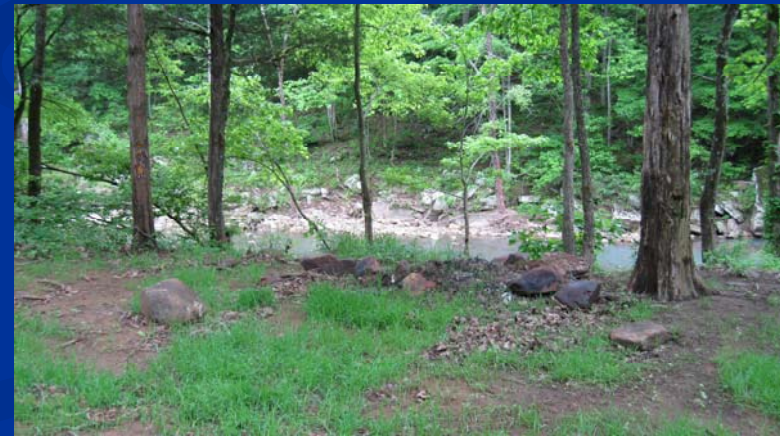
- **Reducing the number dispersed recreation sites**

- Techniques for restoration will be evaluated by this activity:
- Minimize access to the site through one or more of the following
 - Rocks
 - Vegetation
 - Signs
- Plant disturbed areas
- Utilize erosion control technologies
- Construct new suitable recreation sites
- Stimulate natural vegetation
- Enhance the ability for enforcement

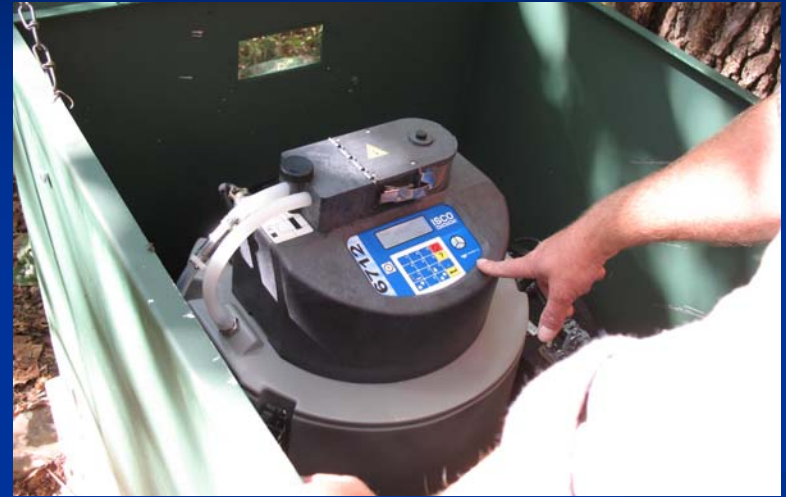
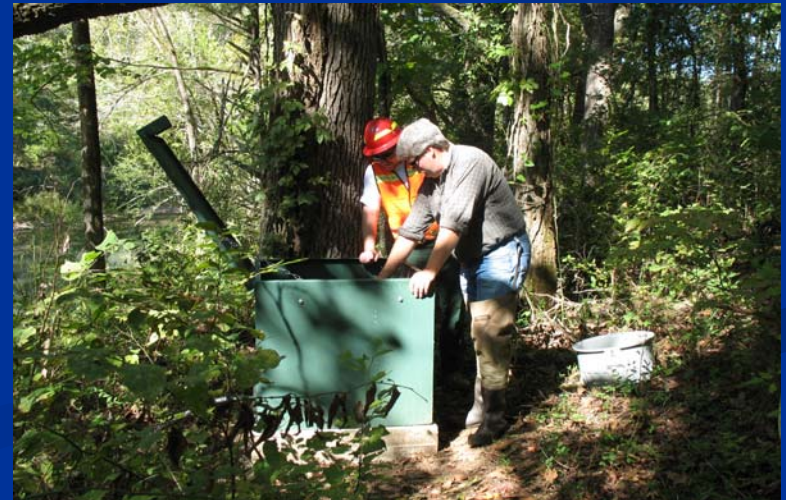
- Evaluate trends in water quality during project activities
- TSS and Turbidity Analysis
- 208 Baseflow Samples
- 675 Storm Samples
