West Fork White River Stream Restoration Project ANRC Project 07-400

Watershed Conservation Resource Center

Demonstration of Natural Channel Design to Restore a Stream Reach Draining an Urbanized Sub-Watershed of Mud Creek ANRC Project 06-600

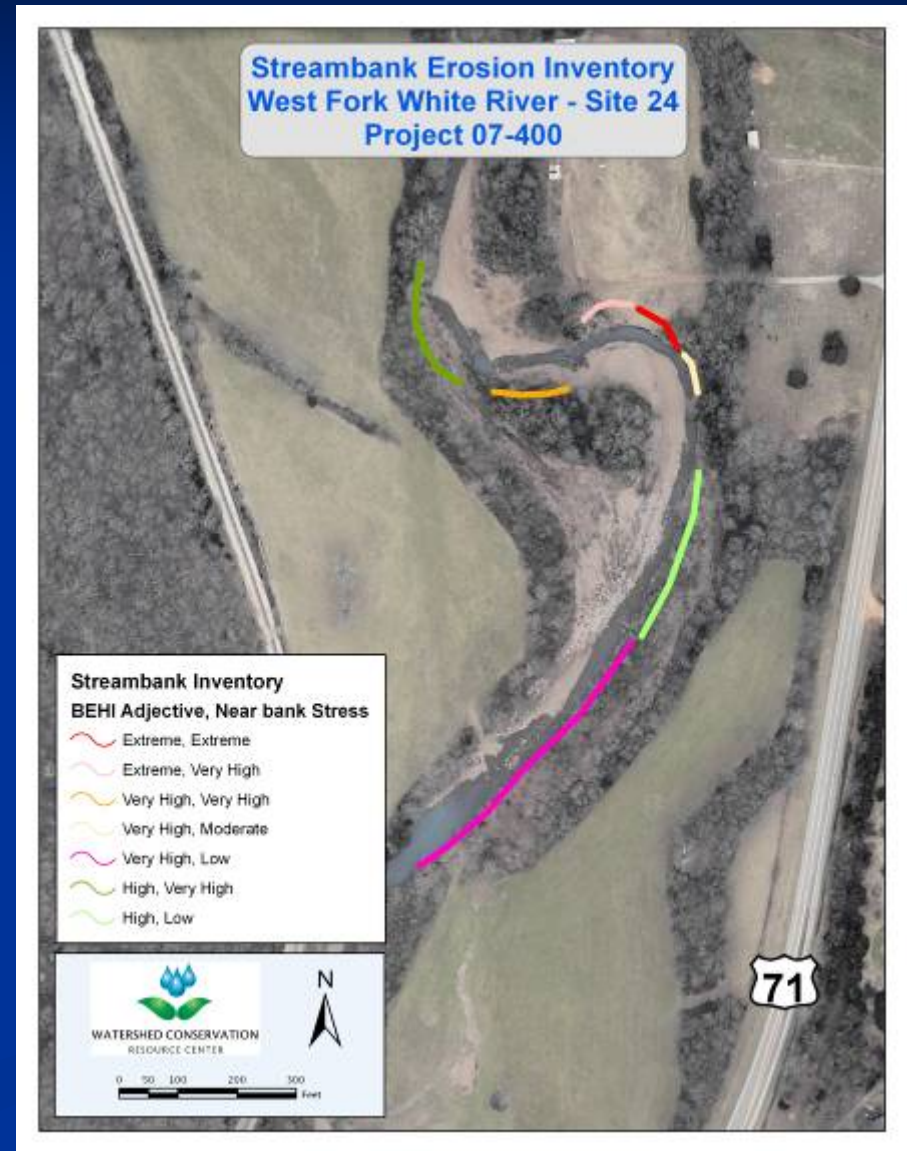
BEHI Mapping

- 7 Mapped Areas
- Total Estimate of Eroding Banks 1400'
- Max Estimated Erosion Rate: ~10 ft/yr
- Estimated Sediment Load: 845 ton/yr

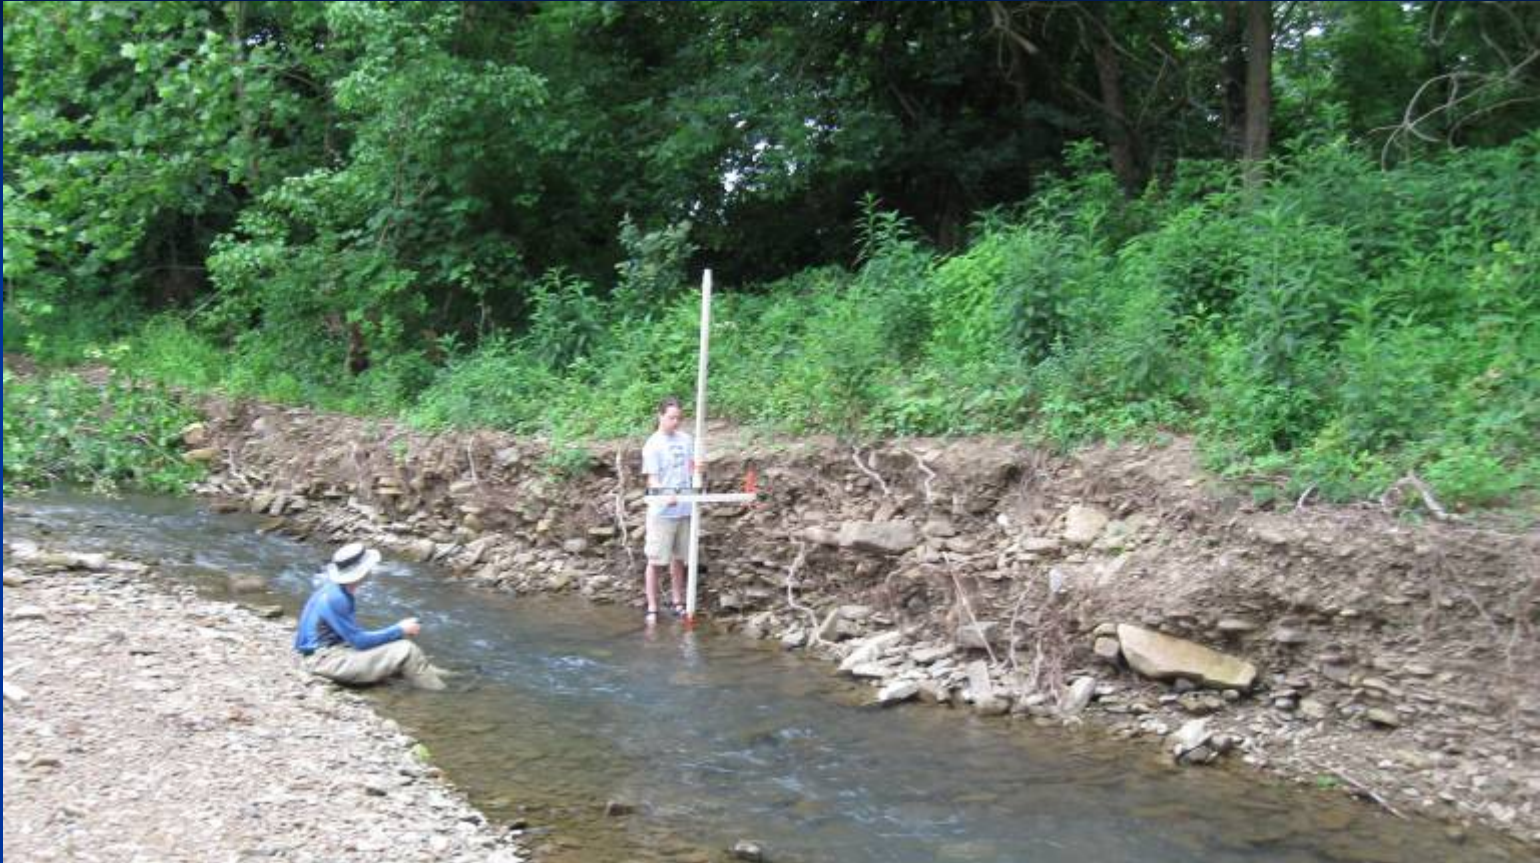
Toe Pin Installation

- 7 Toe Pins Installed (06/24/2008)
- Used to Determine Erosion Rates

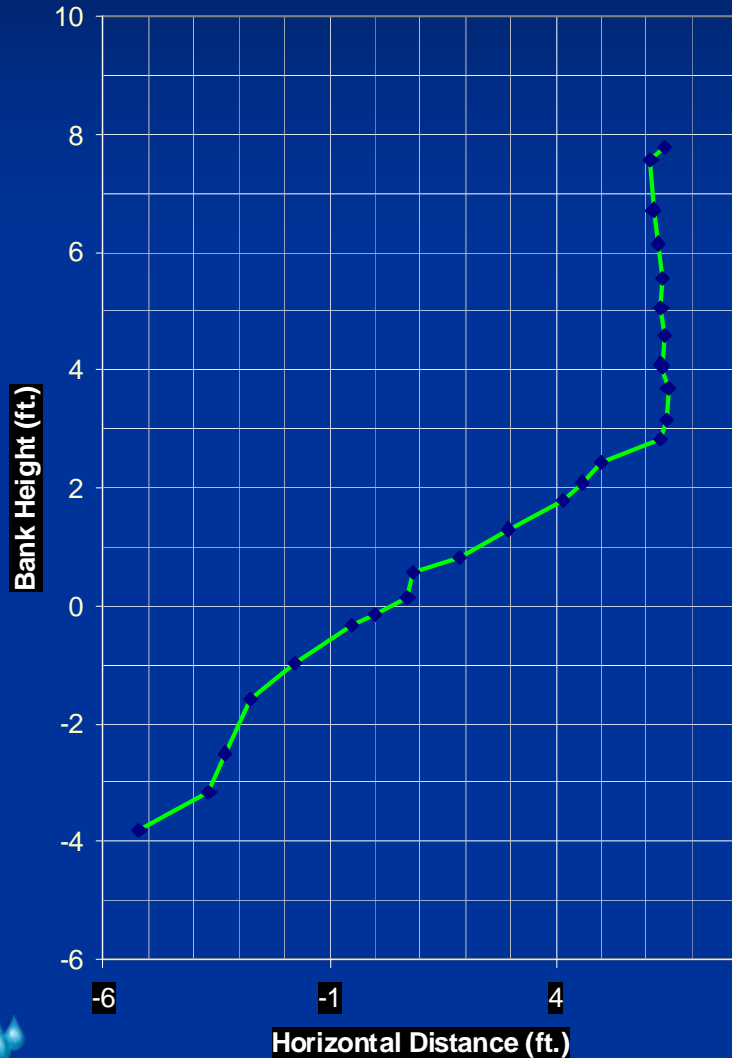
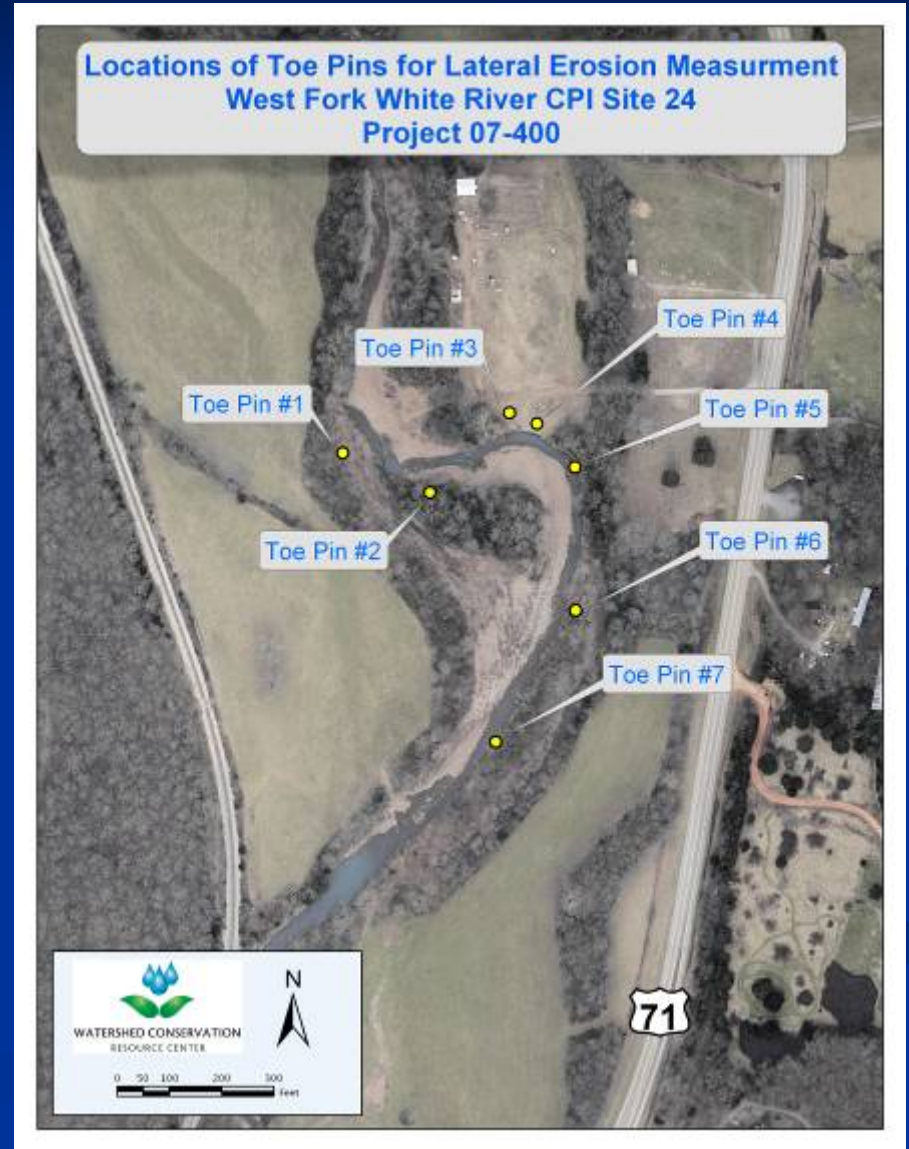
Toe Pin Installation

Toe Pin 3 Profile
as of 6/25/2008

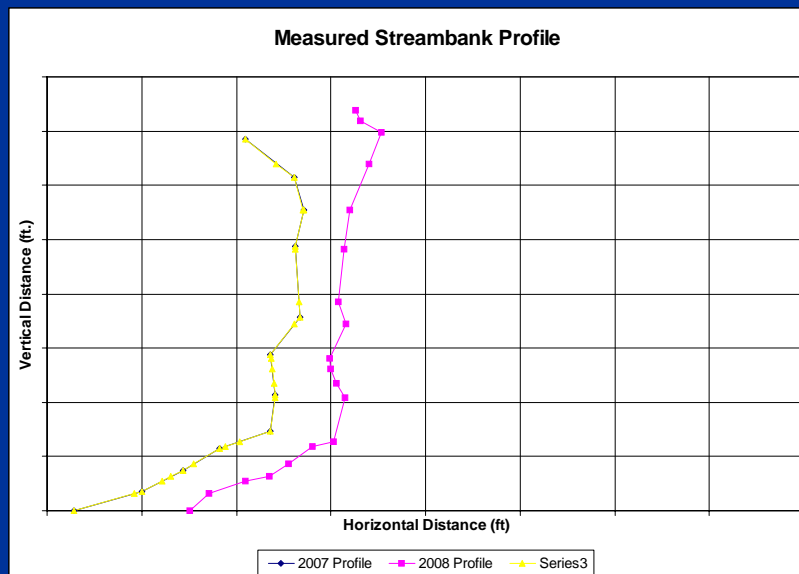
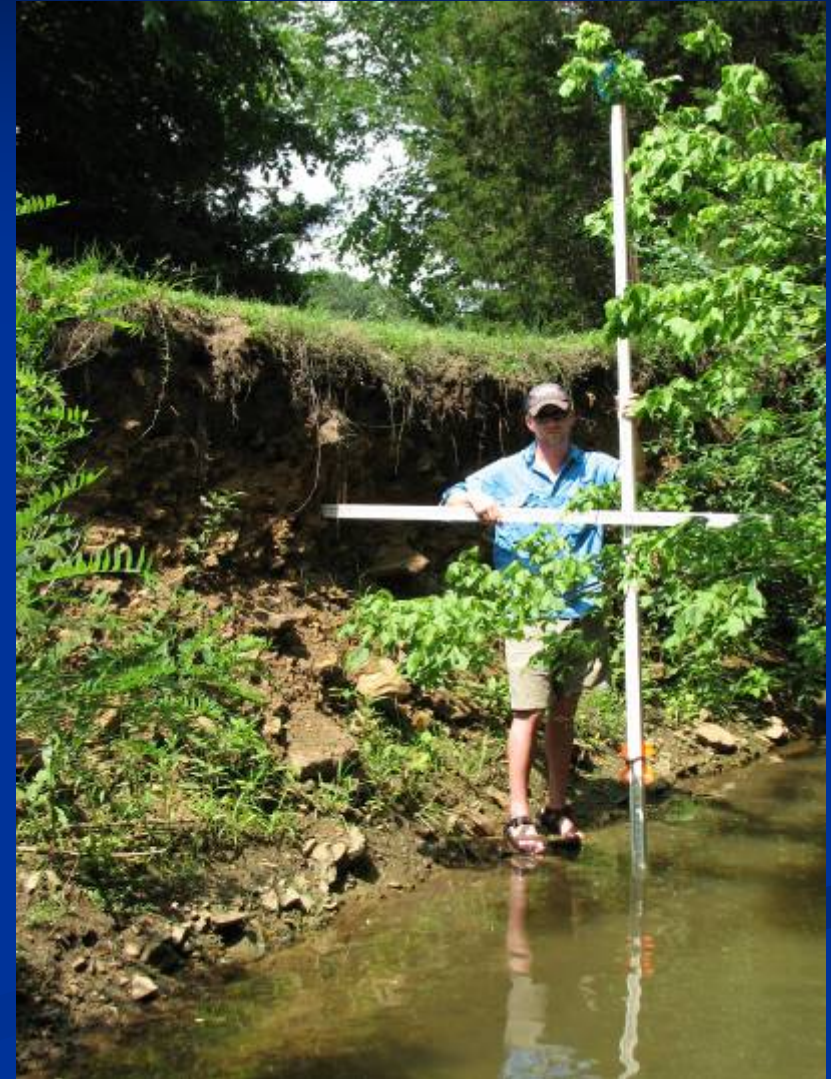
Toe Pin Measurement and Analysis

- Erosion Rate:
Range 0.2 to 0.7 ft/yr
- Estimated Sediment Load:
120,000 lb/yr

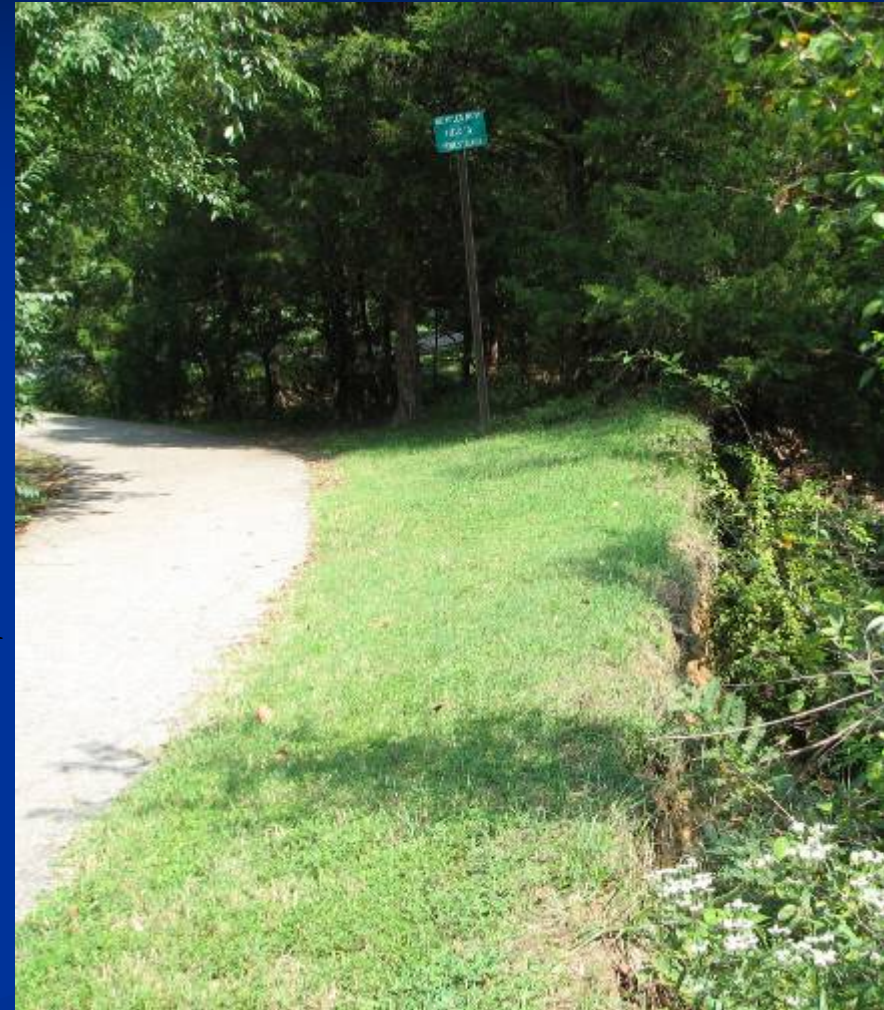
Design Constraints

- Floodplain No-Rise
- Park Infrastructure
 - Trails
 - Bridges
 - Sewer Lines
- Fixed Flood Prone Width
- Limited Allowance for Vegetation Removal
- Presence of Park Patrons

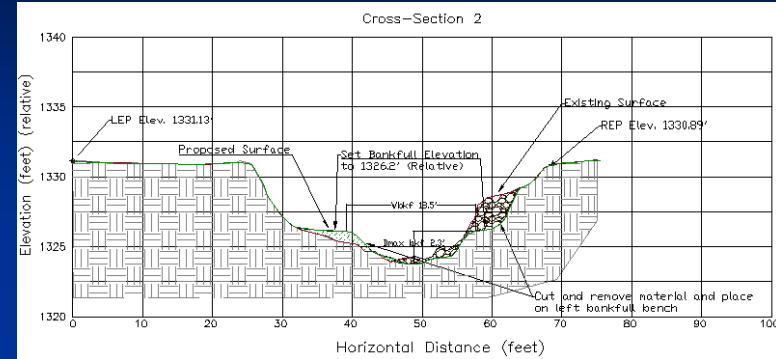
Design Specifics

- Detailed Data Evaluation
 - Topographic Survey
 - Geomorphologic Analysis
 - Hydrology Analysis
- 40 Step Engineering Process
 - Dimension, Pattern, Profile
 - Flow Capacity
 - Sediment Transport
- Bankfull Discharge: 130 cfs
- Design Cross Section: 30 ft²
- Bankfull Slope: 0.01180 ft/ft
- Bankfull Shear: 1.04 lb/ft²

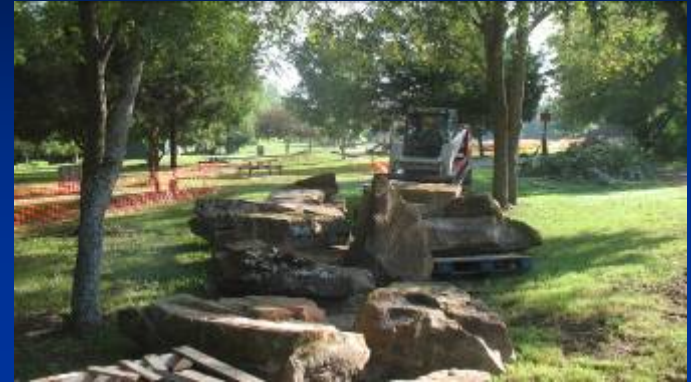
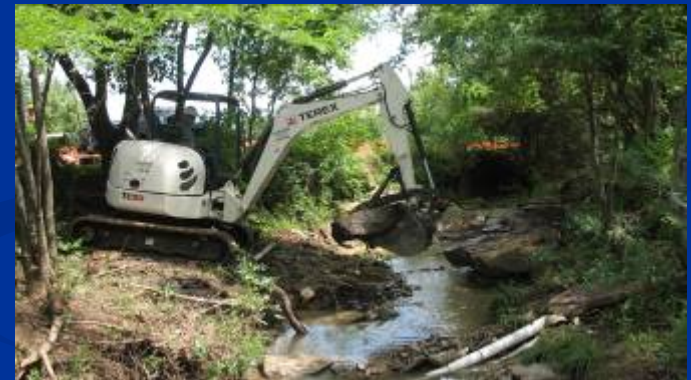
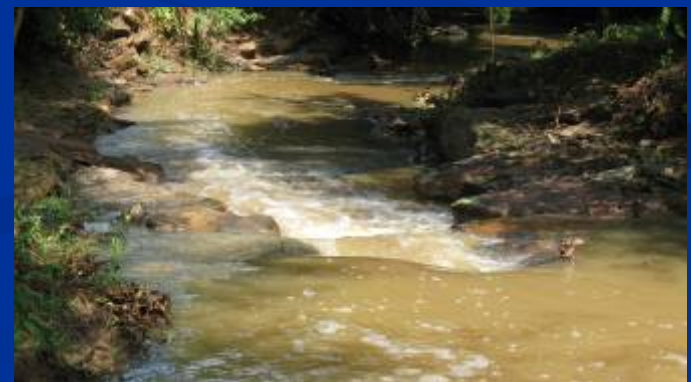
Structure Design

- J-Hook
- Cross-Vanes
- Short Vanes
- Rock Sizing
 - Based on shear force
 - Rock with 3 ft. B-axis
 - Approximately $\frac{3}{4}$ ton per rock
- Vane Slope and Length
 - 20' length with a slope of 8-10%

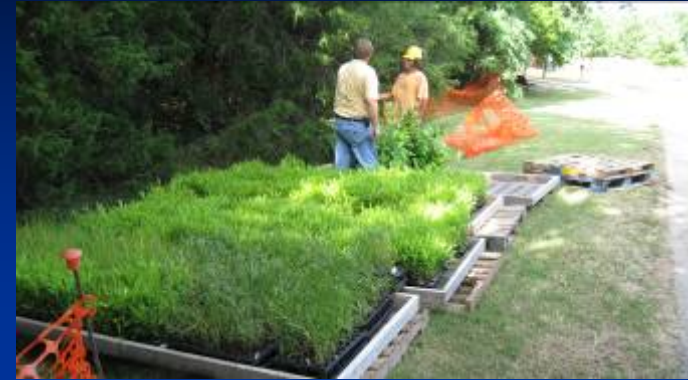
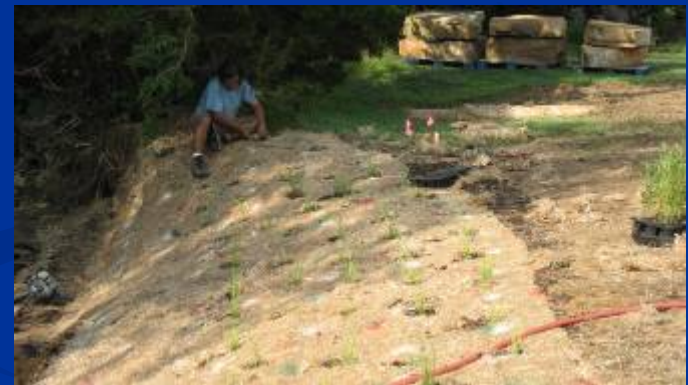
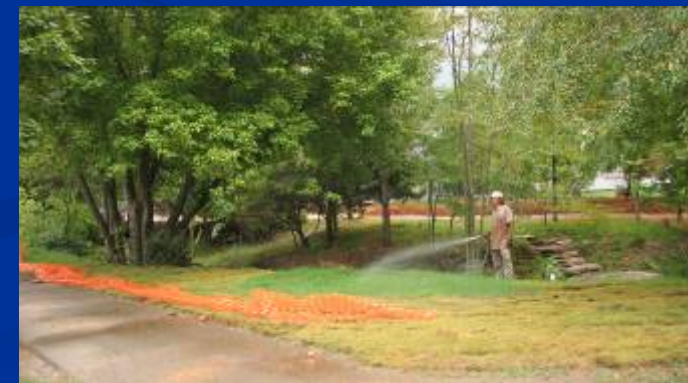
Revegetation Plan

- Critical Element of the Restoration Design
 - Provides Stability (high and moderate flows)
 - Habitat
 - Forage
 - Aesthetics
- Consult with local specialists
- 4000 Individual plants
- Native Species by Sun/Water needs
 - Inland Sea Oats, Prairie Drop Seed
 - Button Bush, Spice Bush
 - Green Ash, Plum, Wafer Ash, Sycamore
- Irrigation into late fall
- Additional planting in the fall

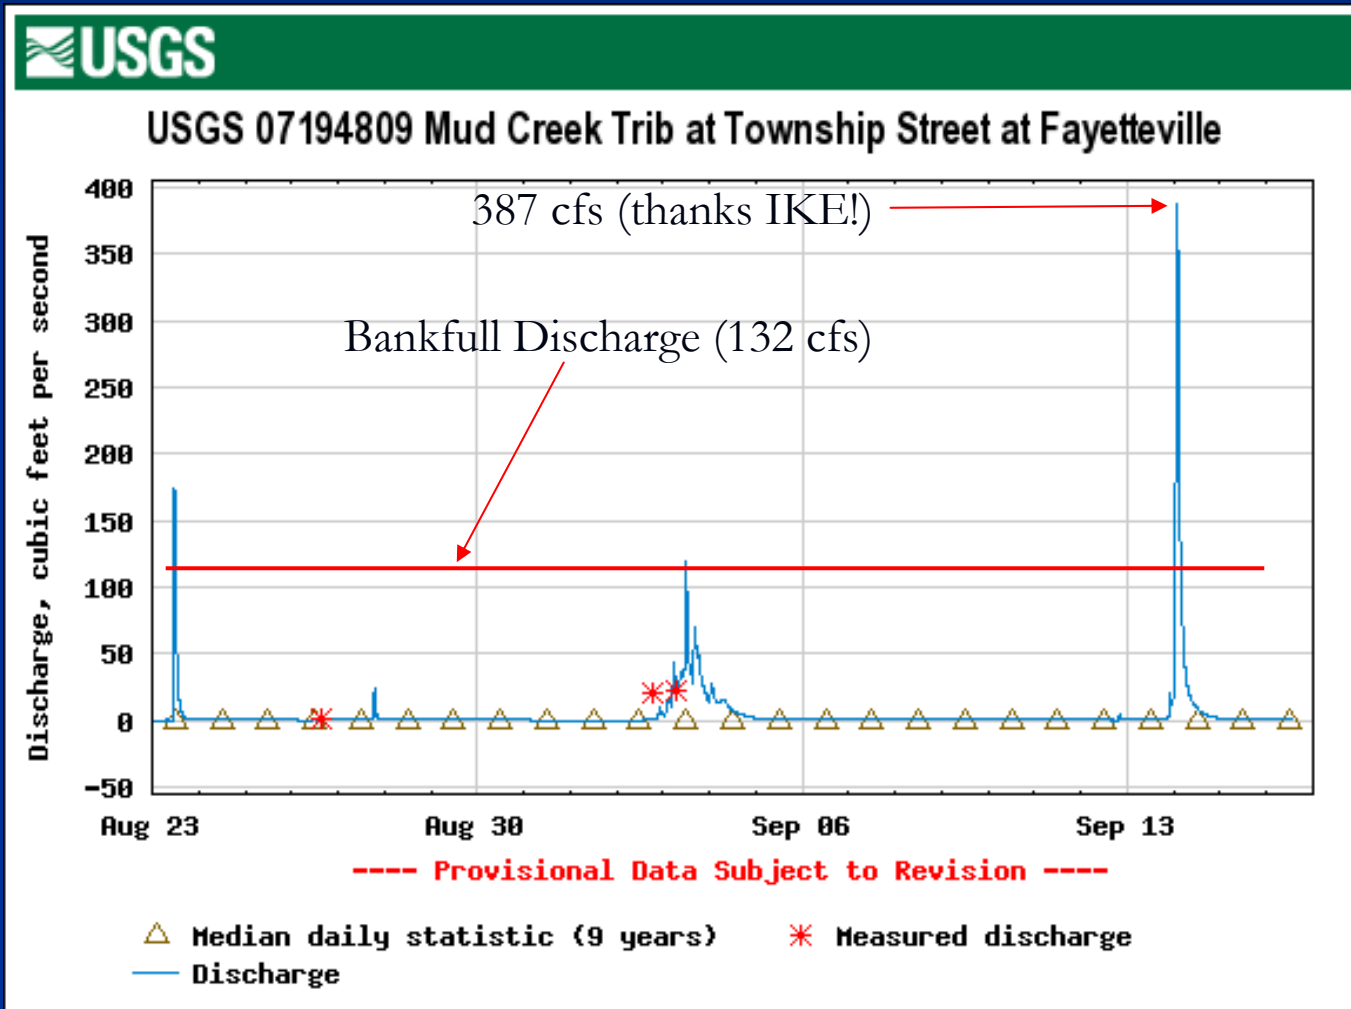
Post Construction Rain

Storm Events within 4 weeks of implementation
