White River Streambank Restoration Project

ANRC Project 09-1900

NPS Annual Meeting September 27, 2012

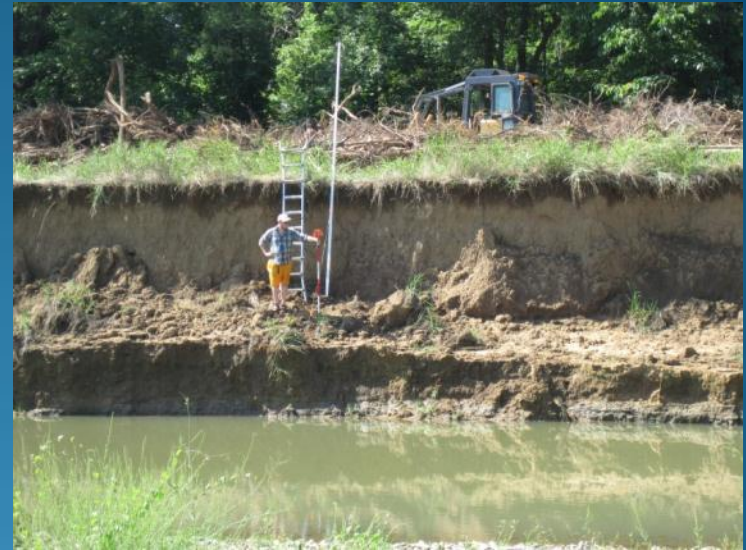
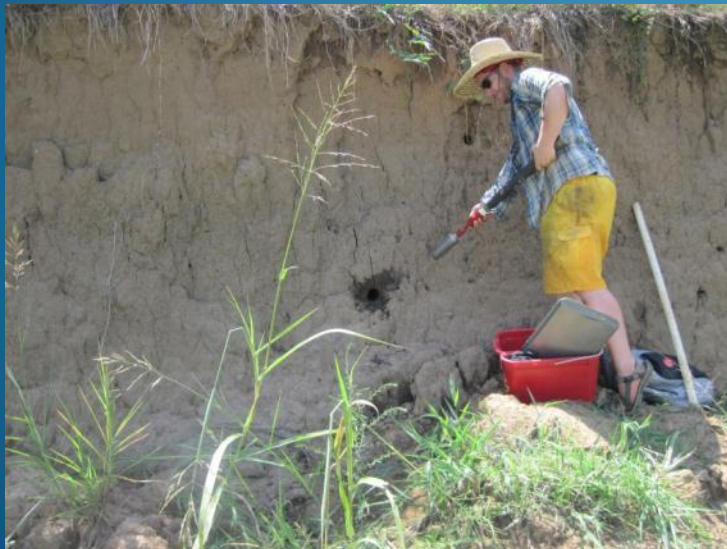
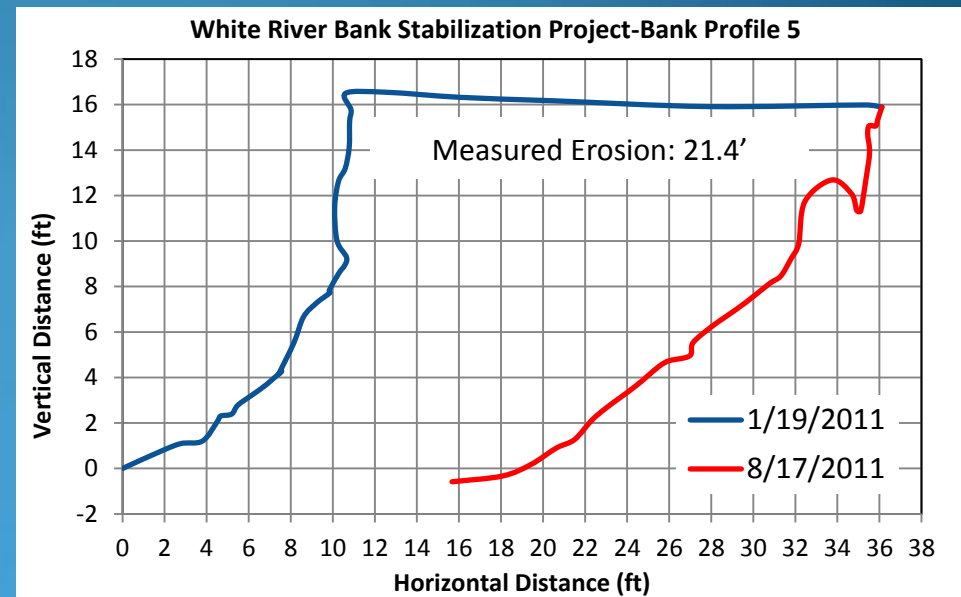
- Bank Erosion Monitoring
 - Bank Profile Survey
 - Resurvey After Spring Rain
- Bank Material Sampling
 - 30 Samples
 - Particle Size and Nutrient Analysis

- Bank Erosion Monitoring Results
 - Sites 1-5 ranged from 3.1 to 21.7 feet over a 7 month period
 - Included two major flood events that occurred in April and May 2011
- Air Photo Evaluation of Lateral Bank Erosion 2009 - 2011
 - Average rate over three years was 14 ft/year

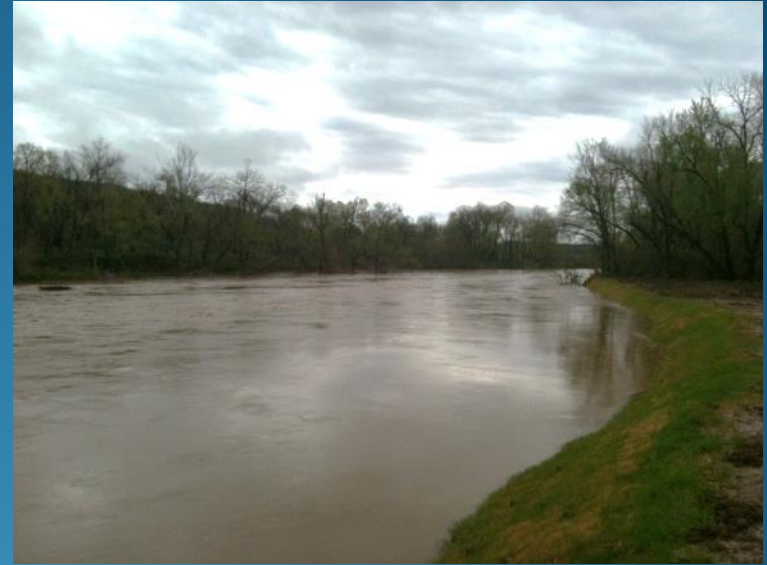
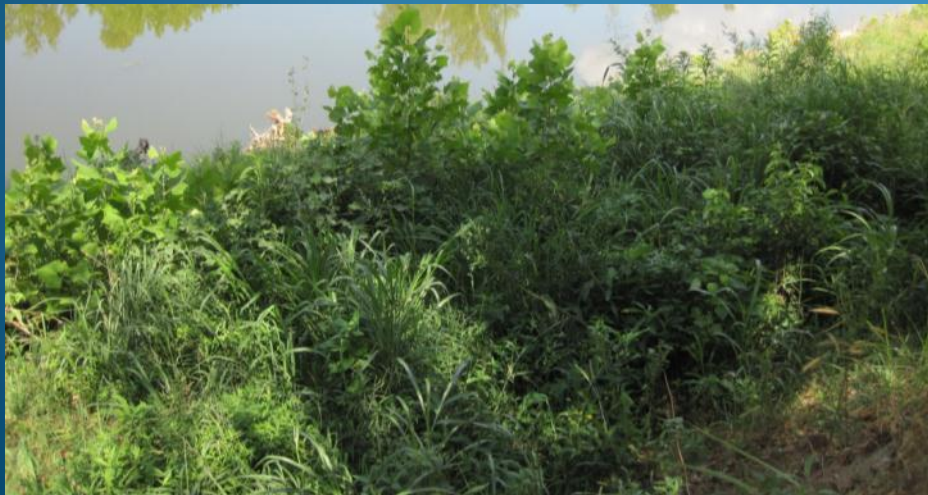
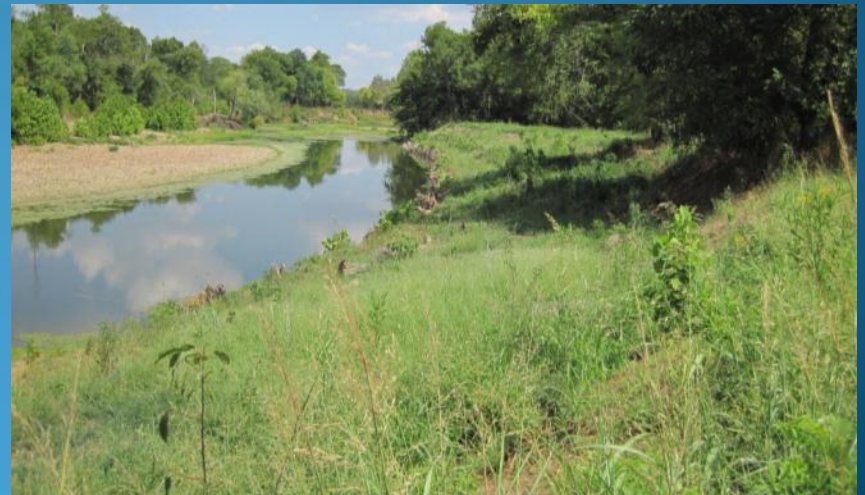
- March 2012 storm, peak flow 13,000 cfs
- Previously, similar storm events generated:
 - 2,000 - 4,000 tons of sediment
 - 2,000 - 4,000 lbs of total phosphorus
- No significant erosion
- Expect 95-100% reduction in annual sediment and nutrient loads from streambank erosion at this site for an average flow year:
 - 11,250 tons/year of sediment reduced
 - 10,500 lbs/year of total phosphorus
 - 19,500 lbs/year of total nitrogen
